UNDERWATER TECHNOLOGY

Hydrex

Case Study II: Hull Repair

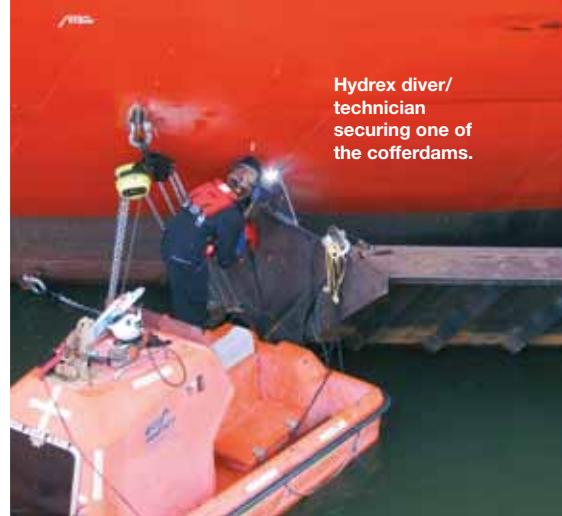
Hydrex diver/
technician
securing one of
the cofferdams.

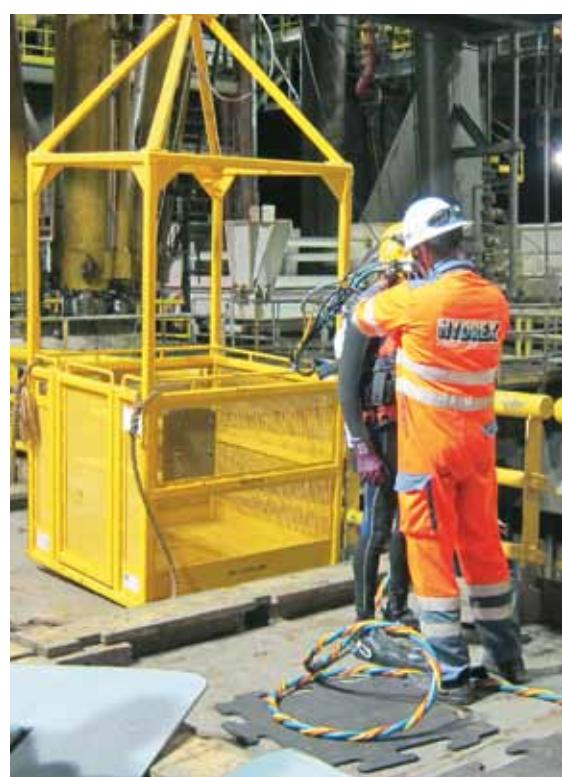
Final touches
being made to
the cofferdams.

was then removed from the thruster tunnel, creating a dry environment inside the tunnel. The required inspection and repair work could then be performed in conditions similar to those in dry-dock. Hydrex technicians removed the tunnel grid to gain access to the bow thruster unit, which was then inspected by original equipment manufacturer specialist who carried out necessary repairs. The Hydrex technicians then removed all the equipment from the tunnel and repositioned the grid. All that remained to be done was re-flood the bow thruster tunnel and detach the cofferdam.

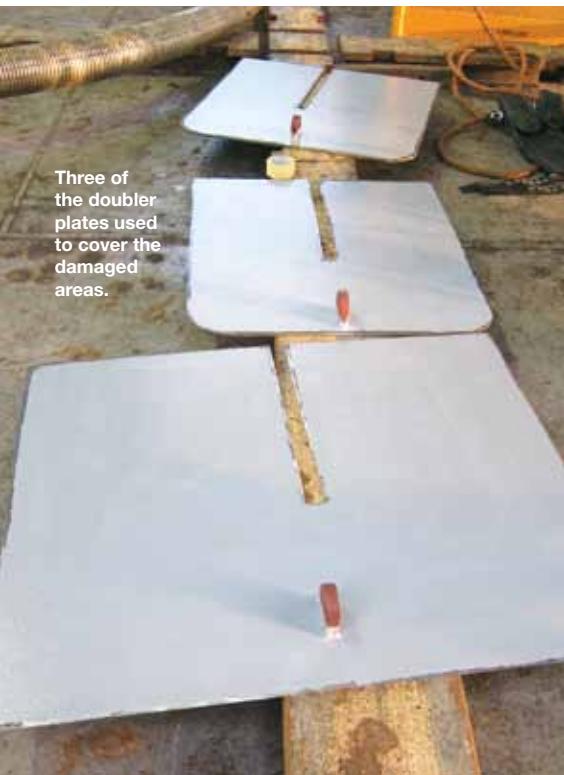
Three of the doubler plates used to cover the damaged areas.

allow the drill ship to sail to the Gulf of Mexico. This part of the operation consisted of the installation of five doubler plates over the damaged areas in the aft bulkhead. Constructed with the exact measurements taken during the detailed inspection, they were positioned and secured underwater by Hydrex certified diver-technician. All water was then emptied from the damaged ballast tank. The crew of the drill ship performed an inspection of the tank and confirmed that the compromised hull was once again fully sealed.

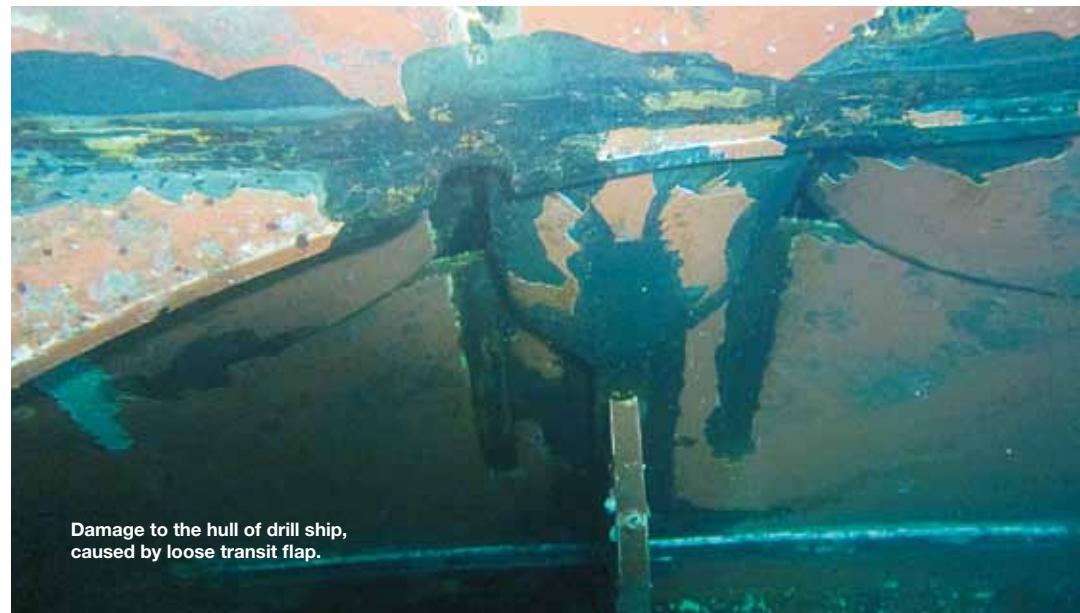
Damage to the hull of drill ship, caused by loose transit flap.

The transit flap of a 225m drill ship came loose and started swinging, causing damage in the aft bulkhead and a leak in the ballast tank. The vessel was located in Trinidad but was about to start a contract in Grand Isles, Gulf of Mexico. A fast solution was needed to prevent further damage and allow the ship to arrive in Grand Isles on time.

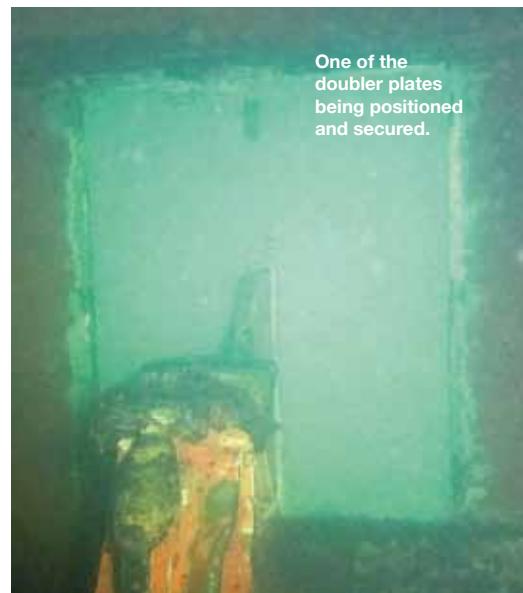
One of the doubler plates being positioned and secured.

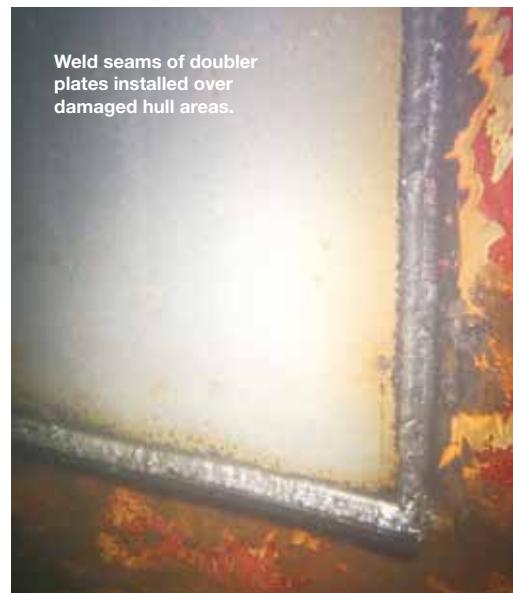
Weld seams of doubler plates installed over damaged hull areas.
