UNDERWATER TECHNOLOGY

Number 201

Underwater repairs in Poland allow ship to sail on after severe grounding damage

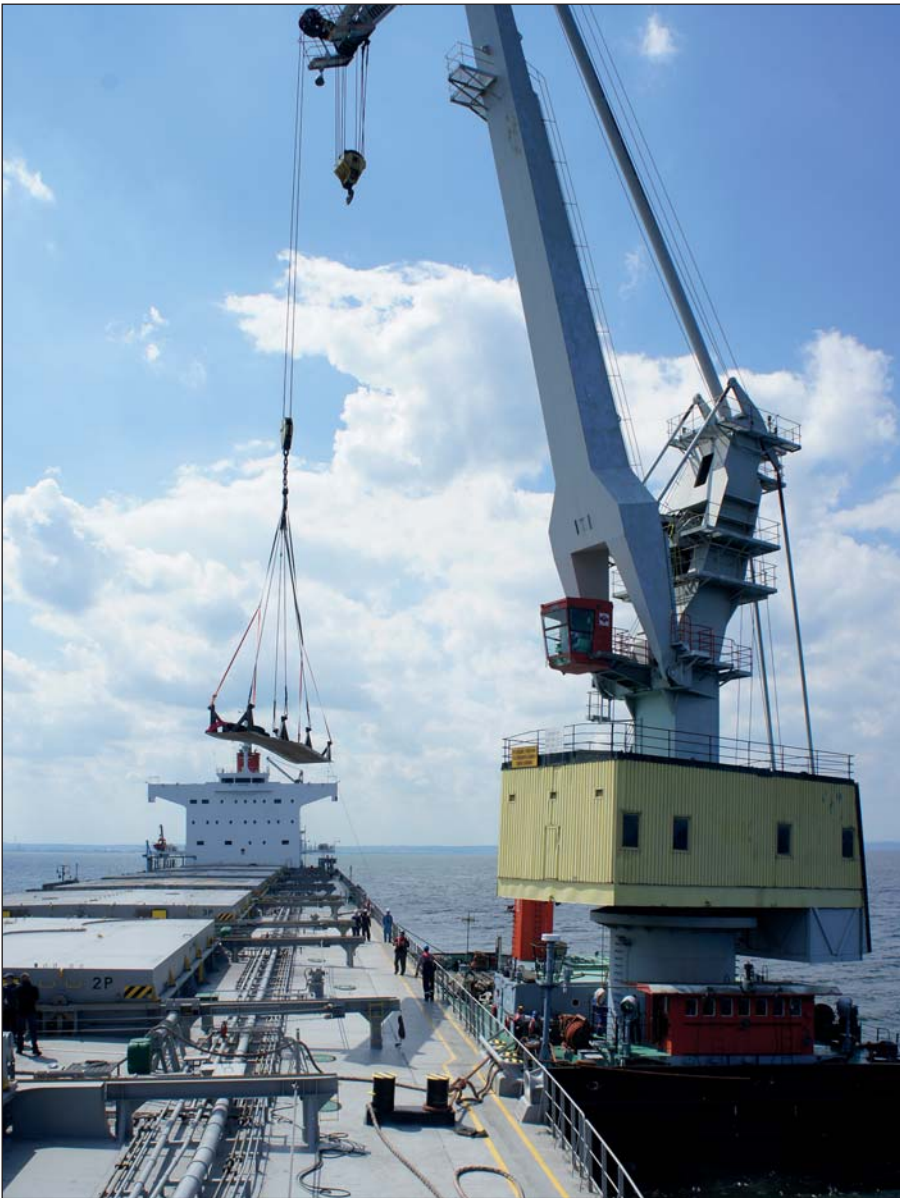
Large flat doubler plate lowered onto deck prior to installment.

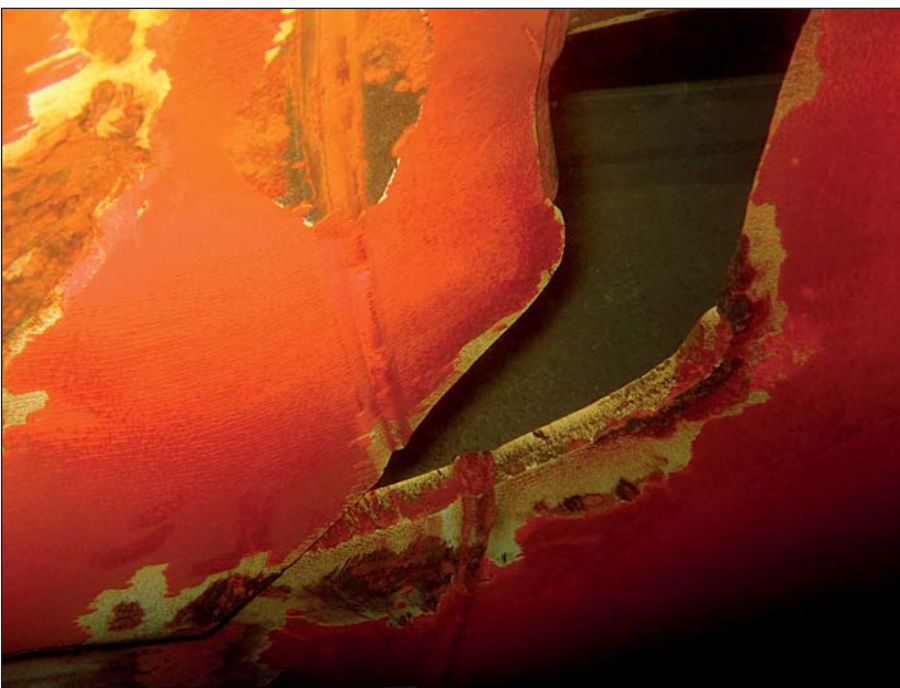
An initial inspection of the damage revealed a 14-meter longitudinal crack on the flat bottom that was up to 1 meter wide in the middle. A second crack was found on the port-

side near the collision bulkhead, measuring 2 meters by 15 centimeter. Several smaller cracks were also discovered in the same area.

The bulker had suffered severe grounding damage.

In Gdansk the operation started with the installation of a flat doubler plate over the largest part of the 14-meter crack. The area around the last part of the crack was too badly deformed and required a special doubler plate that would fit the new shape of the hull.

The first step was to get accurate measurements for the area of damage on a hull that was badly deformed, pierced and indented. These measurements were subsequently used in the fabrication of the doubler plate. The plate was made at a local dockyard under supervision of a Hydrex diver/technician. Extra stiffeners were welded on the doubler plate as additional reinforcements.

The doubler plate was then secured to the hull with a weld all the way around. With the large crack completely closed off, the Hydrex team moved on to the 2-meter crack in the bulkhead.

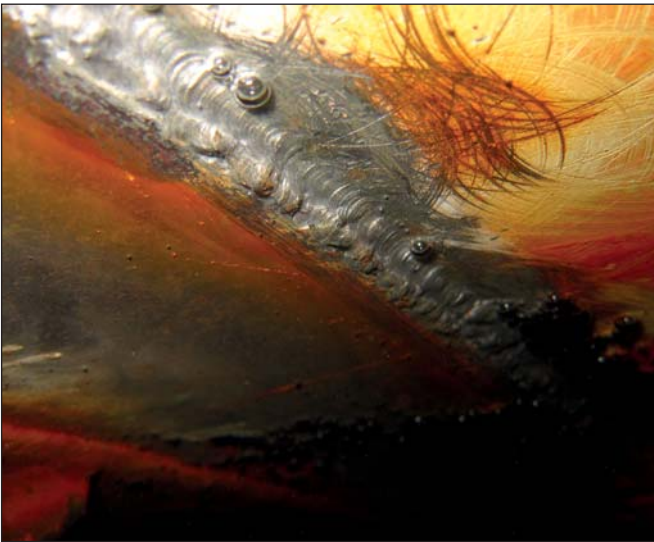
The doubler plates were secured all the way round with a full penetration weld.

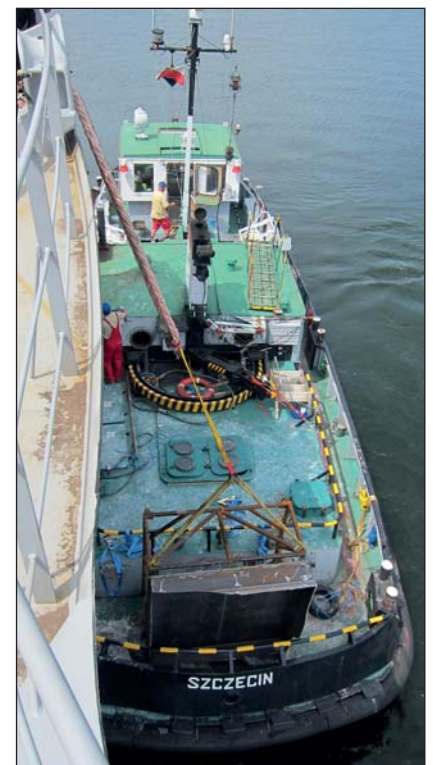
Cofferdam used for the second crack arriving on site.

Because the area around the second crack was deformed too extensively for a regular doubler plate, a special cofferdam was constructed. After it had been constructed, the cofferdam was positioned over the crack and welded all the way around.

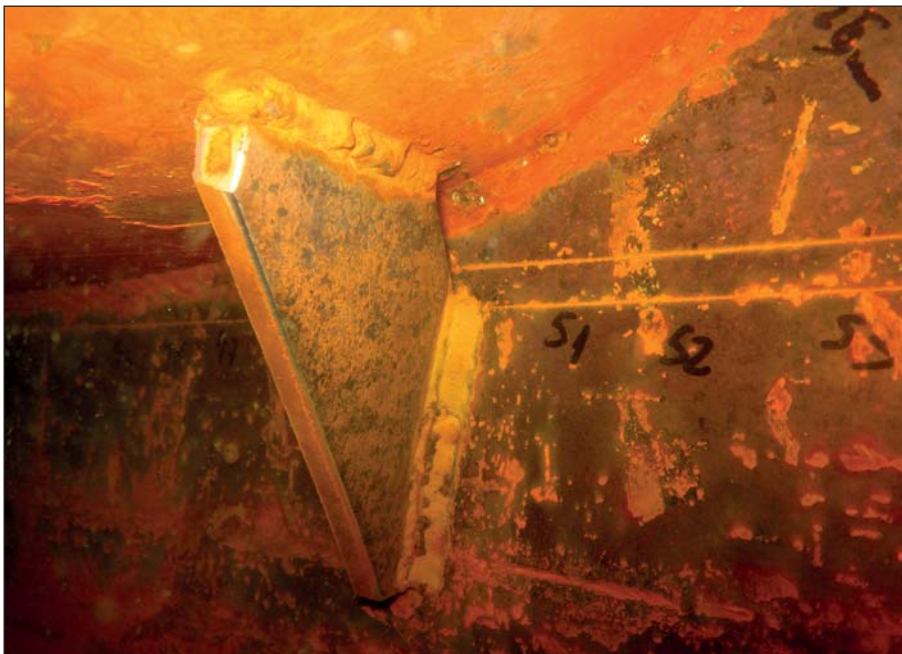
Extra reinforcements were installed around the cofferdam.

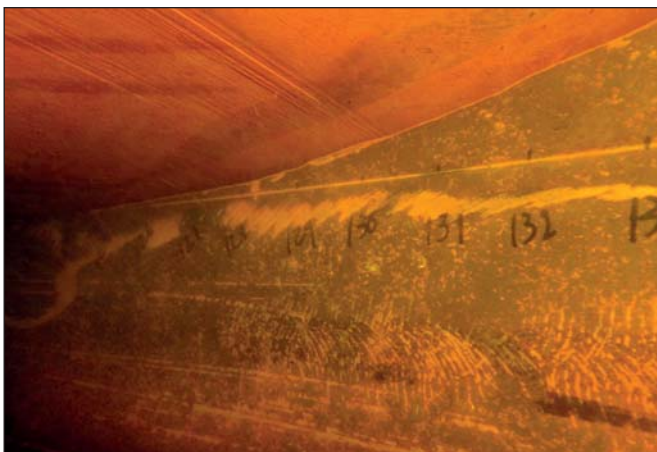
The doubler plates and cofferdam were tailor-made to fit the shape of the hull.

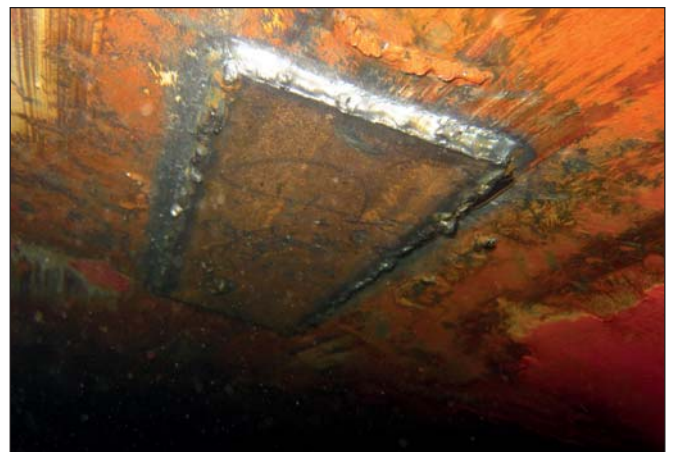
Smaller additional doubler plates were also installed over minor cracks.

During these repairs several smaller doubler plates were installed over the other cracks, closing off the hull

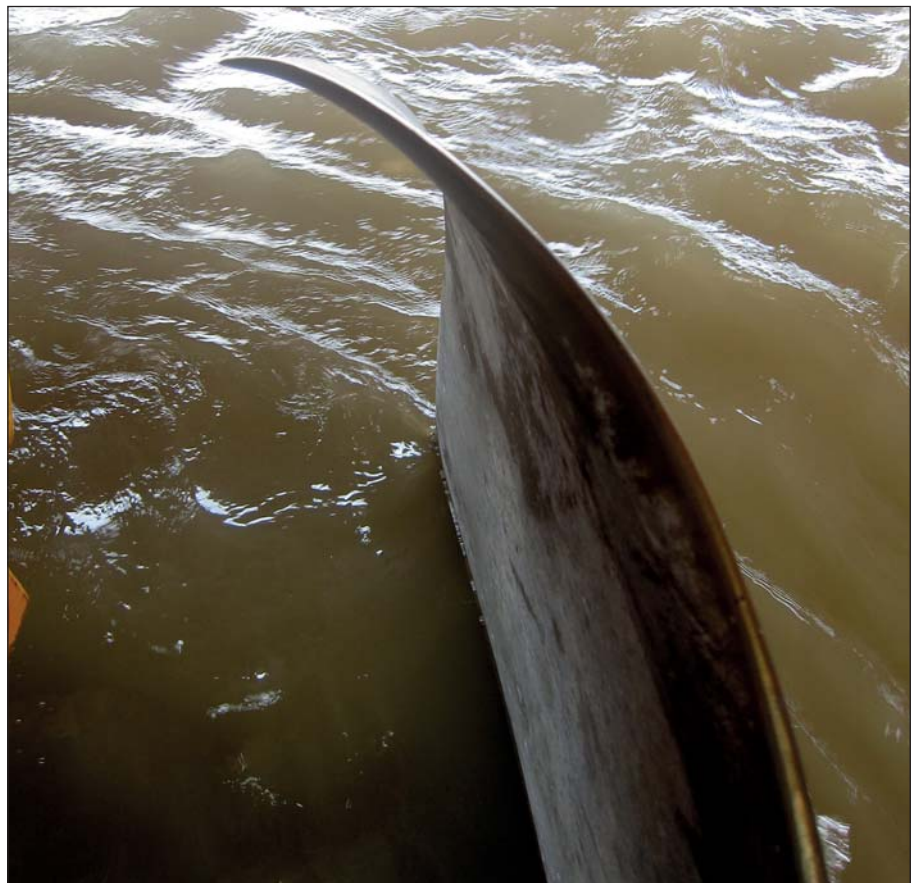
With one of the blades of its propeller severely bent, an oil tanker needed a fast, on-site solution to restore the propeller's balance and efficiency. Hydrex diver/technicians are trained to carry out repairs underwater in the shortest possible time frame. A team from the Hydrex office in Tampa Bay, Florida, was therefore rapidly mobilized to the ship's location in New Orleans to restore the damaged blades to as close to their original condition as possible.

One of the bent propeller blades of a 245-meter oil tanker.

With the survey completed, the team positioned the straightening machine over the bend in the trailing edge of the damaged blade. In close communication with the team leader

in the monitoring station on-shore, the divers returned the bent blade to its original state. When the straightening was complete, the Hydrex technicians polished the blade to make sure that any remaining loss of efficiency would be minimal.

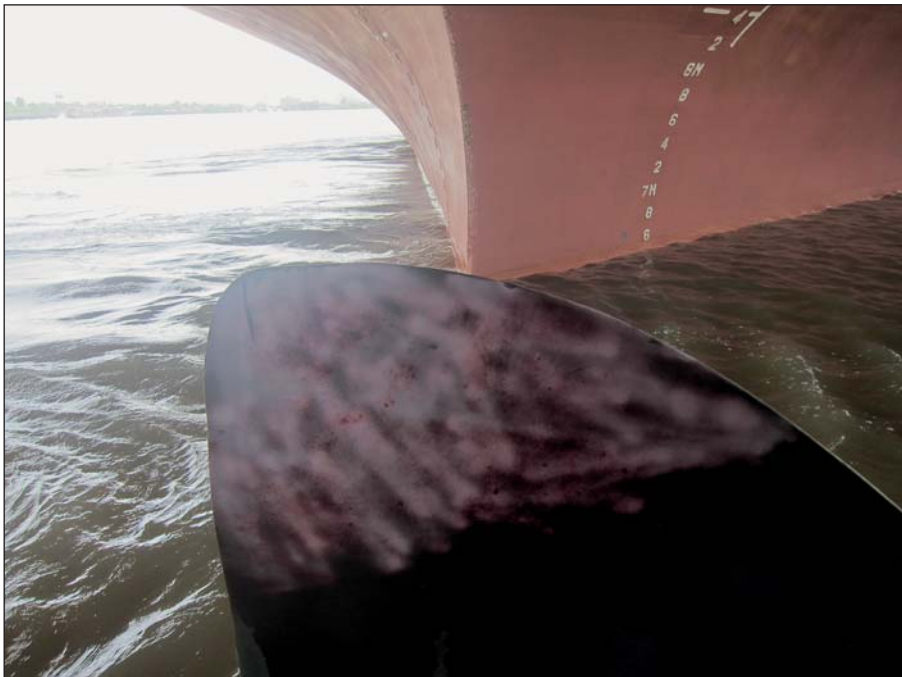
Tests showed that the straightening had been successful.

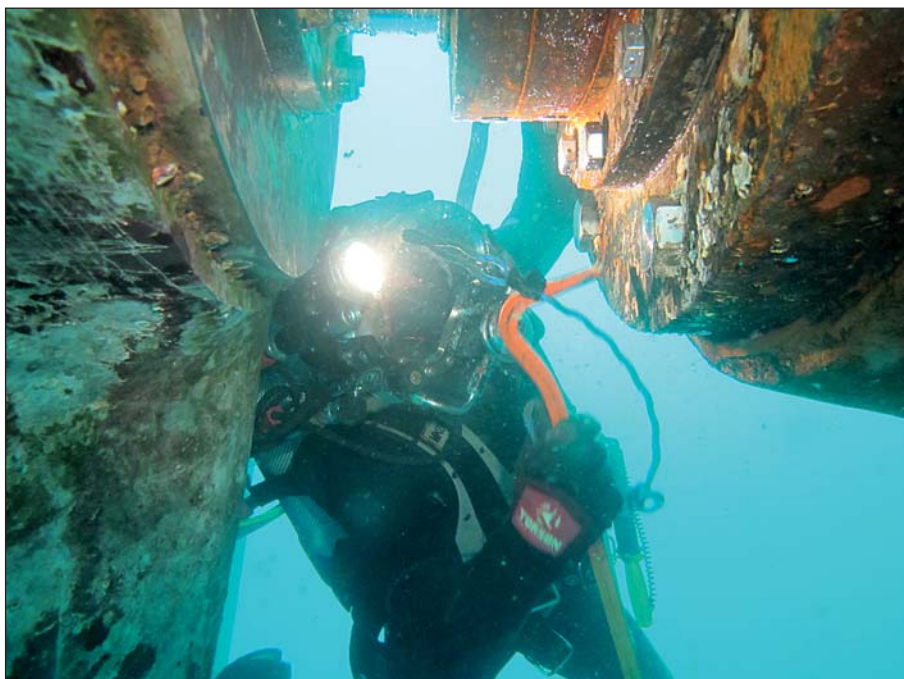
When the fore as well as the aft stern tube seals of a 247-meter tanker were leaking, the vessel was not given permission to enter any port. Unloading at sea and going to

Hydrex diver working on stern tube seal assembly in Gabon.

was installed to create a dry underwater environment around the stern tube seal assembly, Hydrex technicians replaced the fore stern tube seals which are located on the inside. Next the team started the work on the aft seals. This was done inside the flexible mobdock in drydock-like conditions, which are essential for stern tube seal repairs. The diver/technicians cleaned the entire assembly before they removed the damaged seals one by one and replaced them with new ones.

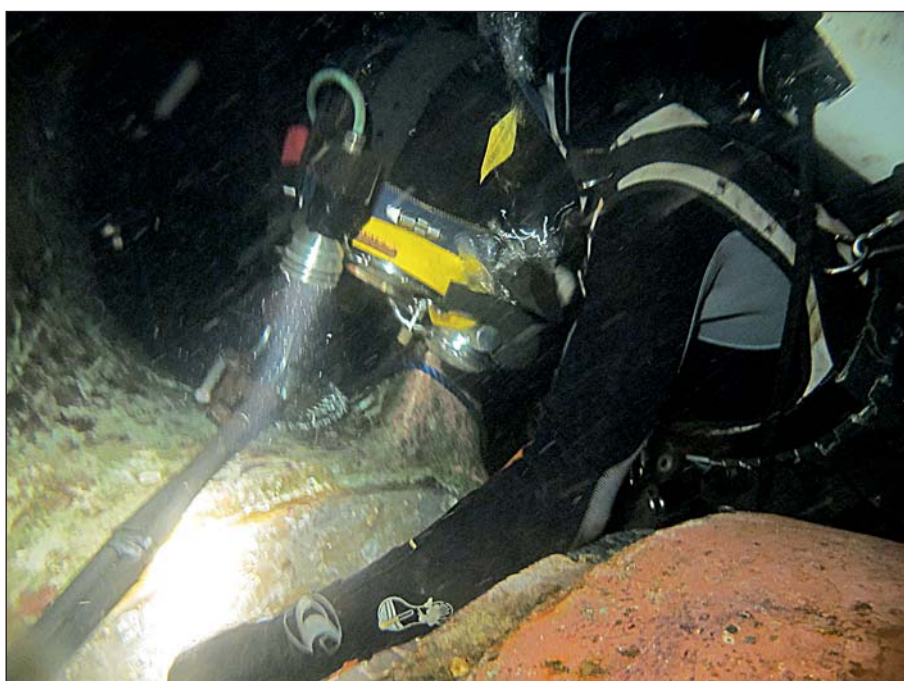
After the diving team had set up a monitoring station, the operation started with a thorough underwater inspection of the stern tube seal assembly. This revealed that a fishing line had caused the leak.

Diver/technician preparing the stern tube seal assembly for mobdock installation.

After the inspection, the team detached the rope guard. The fishing lines entangled around the liner were then removed. The divers then installed the flexible mobdock

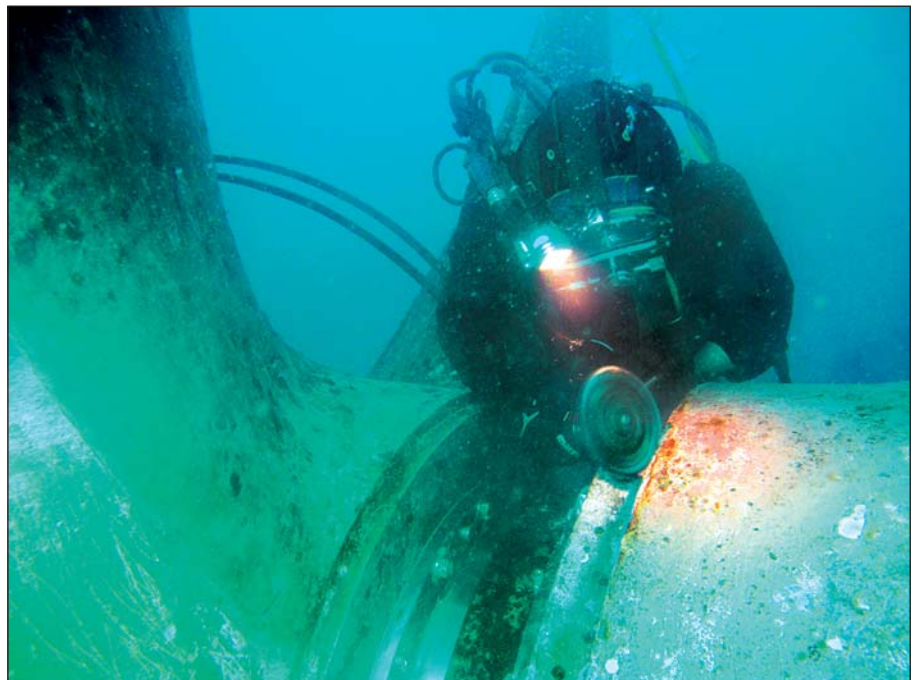
Grinding work on the stern tube edge.

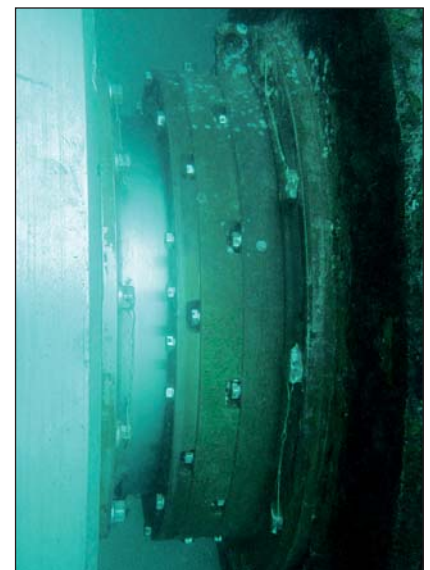
When a 204-meter cruise vessel suffered an oil leak in its stern tube seal assembly, Hydrex was asked to perform a permanent seal replacement. The repair was carried out with the Hydrex flexible mobdock technique and performed in stages to allow the ship to keep the tight schedule of the cruise it was on. A small Hydrex diver/technician team met up with the ship in Kusadasi,

Stern tube seal assembly after seal replacement.

After the diver/technicians had opened up the assembly they removed the damaged stern tube seals one by one and replaced them with new ones. A subsequent leakage test showed that the repair was successful. The team then closed the stern tube seal assembly again and removed the flexible mobdock. This ended the second part of the operation well in time for the cruise ship to sail to its next stop with its passengers.

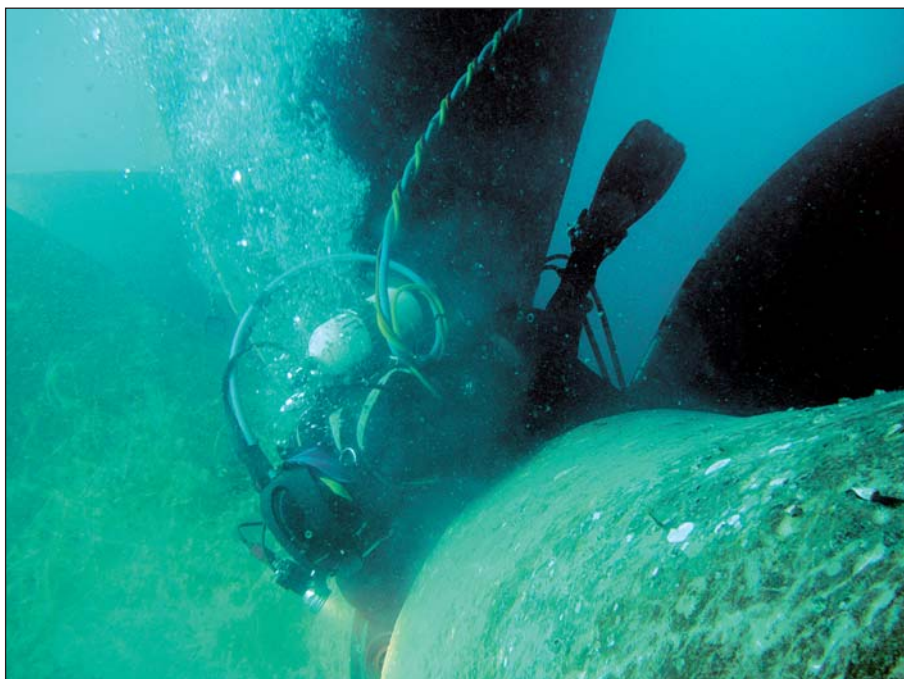
Diver preparing the reinstallation of the rope guard.

In Istanbul, Turkey, the team met up with the vessel again and refitted the rope guard onto the stern tube seal assembly, concluding the operation. The ship could continue its journey free of oil leaks without going to drydock and without any changes to its schedule.
