**Complex steel and cofferdam
repairs carried out afloat**

Complex steel and cofferdam repairs carried out afloat

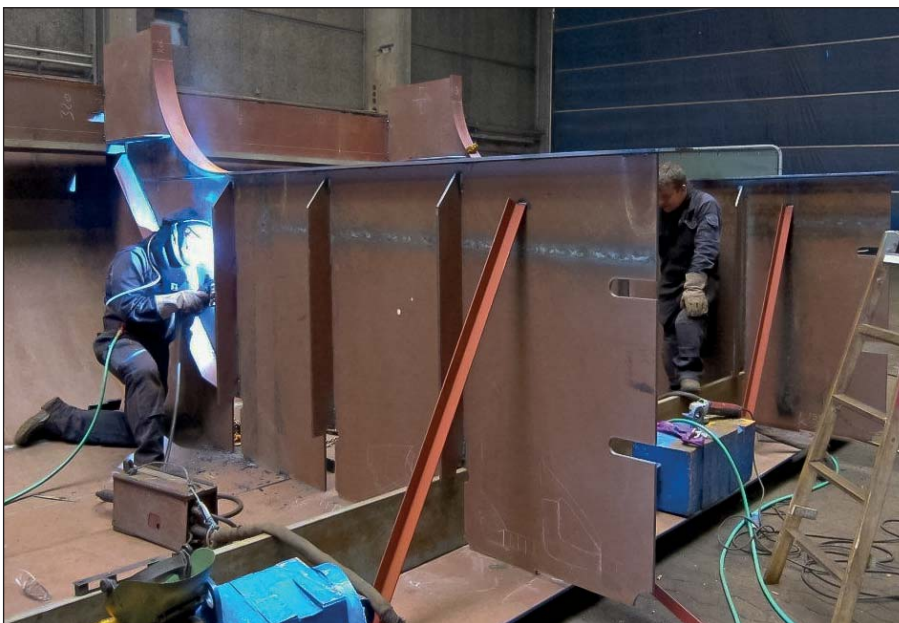
Fabrication of the section used to repair the 5 x 5 meter hole in the aft section of the hull, port side.

Using these measurements and the original drawings of the ship, the naval architects were then able to produce final drawings from which a section and a doubler plate could be fabricated and installed. As fabrication of the section and the doubler plate was completed, preparation for installation began. In the case of the section it was necessary to cut through the hull plates where the hull was distorted and broken. Divers proceeded to cut a hole in the hull about 5 x 5 meters in size. The prefabricated insert was lowered into the water and rigged into place

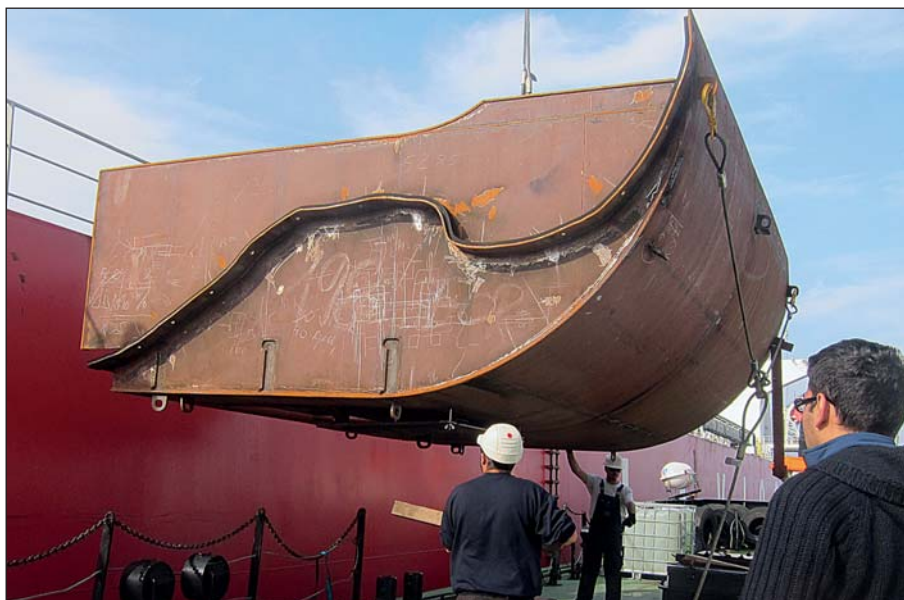
The finished section being lowered into the water.

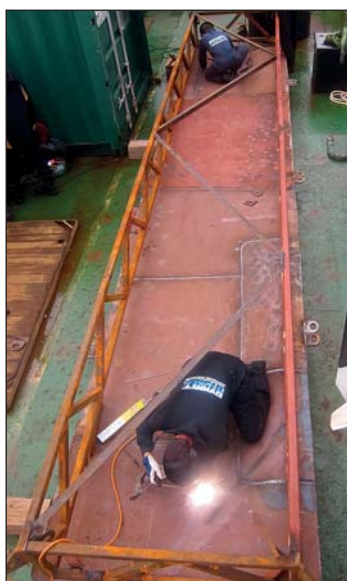
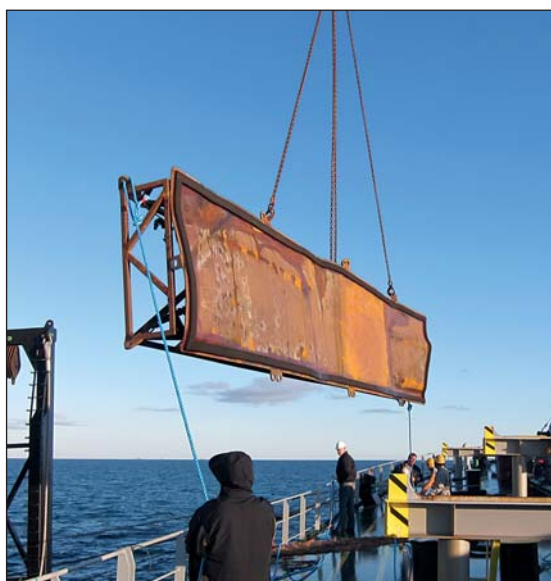
with chain blocks. While work was going ahead with the section, another Hydrex team worked on the fabrication and installation of the 8 x 1.8 m doubler plate in the area of DBBT No. 1. The frame was fabricated and used for measurement and then the plate itself was cut, pre-shaped and attached.

Preparing and lowering the doubler plate into the water so that it could be welded in place to repair the 8 x 1.8 m rip in the hull near the forepeak.

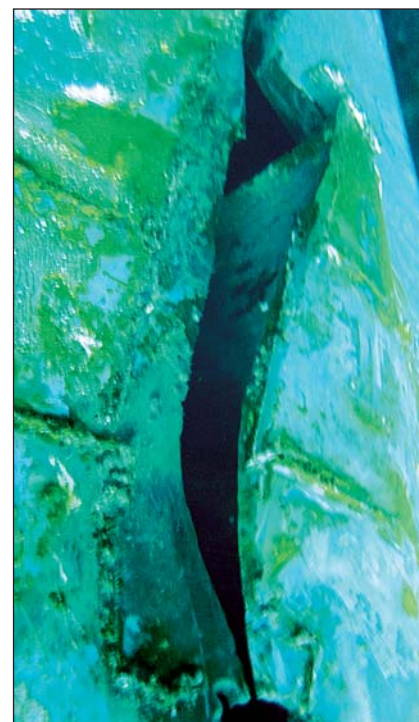
When the shell plating of a 300-meter bulker was indented over a length of 150 meters after a grounding in the Suez Canal, a large crack 1.5 meters long appeared, making it impossible for the vessel to sail any further. To close off the crack and allow the vessel to continue its route, Hydrex sent a nine man diver/technician team to the vessel's location, 21 miles off the coast of Fujairah, United Arabian Emirates.

A crack of 1.5 meter appeared after sailing to Fujairah, making it impossible for the vessel to continue its voyage.

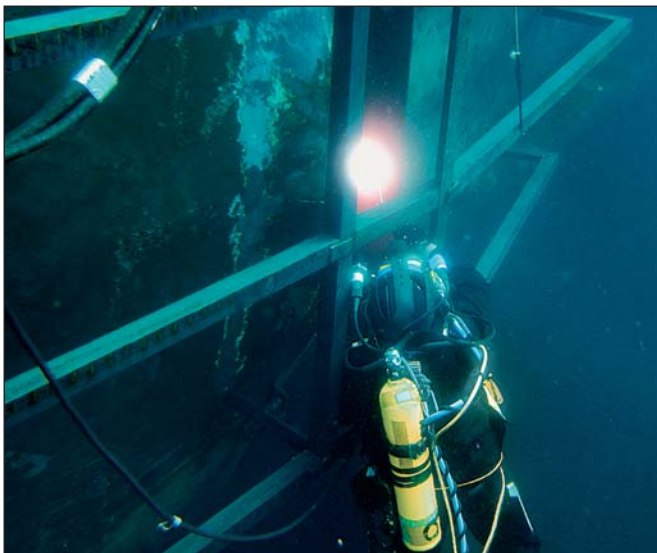
A rotating diver/technician team was mobilized to make sure that the operation could continue for 12 hours each day, despite the working depth of 22 meter.

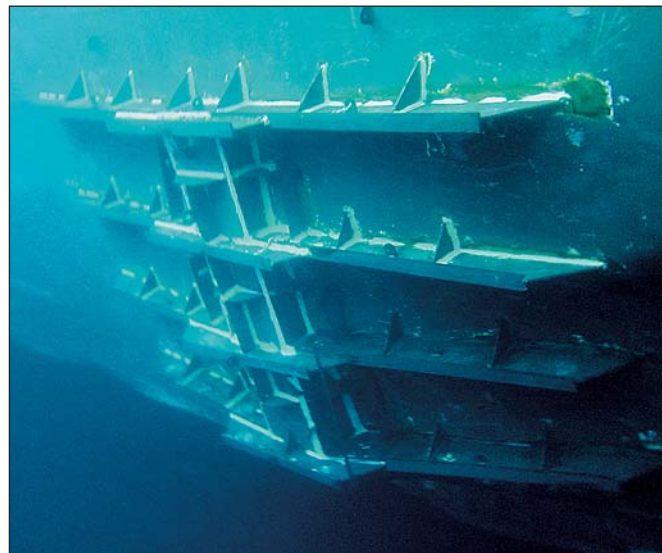
The cofferdam allowed the ship to sail to China for unloading.

To get a perfect assessment of the way the shell plating had been compressed, a special frame was made and secured over the damaged area. This allowed the diver/technician team to get exact measurements of the distorted plating. These measurements were then used to create a special cofferdam that would cover the crack and prevent it from growing further. After the cofferdam had been positioned and secured, it was reinforced with longitudinal stiffeners and additional fortifications

until it was strong enough to hold the water pressure. The tank behind the crack was then emptied, bringing the vessel back to its previous draft of 18 meters. In total the reinforcements covered an area of 18m² and the combined length of all the welds was over 500 m. When the operation was finished, only a few reinforcements needed to be added to the inside of the hull to prepare the ship for its journey to China.

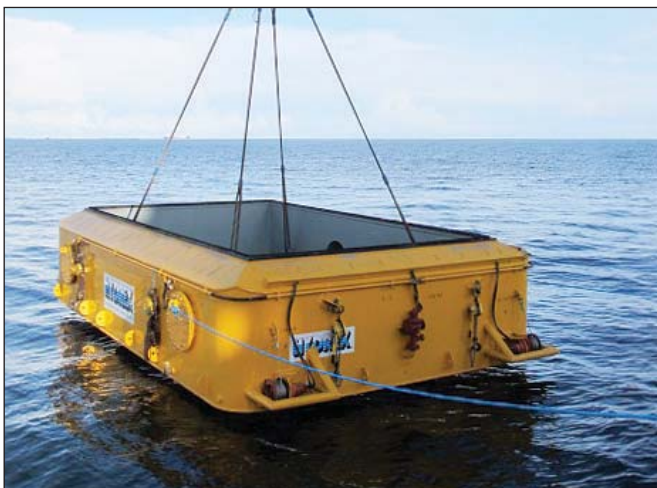
Tailor made 9x6x2 meter mobdock stored in Gabon allows very fast mobilization whenever needed.

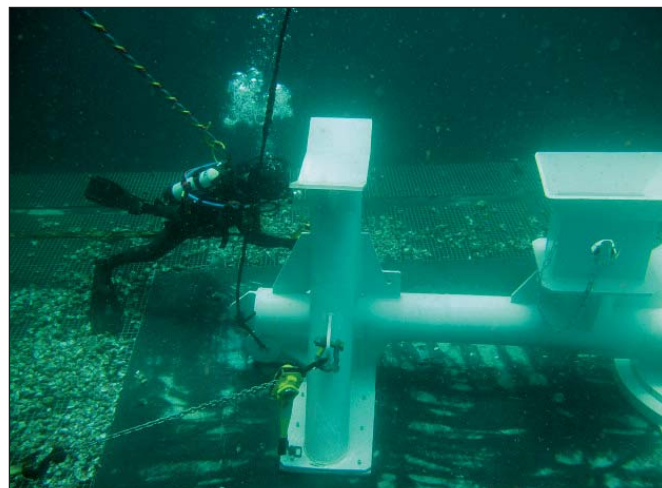
A special support cradle was used to transport the 40 ton thruster underwater.

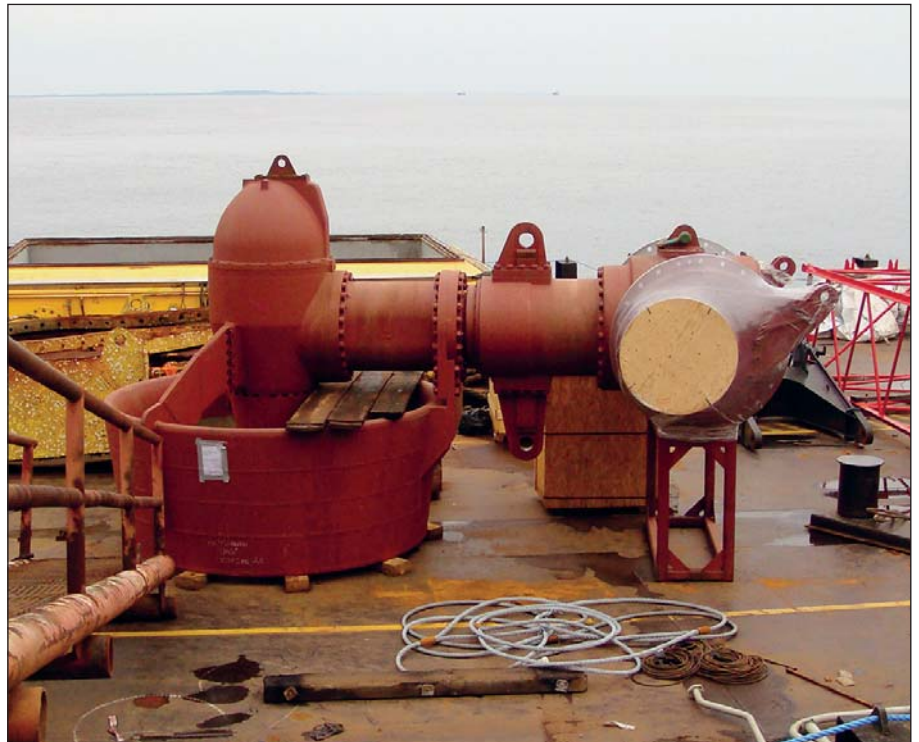
Spare thruster unit brought onto work barge.

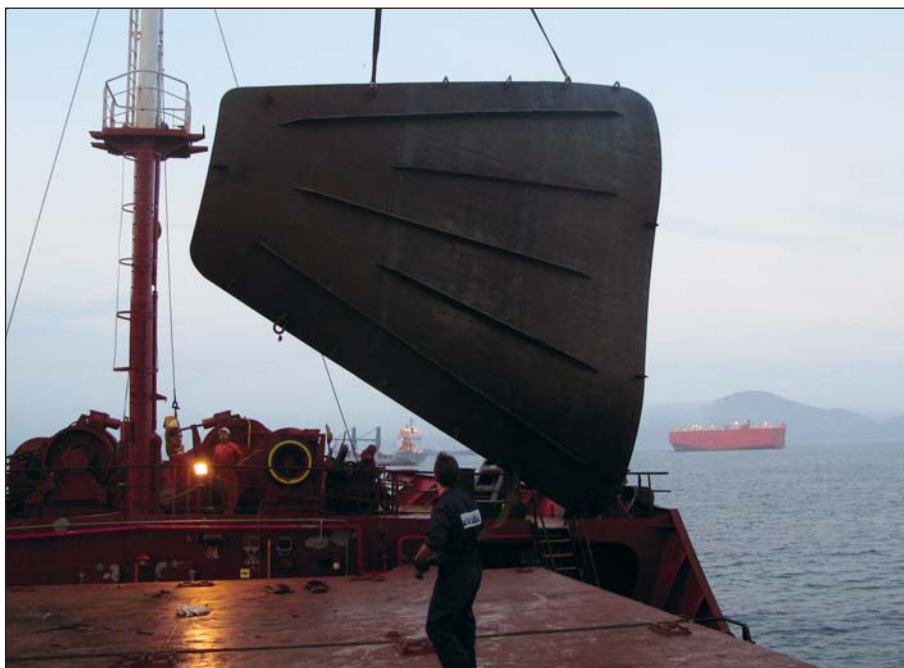
Large doubler plate ready to be lowered into the water in Peru.

started working on the second one. Due to its size the plate was delivered in three parts and was then welded together by the Hydrex team to its full size of 6 m x 6 m. Next it was reinforced with stiffeners to make sure it would be able to withstand the water pressure.

The plate was then lowered into the water with hoisting equipment. Due to the very specific shape of the affected area it was essential that the plate was precisely positioned over the designated section. Next it was welded underwater by our certified welders.

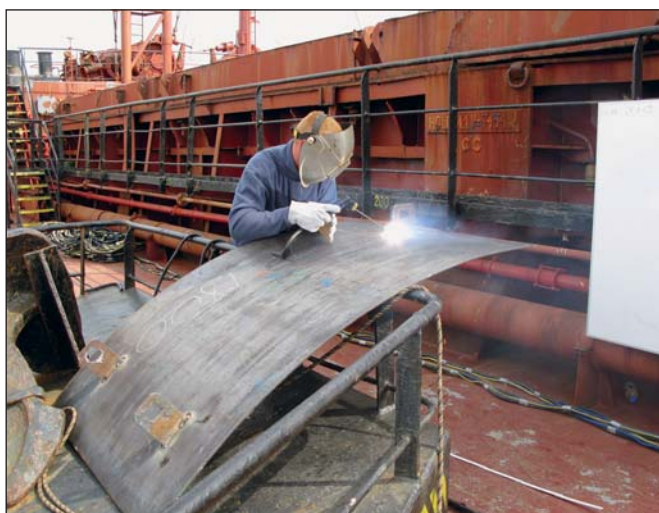
Welding work on the smaller of two doubler plates.

Because the bottom plating had been damaged in two different places it was decided to carefully sail the vessel to a nearby and more suitable location in Lima at the reduced speed of 7 knots. There two doubler plates would be installed at anchor-age: one on the port side to cover a crack with a length of 1500 mm, the other to close off an opening situated on the starboard side that measured up to 3500 mm at its widest point. While the smaller doubler plate, still measuring 1200 mm x 1800 mm, was installed, a local workshop

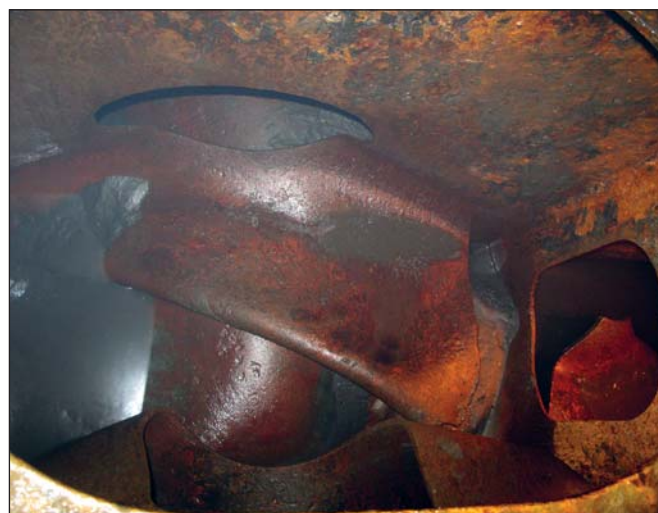
When bad weather caused a 195-meter bulk carrier to roll heavily while at anchorage in Chicama, Peru, it scraped against the seabed and suffered severe damage to the forward end of its bottom plating.

Severe damage inside the bulk carrier in Peru.

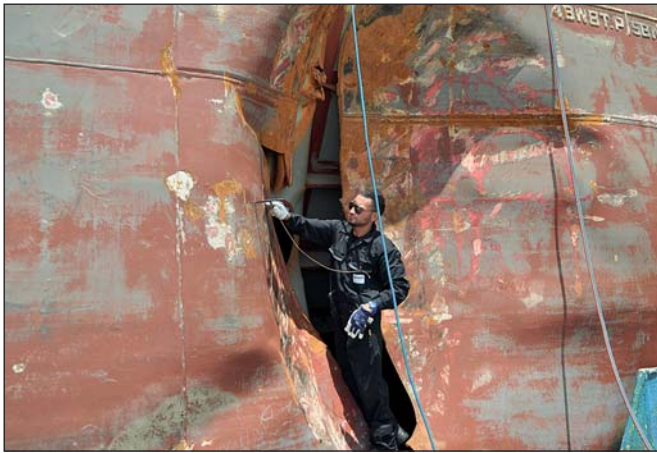
A full inspection of the damage was first carried out.

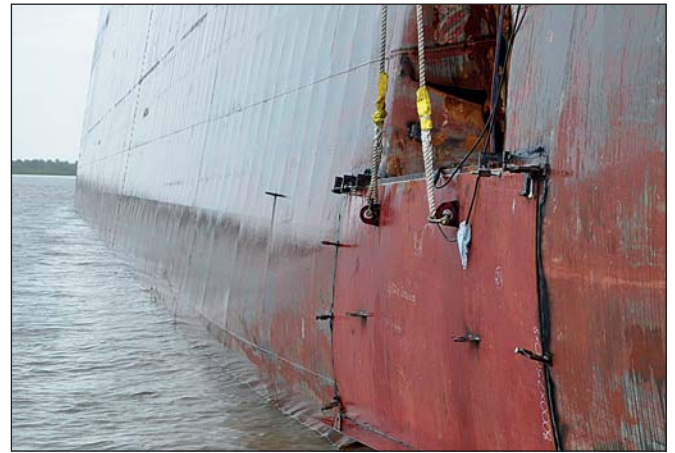
The doubler plate was fitted to the slightly rounded shape of the hull.

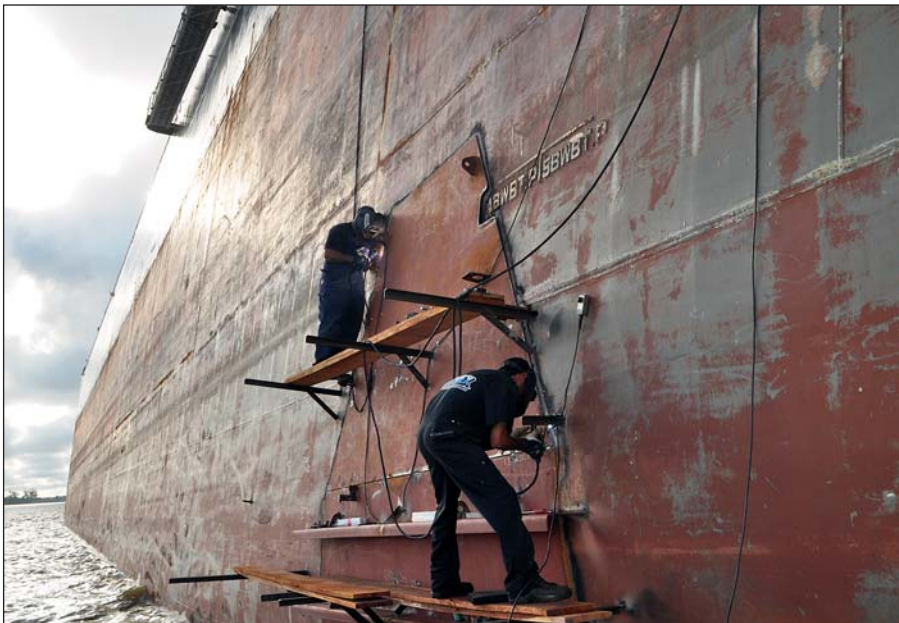
Hydrex certified welders securing doubler plate on bulker in Abidjan.

The same procedure was repeated for the top part of the doubler plate. This part of the plate was trapezium-shaped with a base of 4.5 meters wide and a height of 2.5 meters. Both parts of the plate were then welded together to finalize the repair.

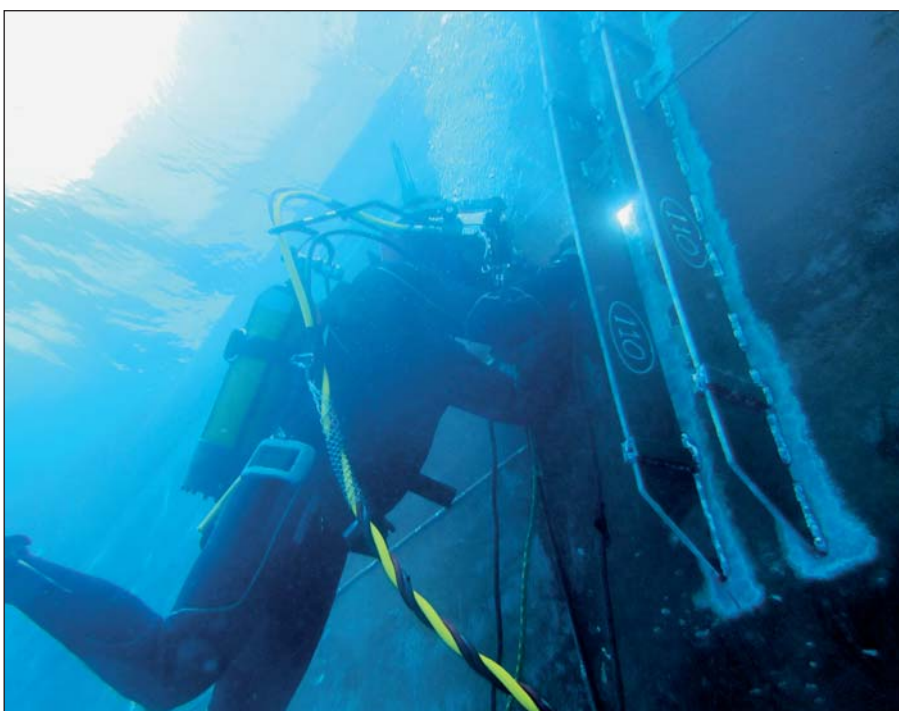
The tanker was berthed in Egypt when another vessel struck her portside hull. This caused a large hole, severe cracks and dented plating. The collision also pushed the vessel's starboardside hard against the fenders, denting the plating on that side as well.

Hydrex diver/technician welding temporary stiffeners on the starboardside plating.

The damaged area on the portside was closed off with an open top cofferdam. All water was then removed from inside the cofferdam. The yard replaced the dented shell plating. The affected web frames were also replaced. While the yard was performing the insert repair, the Hydrex diver/technicians installed temporary stiffeners on the outside of the dented starboard plating.

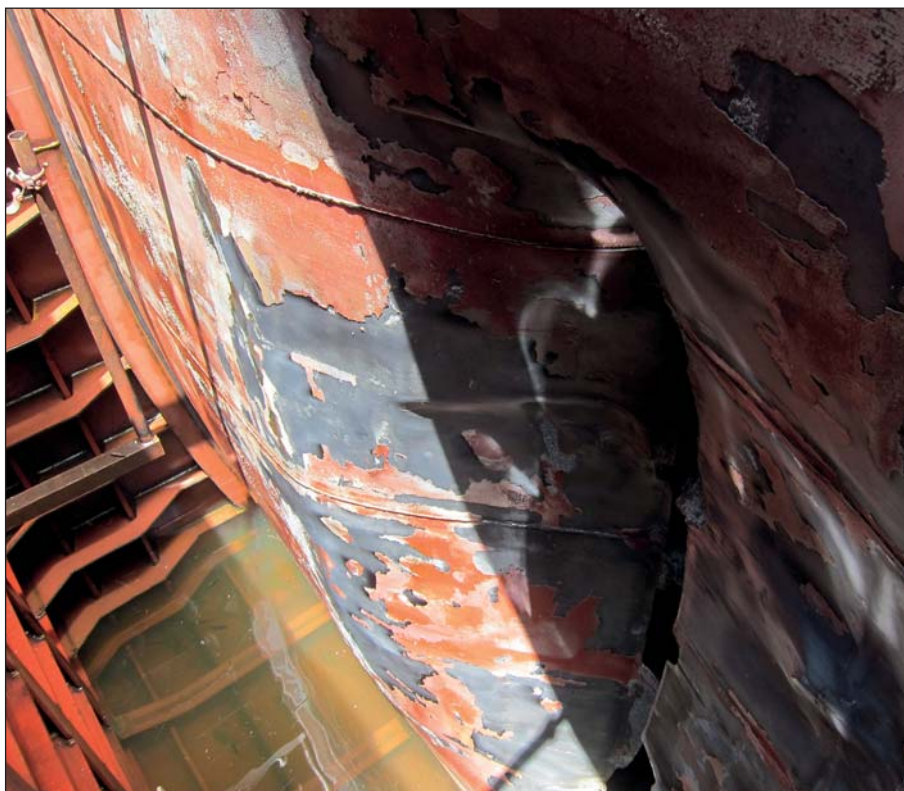
The damaged plating inside the emptied cofferdam.

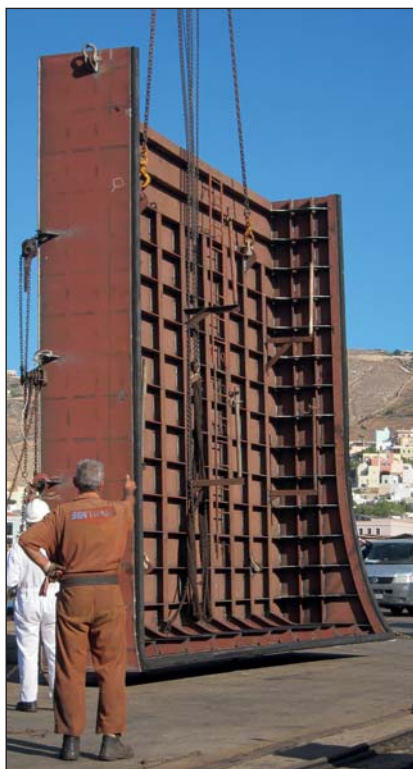
Open top cofferdam ready to be lowered into the water.
