# Permanent afloat repairs with unique rudder mobdock

# Rudder repair case studies

## Emergency flap rudder repair in Greenland

# Fast repairs in Spain and France put a spin on propeller cropping

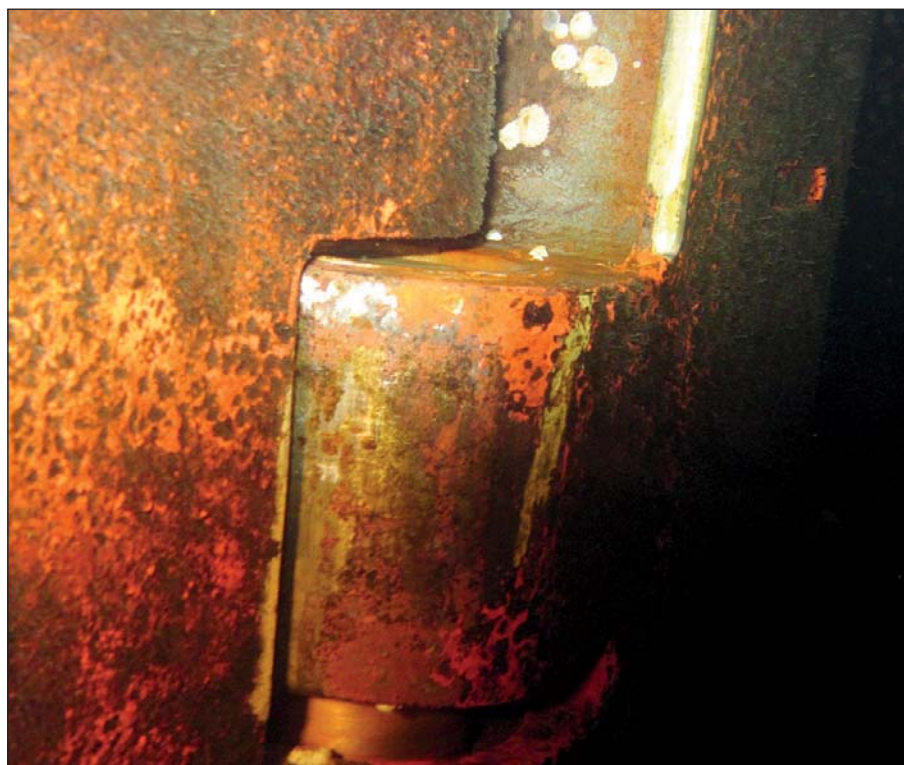
A preliminary inspection by a local diving company revealed that one of the hinges of the rudder flap had come loose. To keep on sailing without a repair posed a great risk as there was a real chance that the damage would have deteriorated. Securing the rudder flap was the only possible underwater solution.

*The top hinge of the rudder flap had come loose.*

A secondary underwater inspection was performed by our divers to get the exact measurements for the girders. Next the plates were cut on-site by our team to the exact size. The rudder and its flap were then put in the neutral position. Three girders were placed on each side of the rudder, securing the flap to the rudder. The plates were welded underwater by our divers. A steering test was successfully performed, concluding the repair.

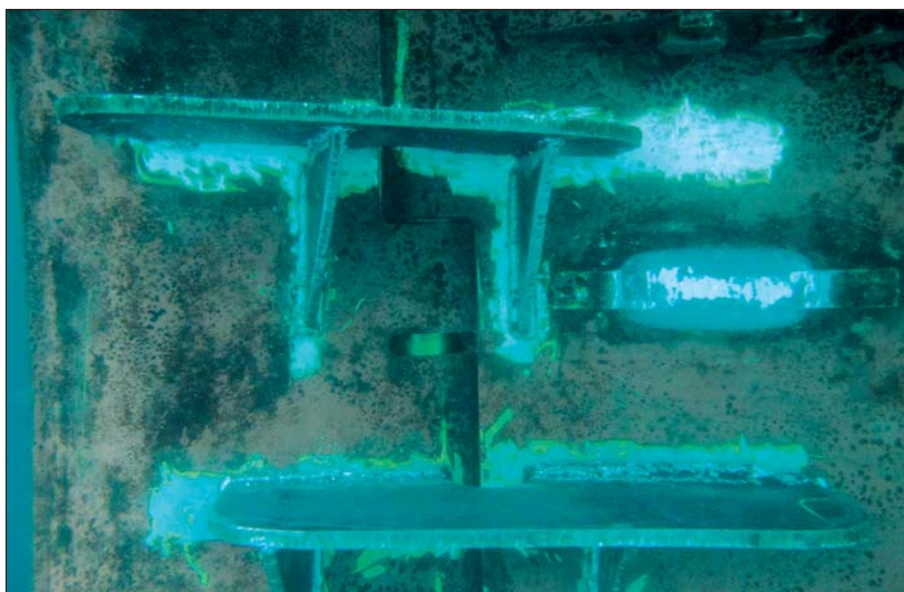
*Girders were used to secure the flap to the rudder.*

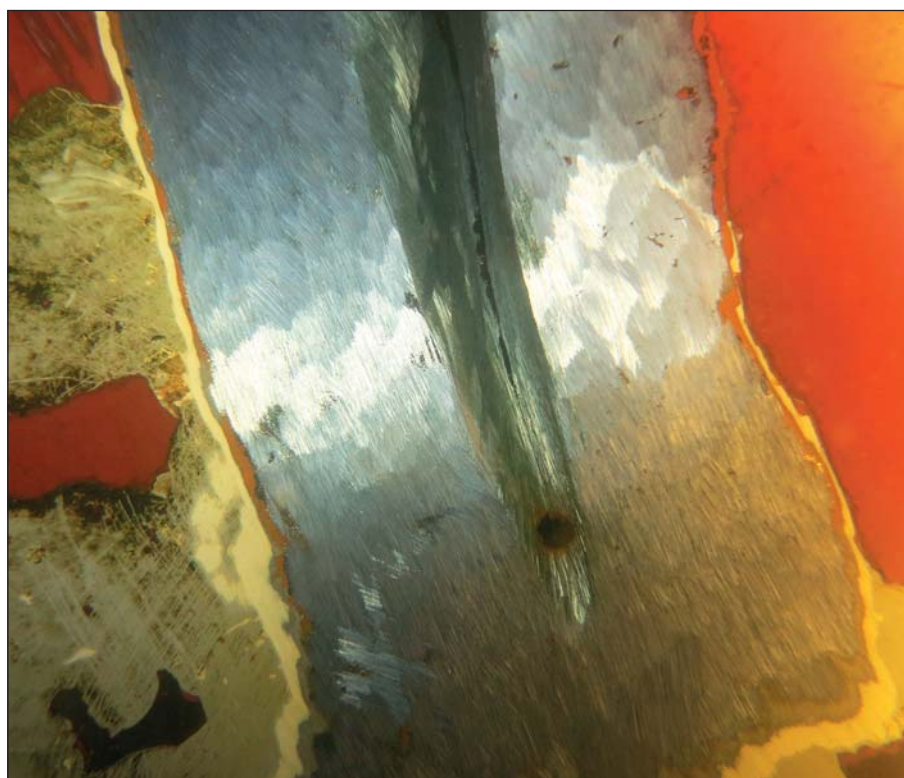
A 690-mm crack was found, partially covering the weld seam of the portside rudder cover plate. The crack was curved at the top and the bottom. Crack arrests had already been made at both ends to prevent it from spreading further. A more thorough solution was now needed to fix the problem.

*The crack and the surrounding area was cleaned and ground first.*

In consultation with the class surveyor a repair plan was devised. First the Hydrex diver/technicians ground out the crack in a v-shape. They also ground the surrounding area. Then a root weld was put in the crack. Next the team filled the crack with welding beads. The repair was finalized with a steel reinforcement bracket that was installed over the

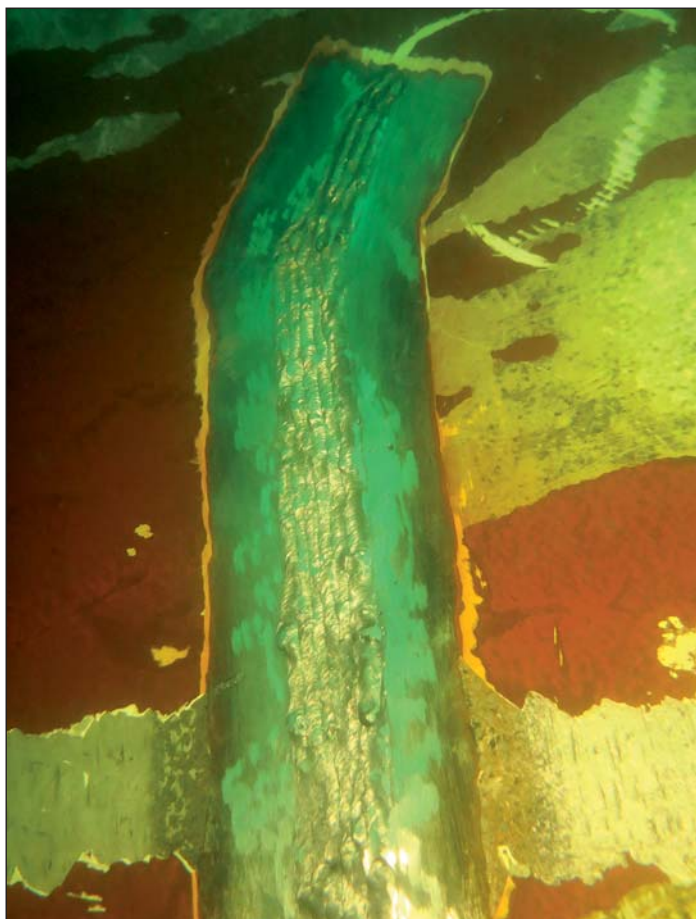
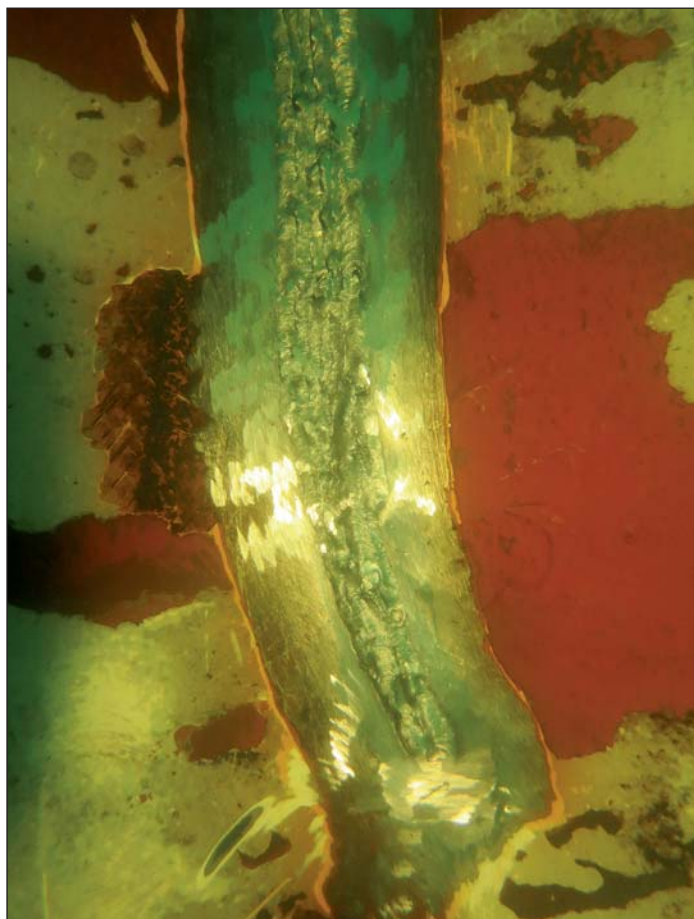
*After the crack was filled, the vessel could sail until the next scheduled docking.*

A successful pressure test was performed to make sure that the dry rudder compartment behind the crack was not compromised. The surveyor then gave his approval for the repair.

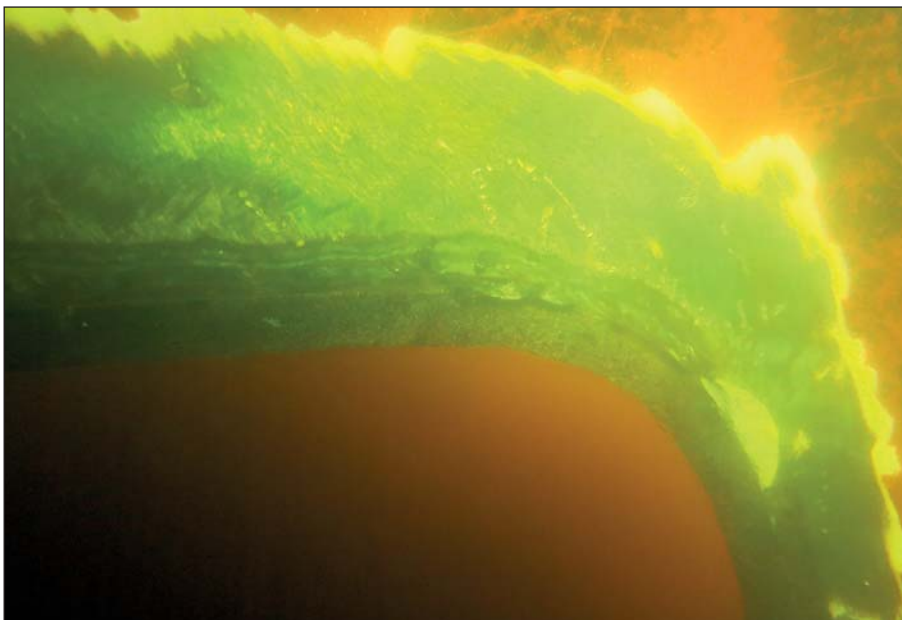
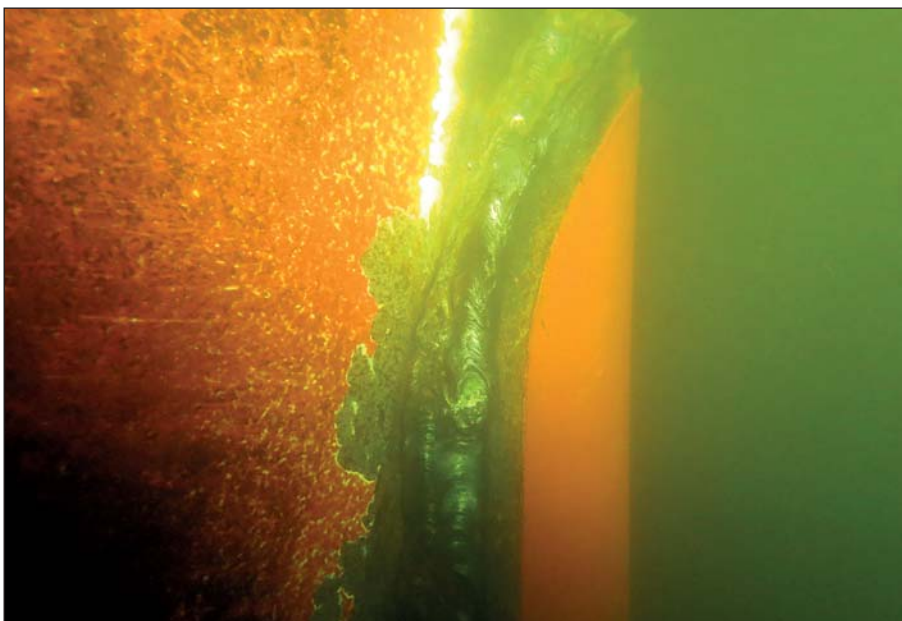
A Hydrex diving team mobilized to a 170-meter container vessel with one of our workboats. The team installed a doubler plate over the cavitated area of the rudder during the ship's scheduled maintenance stop in Rotterdam.

*Doubler plate secured by certified Hydrex welders.*

When the rudder had been prepared our certified diver/welders fitted the plate and secured it. The team then installed anodes on both sides of the rudder for further protection. This concluded the repair.

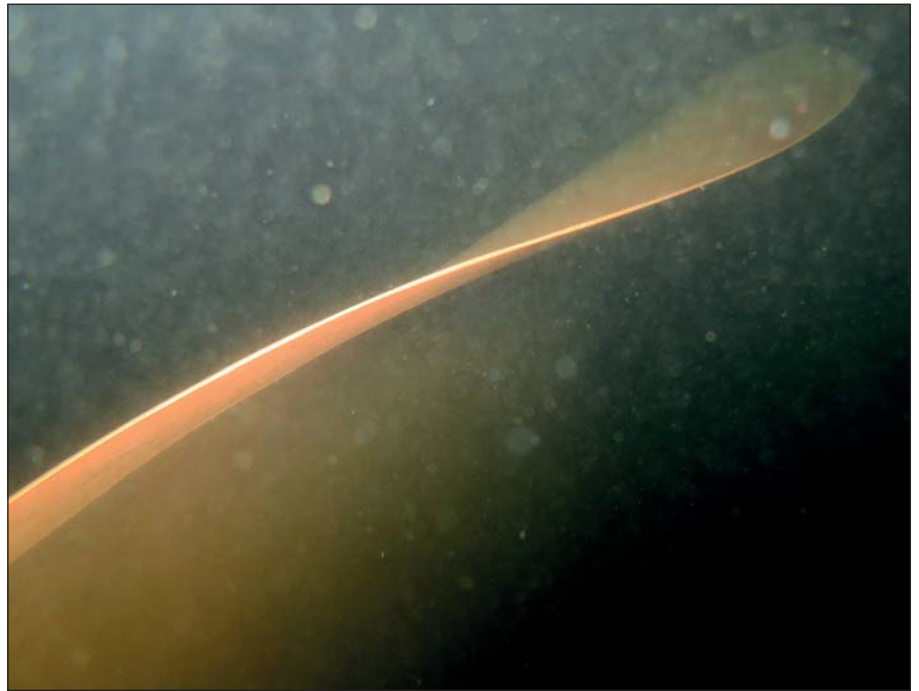
*One of the bent blades of the bulker in Dunkirk.*

After the equipment arrived at the vessel's location the team started the operation with a detailed survey of the affected propeller blades. The inspection revealed that the four blades were bent over angles of up to 90 degrees. The team then used the information acquired during the inspection to calculate and deter-

mine the correct measurements needed to modify the trailing edges of the propeller blades. Next the divers cropped the blades and ground their edges to give them the correct radius. When the cropping was complete, the Hydrex technicians polished the blades to make sure that any remaining loss of efficiency would be minimal.

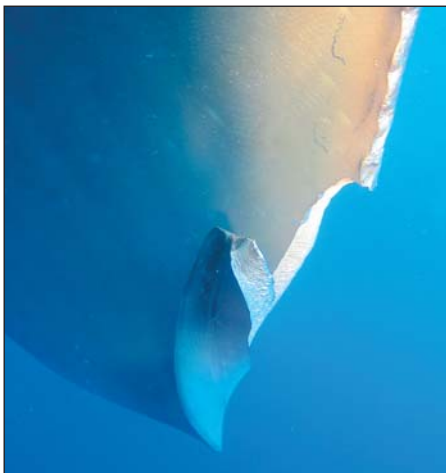
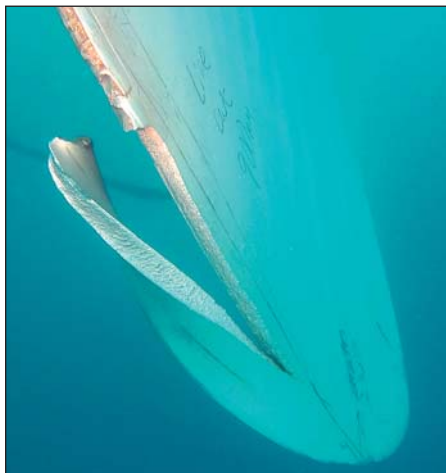
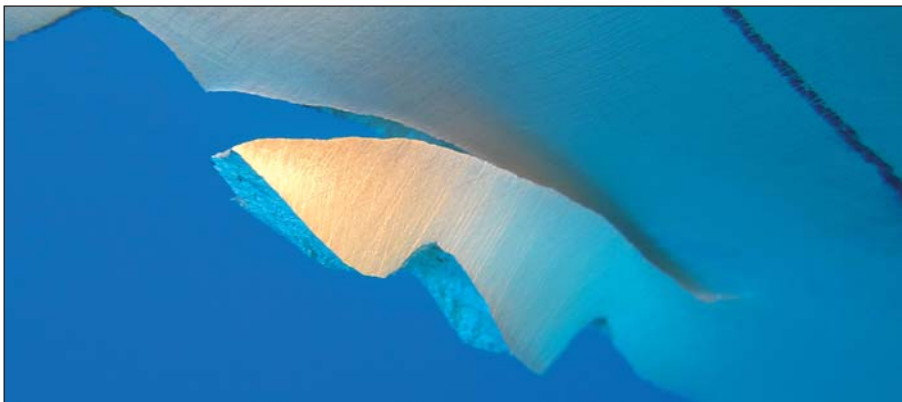
*Damaged leading edges of the blades of the vessel in Algeciras.*

The damage to the blades of the 170-meter ship was less severe. It consisted of cracks, cuts and missing chips on the leading edges of the four blades. Despite the relative size of the affected areas, the uneven surface caused a drop in the performance of the propeller. Cropping all four blades was the only way to bring the propeller's

The repair was carried out by a Hydrex diver/technician team mobilized from the close-by office in Algeciras following the same procedure as the operation in Dunkirk.

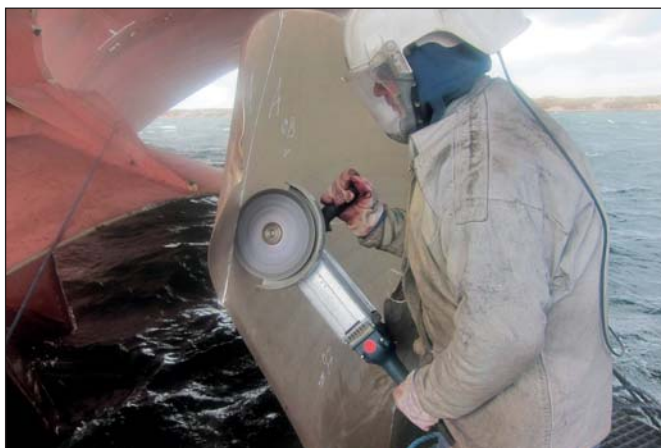
*Hydrex technician cropping one of the blades in France.*

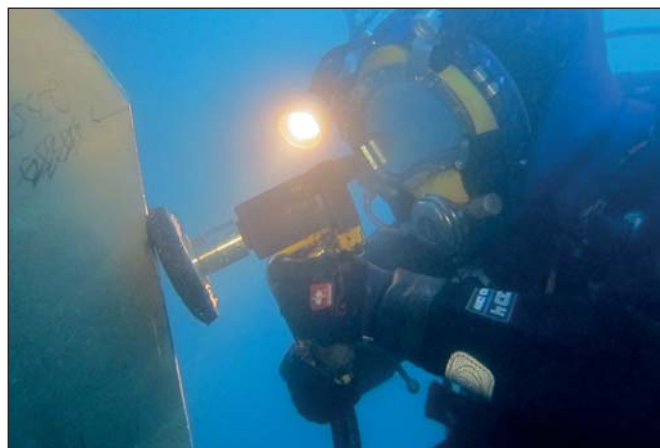
*Hydrex diver grinding the edge of one of the cropped blades.*

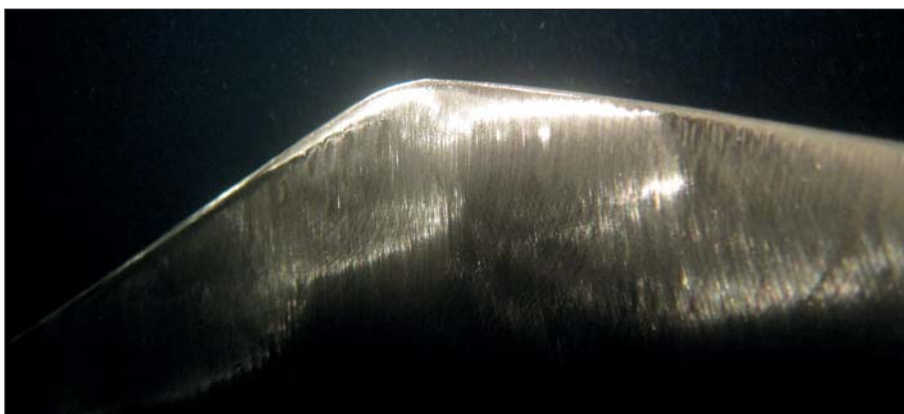
*Polishing the cropped blades prevents performance loss.*
