Our range of propeller repairs restore efficiency and save money

Navios Sagittarius: behind the scenes at a remarkable salvage operation

Underwater propeller blade straightening in Tenerife

Underwater blade cropping in Vietnam

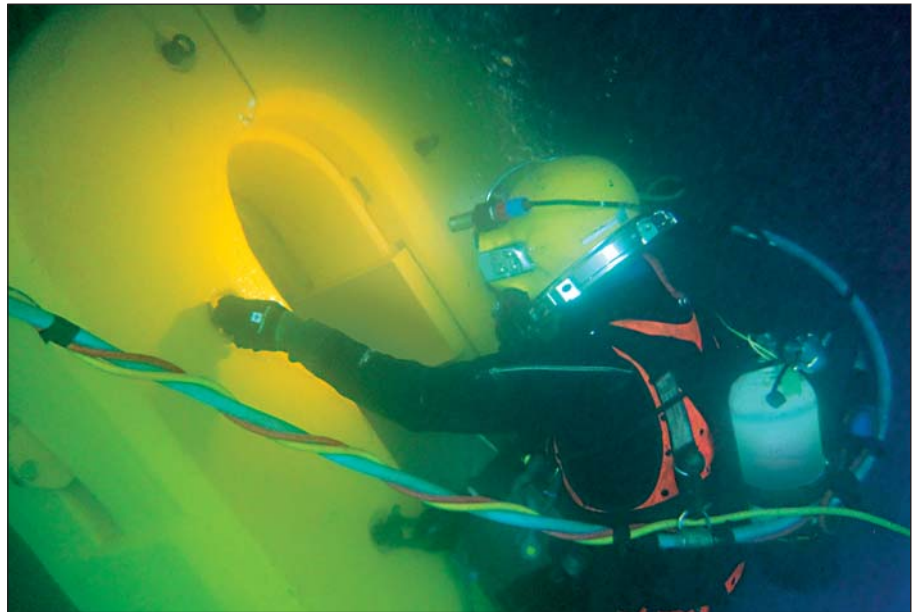
Diver positioning our propeller blade straightening machine.

The team positioned the straightening machine over the bend in the trailing edge of the first damaged blade. In close communication with the team leader in the monitoring station on-shore, the divers returned the bent blade to its original state. When the straightening was complete, our technicians cleaned the blade to make sure that any remaining loss of efficiency would be minimal. The same procedure was then repeated on the other three blades.

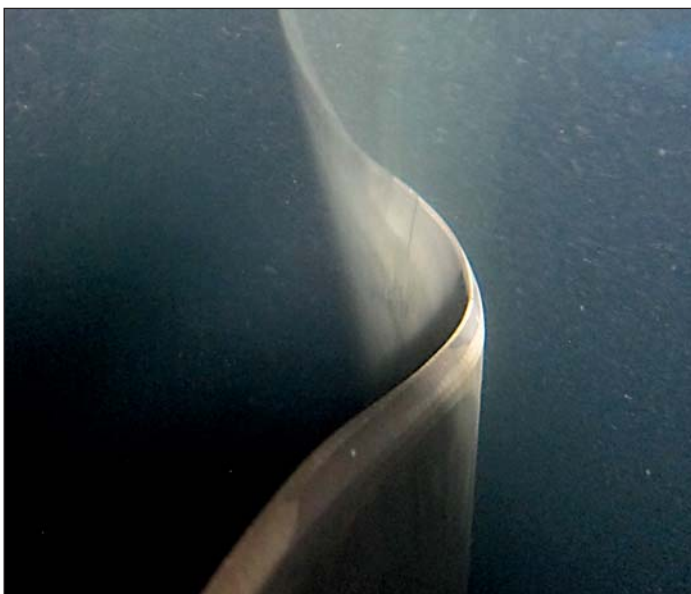
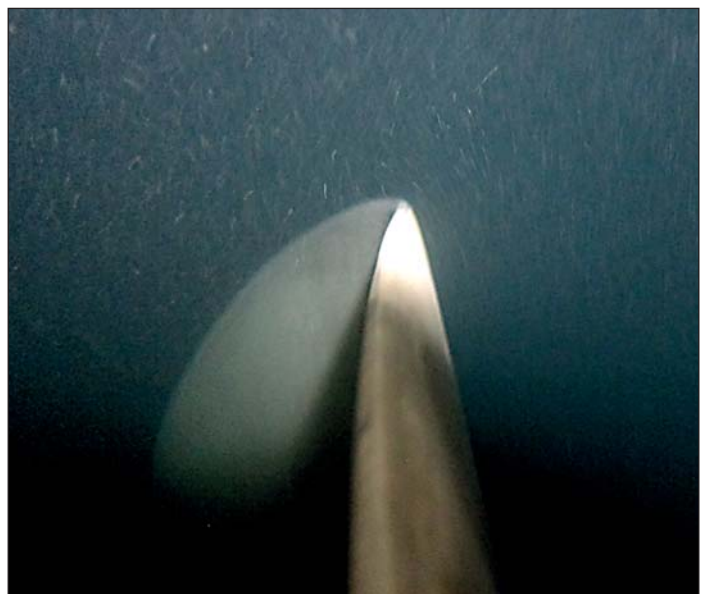
The crew of the ship had noticed that the engine was overloading. This was the result of damaged propeller blades that were performing below average. The engine had a higher workload, leading to an increased fuel consumption and added stress.

A detailed survey of the ship's two propellers by our team revealed that the four starboard side propeller blades of the vessel were bent. A fast, on-site solution to restore the propeller's balance and efficiency was needed. Luckily the port side propeller blades were in good condition and did not require any repairs.

Severely bent propeller blades on cruise ship in Tenerife.

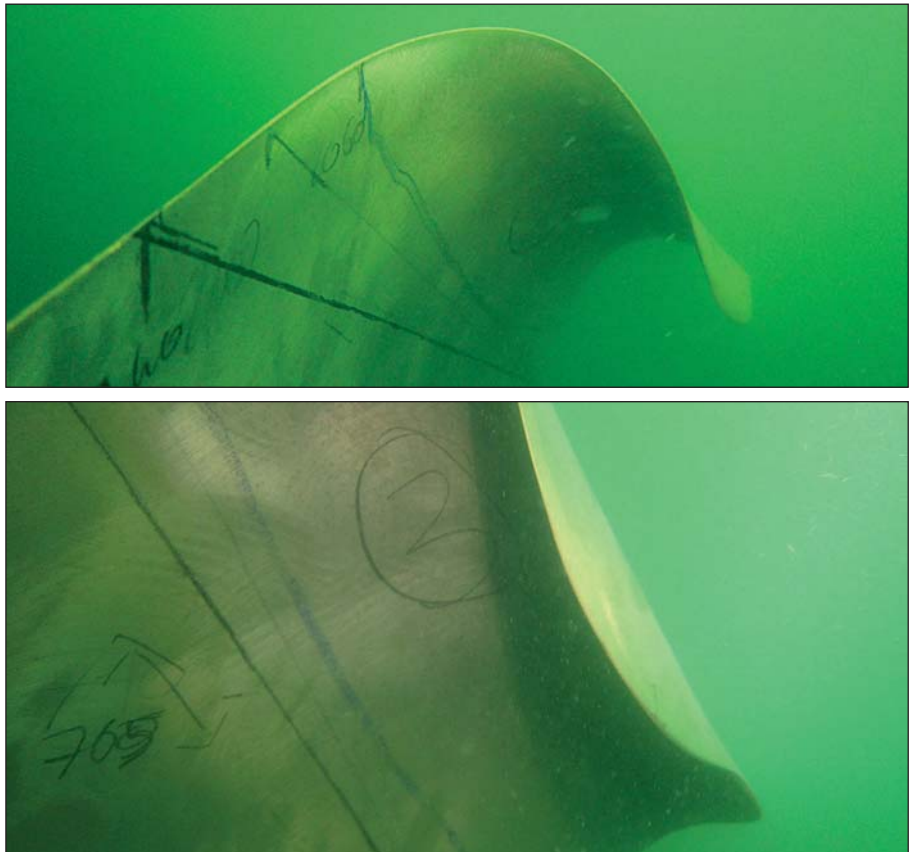
Our men started the operation with a detailed survey of the affected propeller blades. The inspection revealed that the four blades were bent over angles of 90 to almost 180 degrees.

Bent propeller blades of bulk carrier in Vietnam.

The team then used the information acquired during the inspection to calculate and determine the exact measurements needed to modify the trailing edges of the propeller blades.

Next the divers cropped the blades and ground their edges to give them the correct radius. When the cropping was complete, they polished the blades to make sure that any remaining loss of efficiency would be minimal.

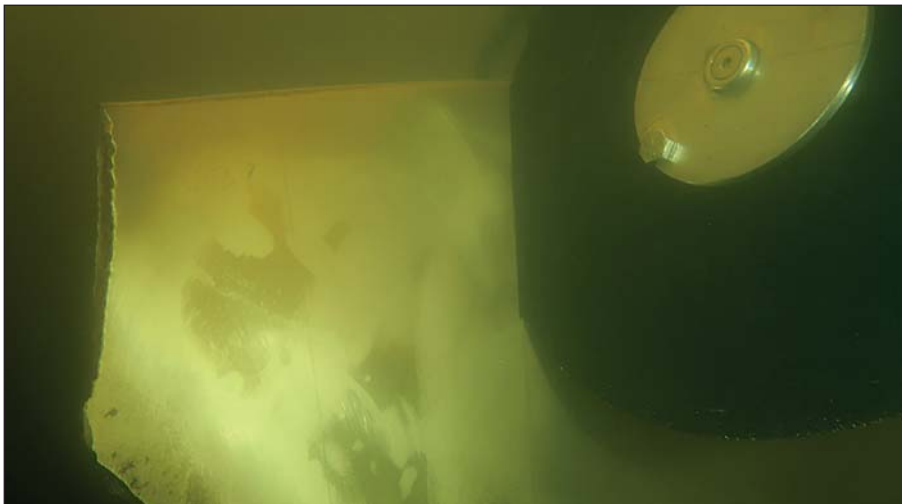
Cropping the damaged blade.

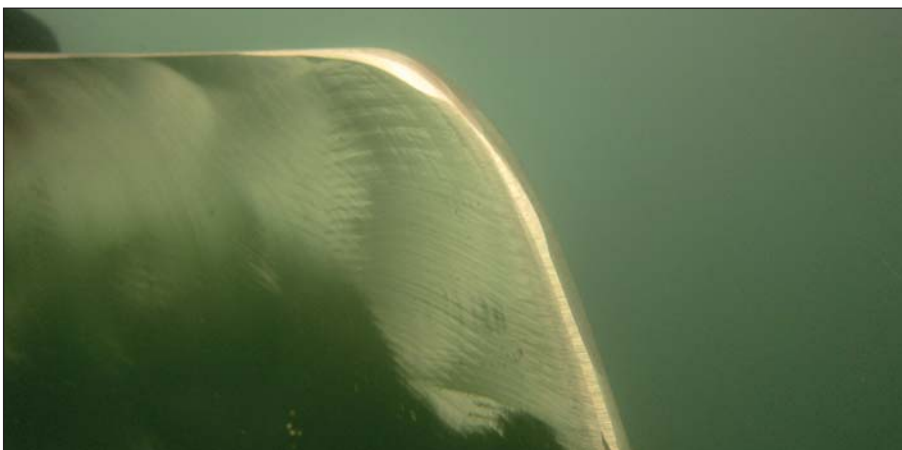
Cropped and polished propeller blade of bulk carrier.

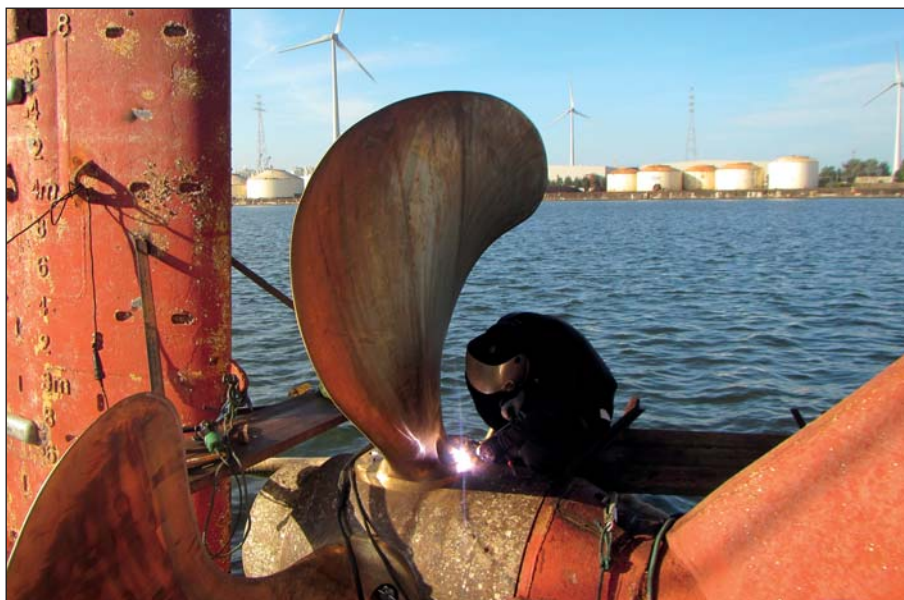
Welding the securing of the bolts.

The operation was carried out while the vessel was alongside and trimmed so that the blades could be surfaced one by one. Our men started the repair with the installation of chain blocks to rig the first blade. They then removed the blade bolts and lifted the blade. A blind flange was installed to prevent water

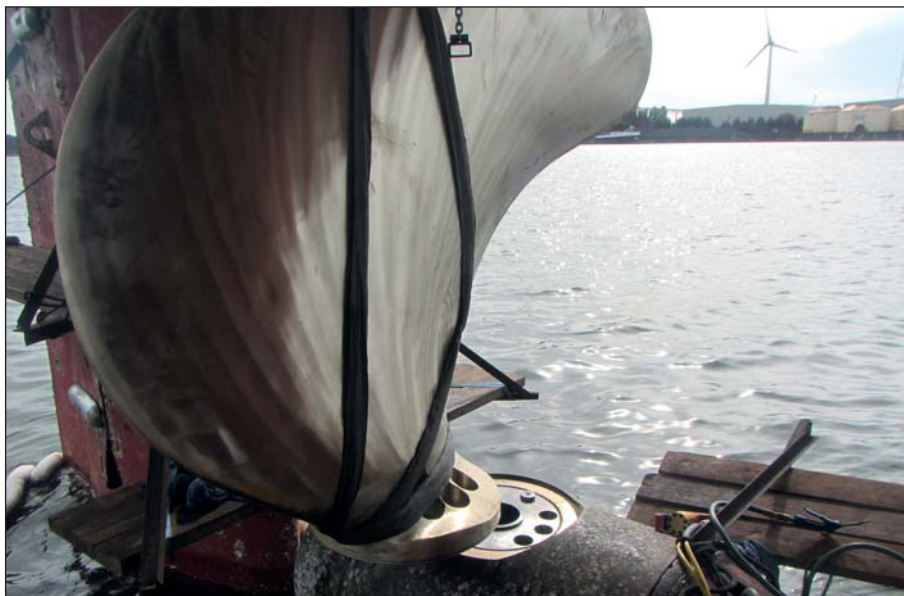
Blade repositioned over the propeller hub.

When the blades arrived back on location, they were installed using the reverse procedure. The operation was finished swiftly to enable the owner to sail his ship with only the bare minimum of delay. A costly drydock detour was avoided.

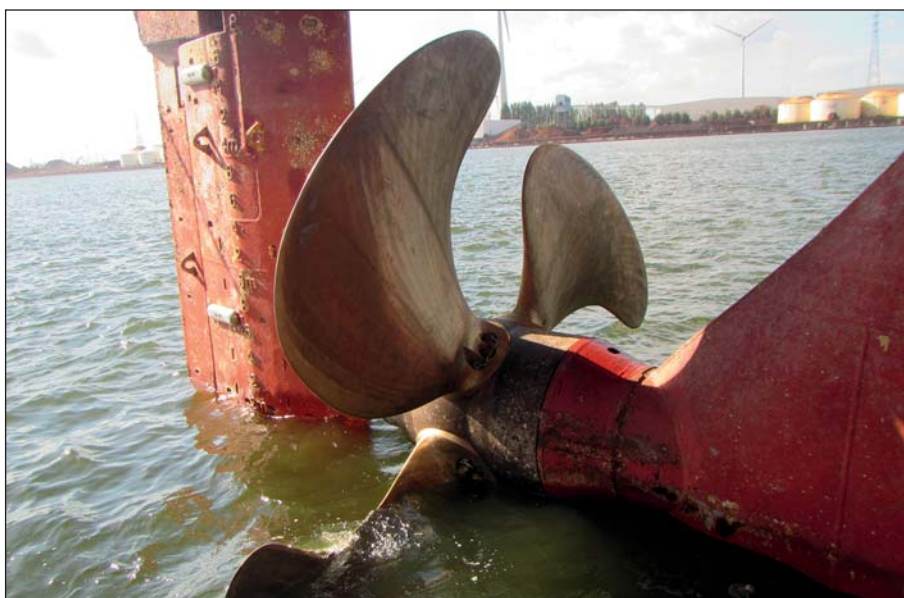
Propeller with overhauled blades ready to sail.

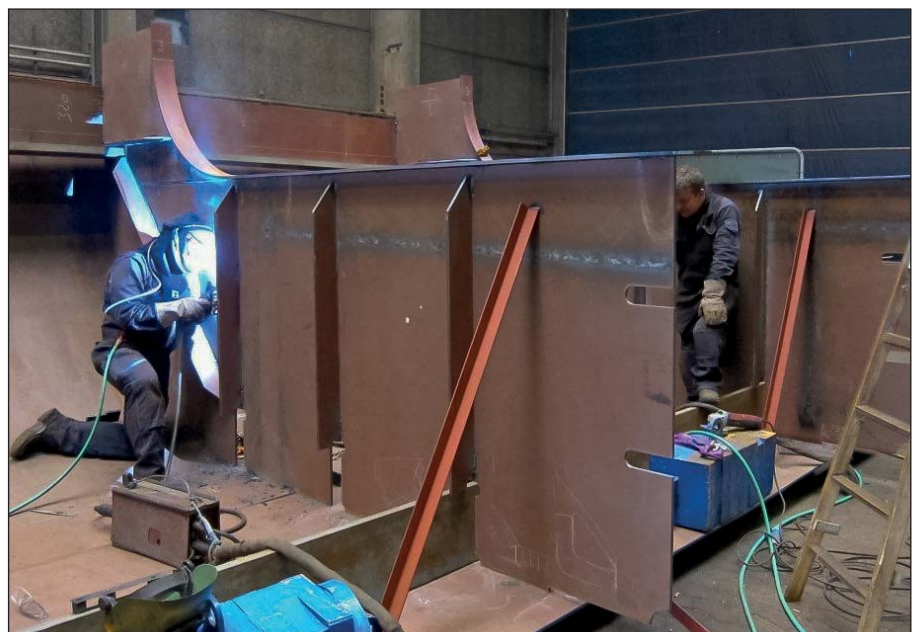
Fabrication of the section used to repair the 5 x 5 meter hole in the aft section of the hull, port side.

Using these measurements and the original drawings of the ship, the naval architects were able to produce final drawings from which a section and a doubler plate could be fabricated and installed. As fabrication of the section and the doubler plate was completed, preparation for installation began. In the case of the section it was necessary to cut through the hull plates where the hull was distort-

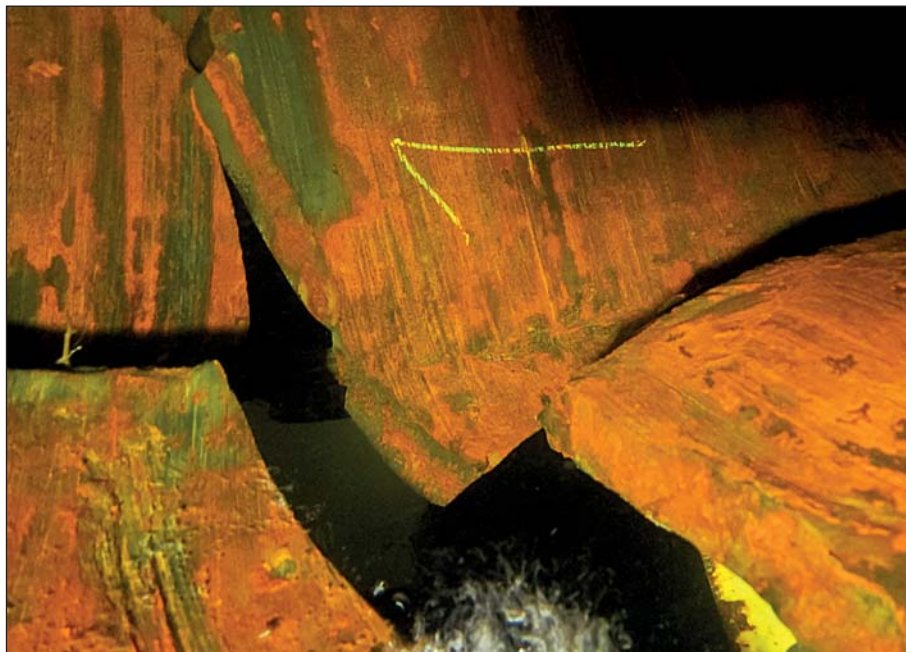
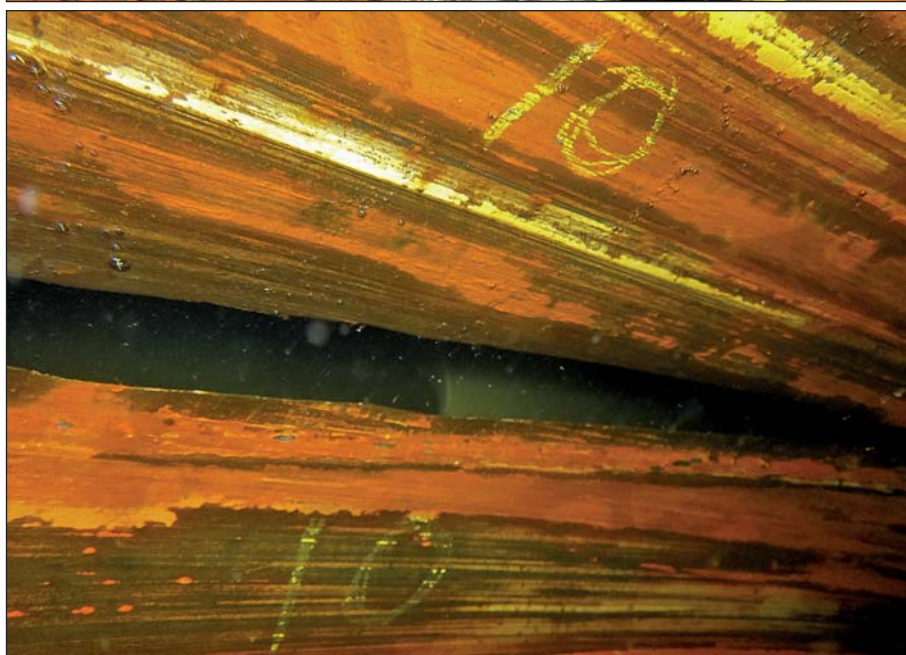
Severe damage to the hull as revealed by the detailed video inspection carried out by Hydrex divers.

Our diver/technician team examined the hull, took measurements and photographed and videoed the damage. They reported two very large holes in the hull, one about 5 x 5 meters aft on the port side and the

other about 8 x 1.8 meters near the forepeak on the port side, as well as many smaller holes, cracks and indentations.

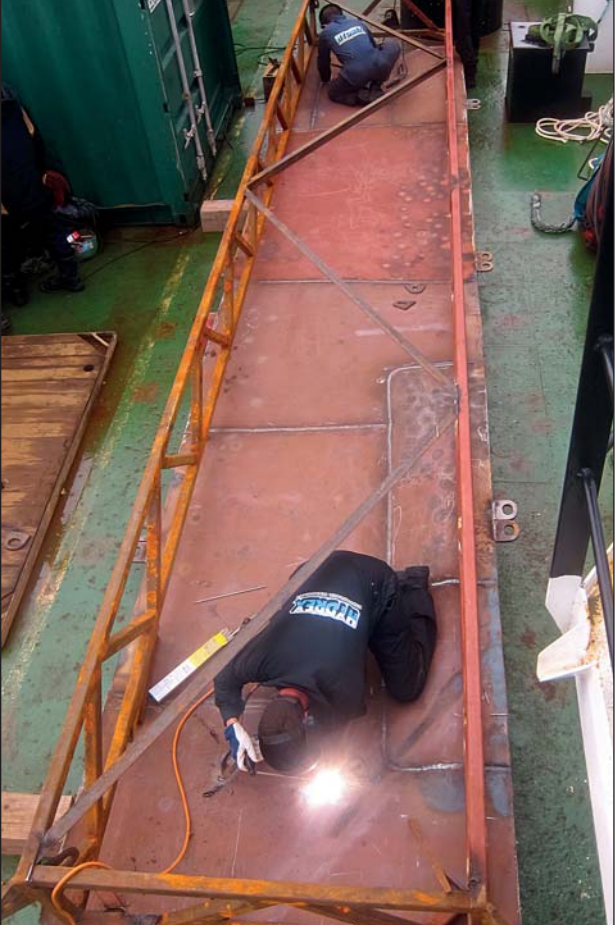
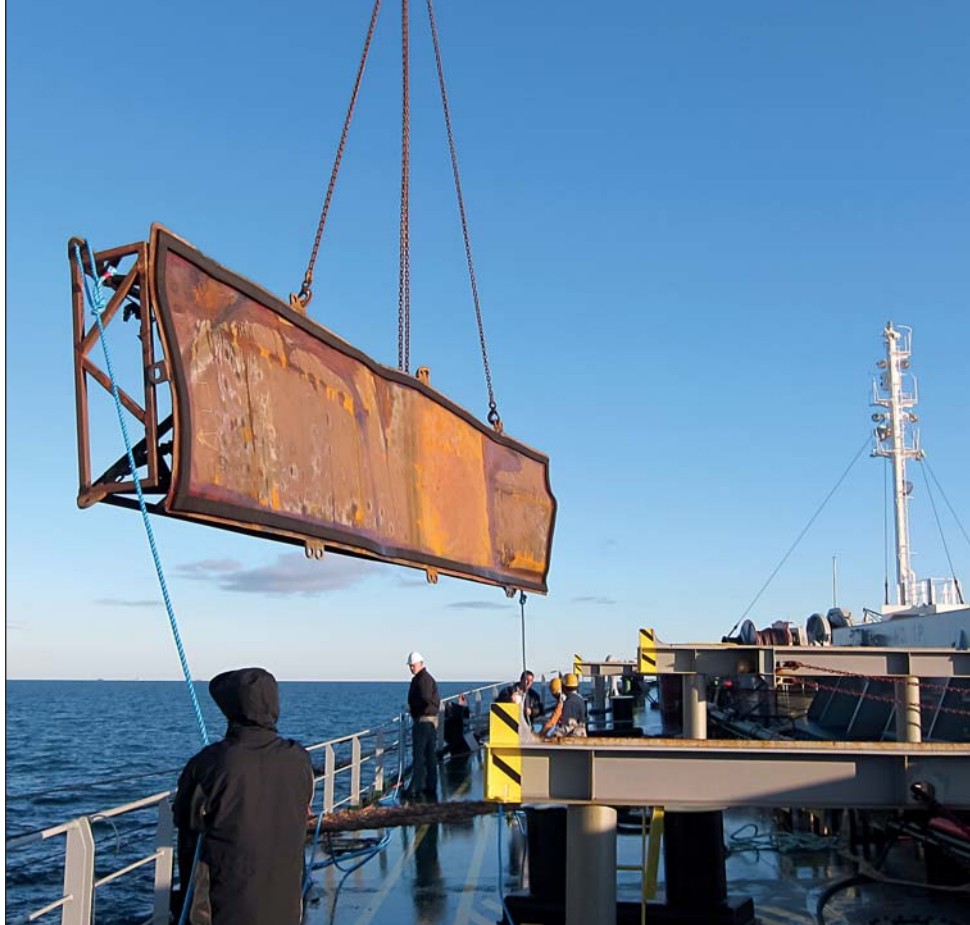
Preparing and lowering the doubler plate into the water so that it could be welded in place to repair the 8 x 1.8 m rip in the hull near the forepeak.

with chain blocks. While work was going ahead with the section, another Hydrex team worked on the fabrication and installation of the 8 x 1.8 m doubler plate in the area of DBBT No. 1. The frame was fabricated and

used for measurement and then the plate itself was cut, pre-shaped and attached.

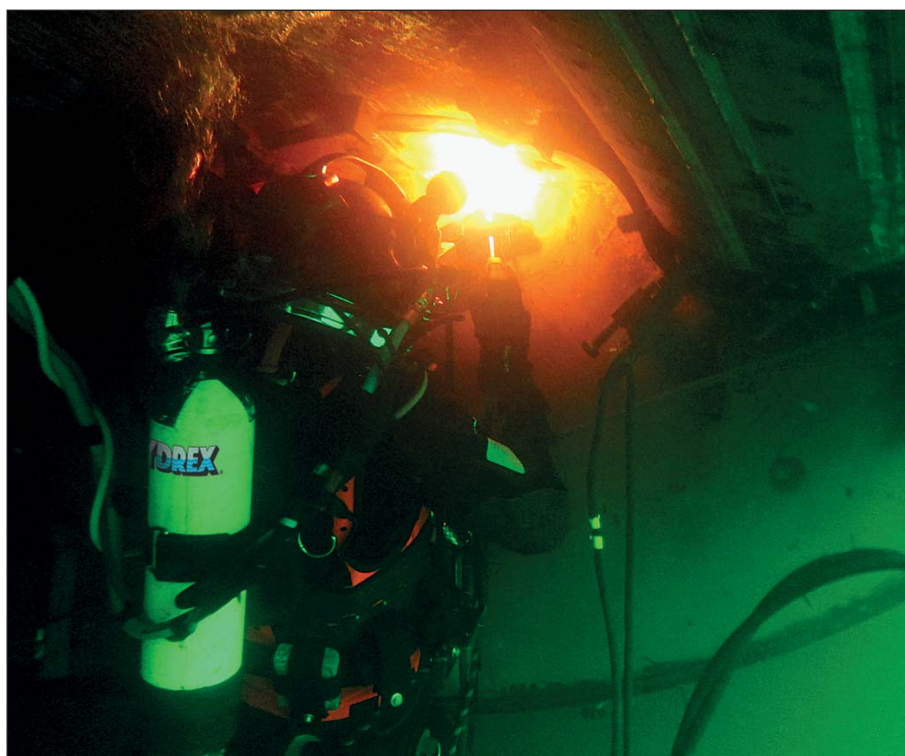
Repairs to smaller areas of damage where the hull was holed or cracked.

In addition to the repair of the two main areas of damage, there were many smaller holes and cracks which had to be repaired so that the vessel could sail. These holes and cracks were being repaired while the work of designing and fabricating the section and large doubler plate was going forward.

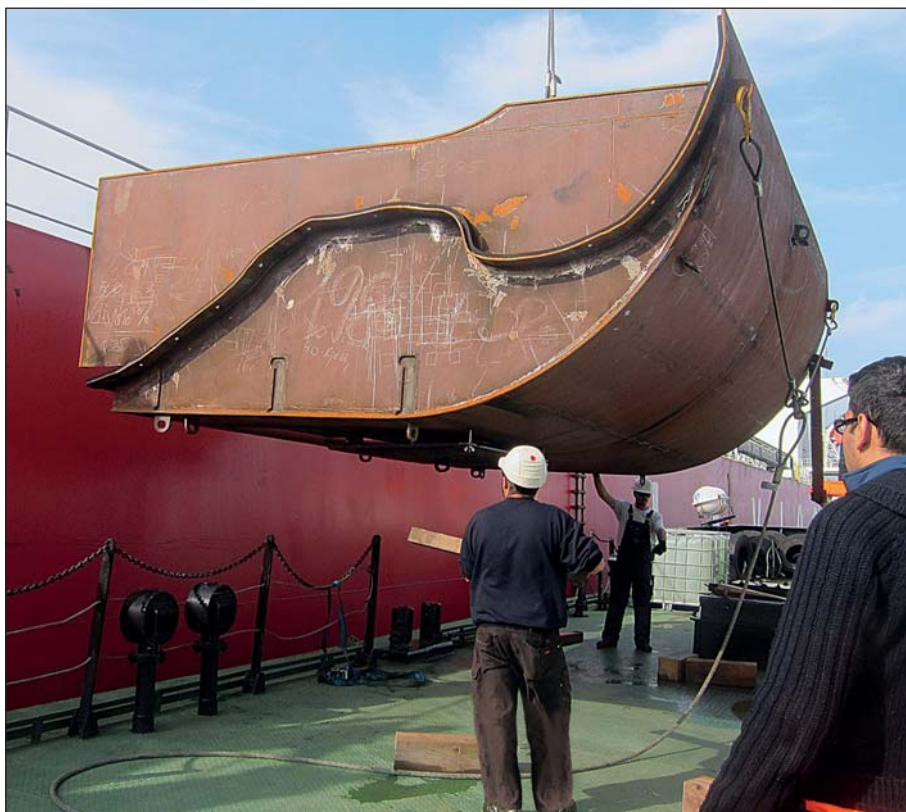
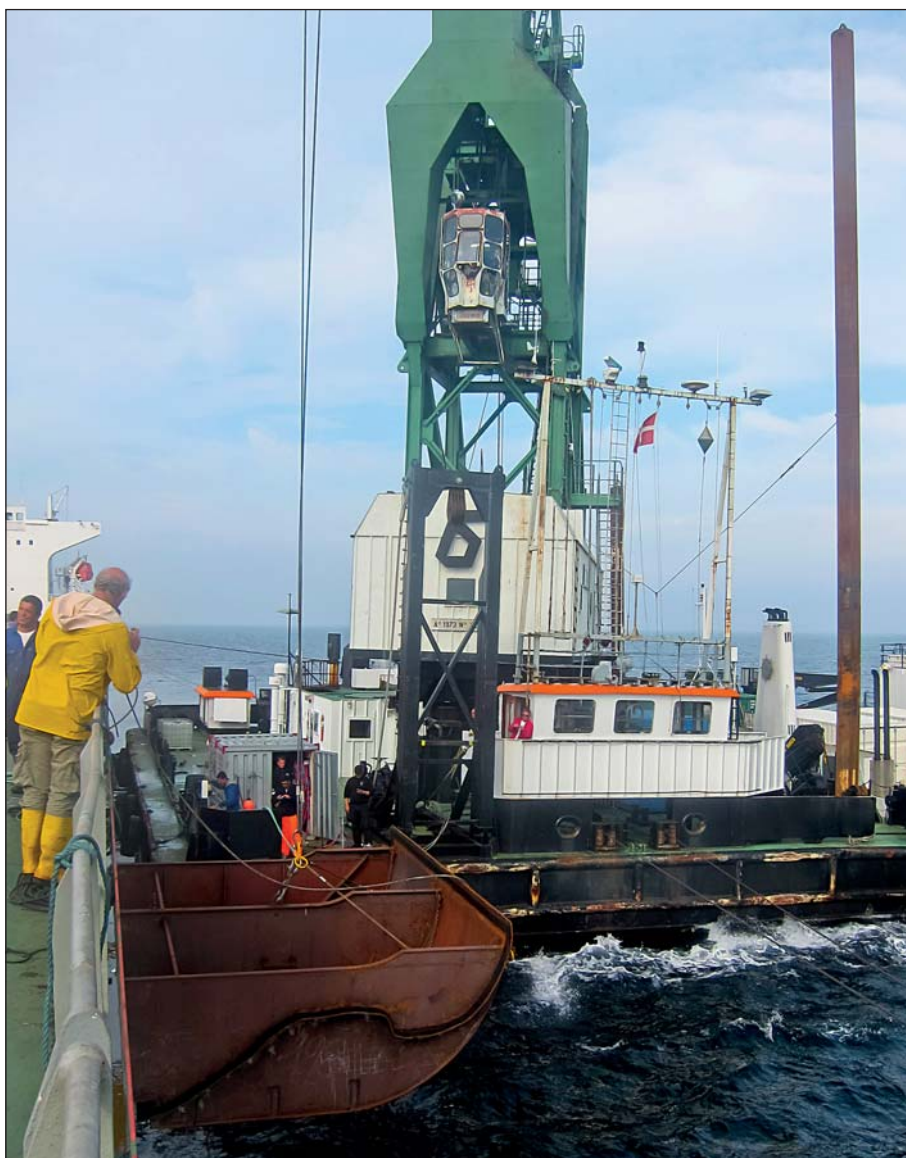
The finished section being lowered into the water and inserted into the cut-out in the hull using chain blocks.

ed and broken. Our divers proceeded to cut a hole in the hull about 5 x 5 meters in size.

The prefabricated insert was lowered into the water and rigged into place
