On-site repair on azimuth thruster in Gabon

30 days to remove, overhaul and re-install a 40-ton thruster

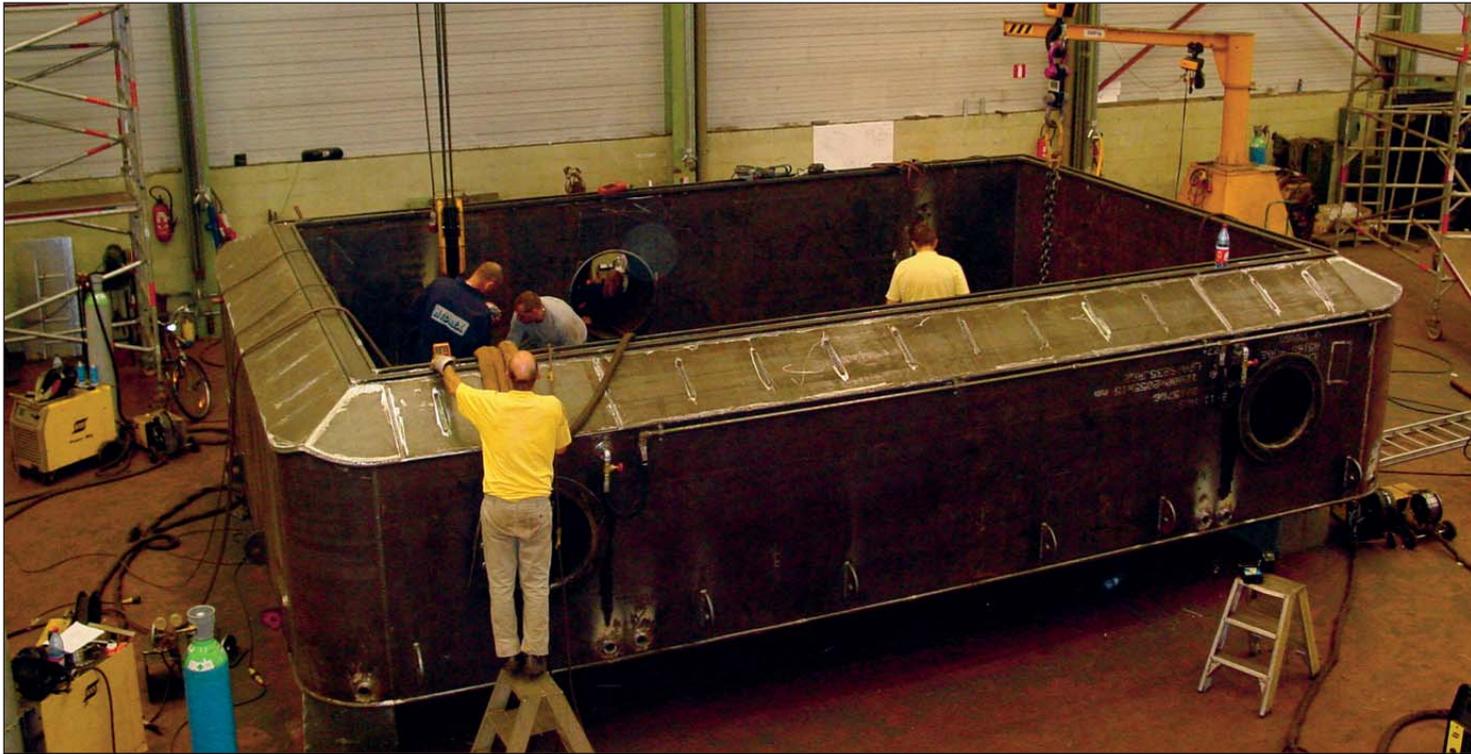
Mobdock construction.

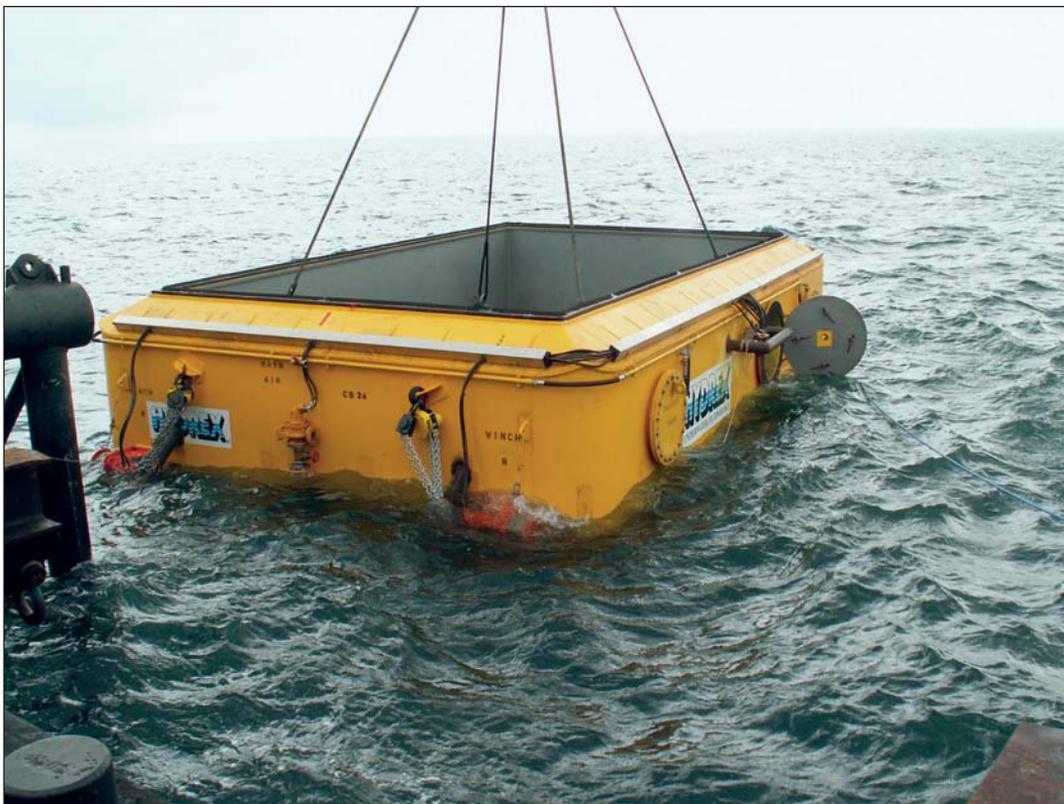
Immersion of mobdock.

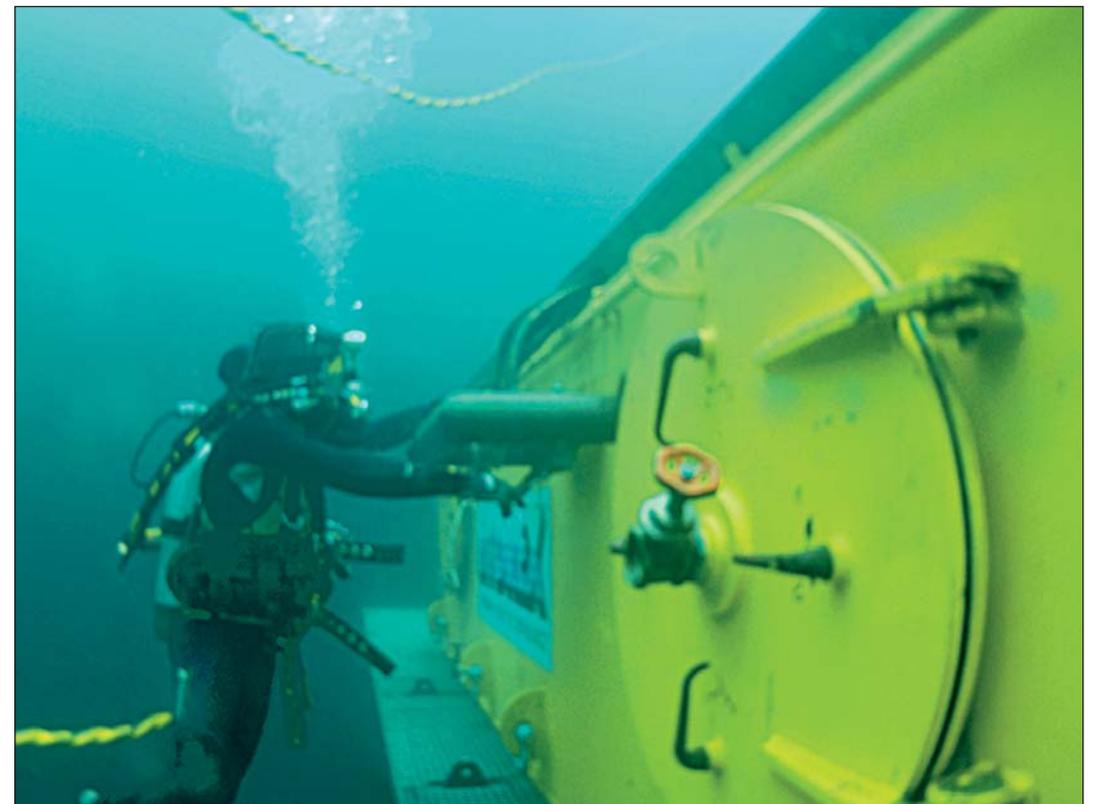
Preparation underwater.

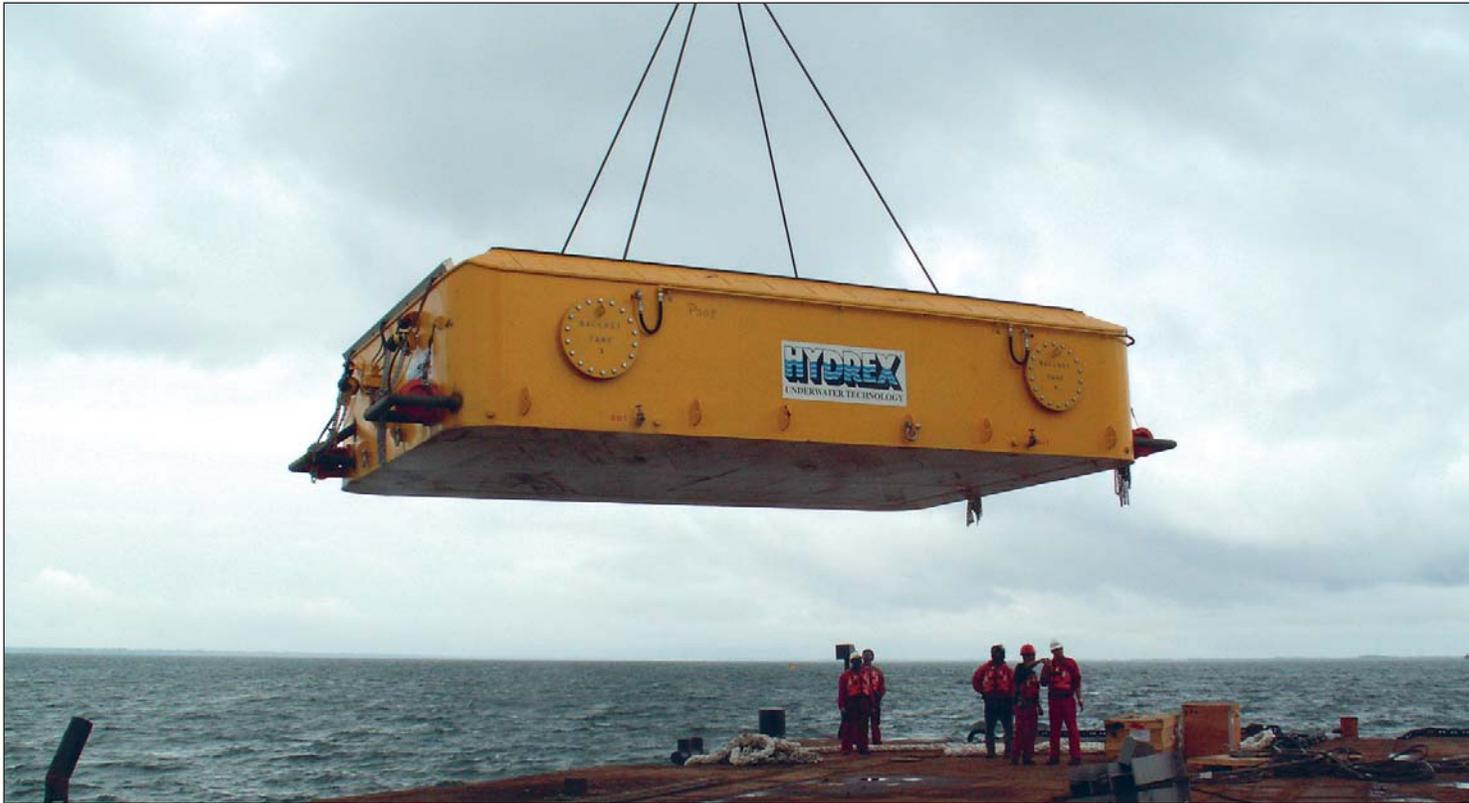
Positioning the mobdock.

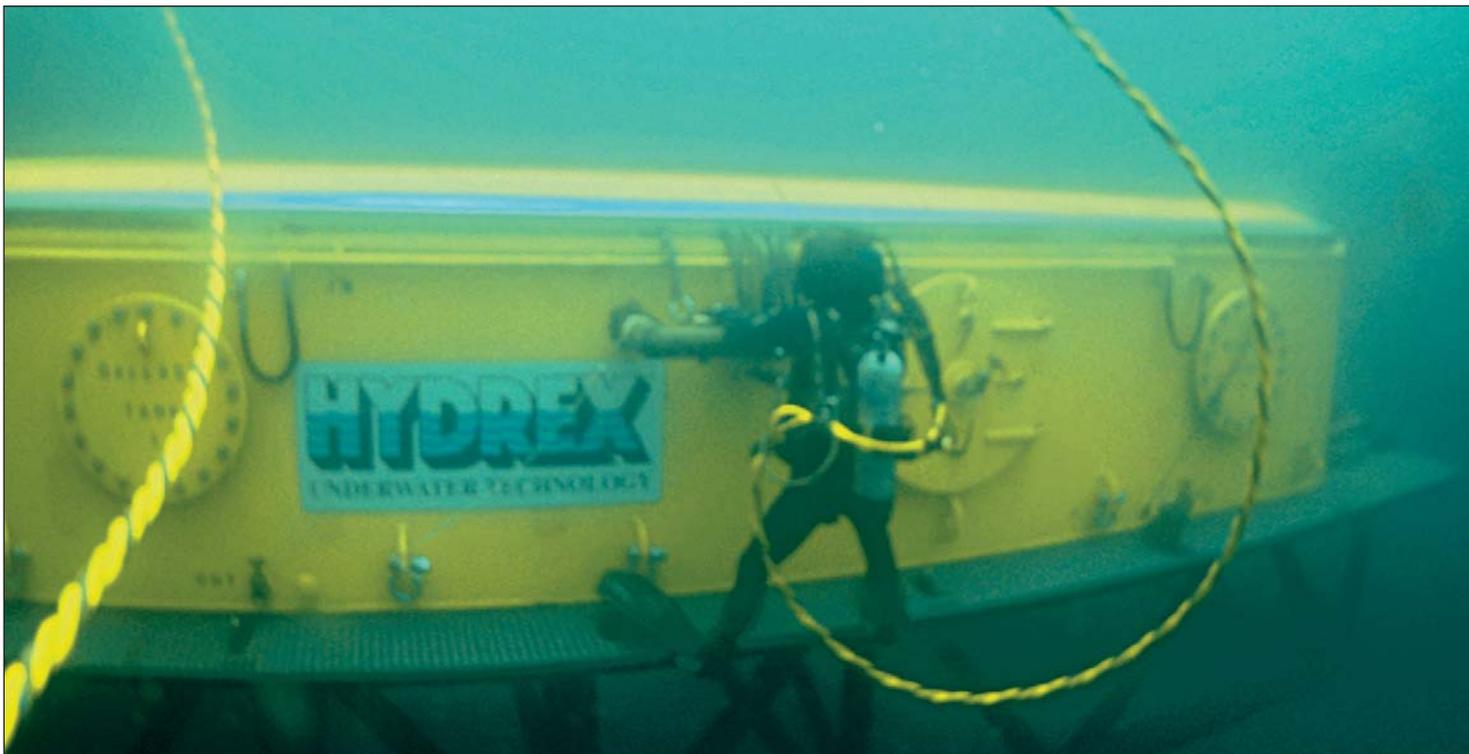
Mobdock underwater.

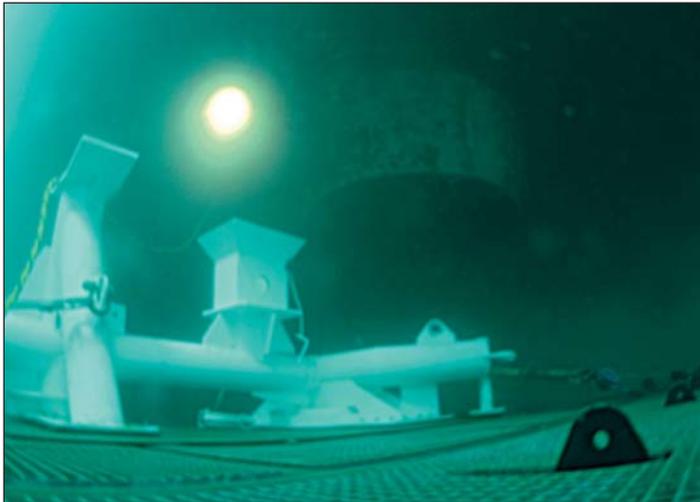
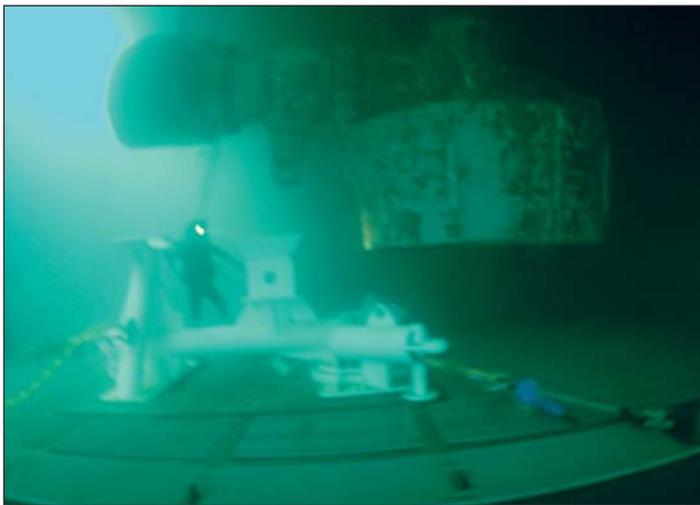
Lowering the thruster beneath the crane barge.

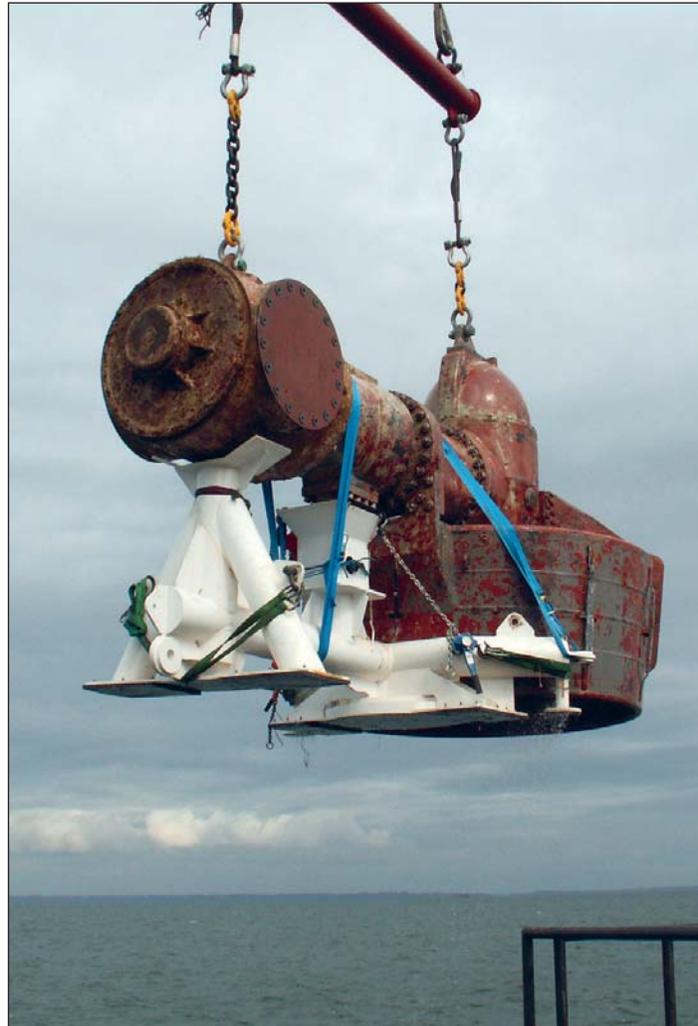
Transporting thruster out of water for repairs.

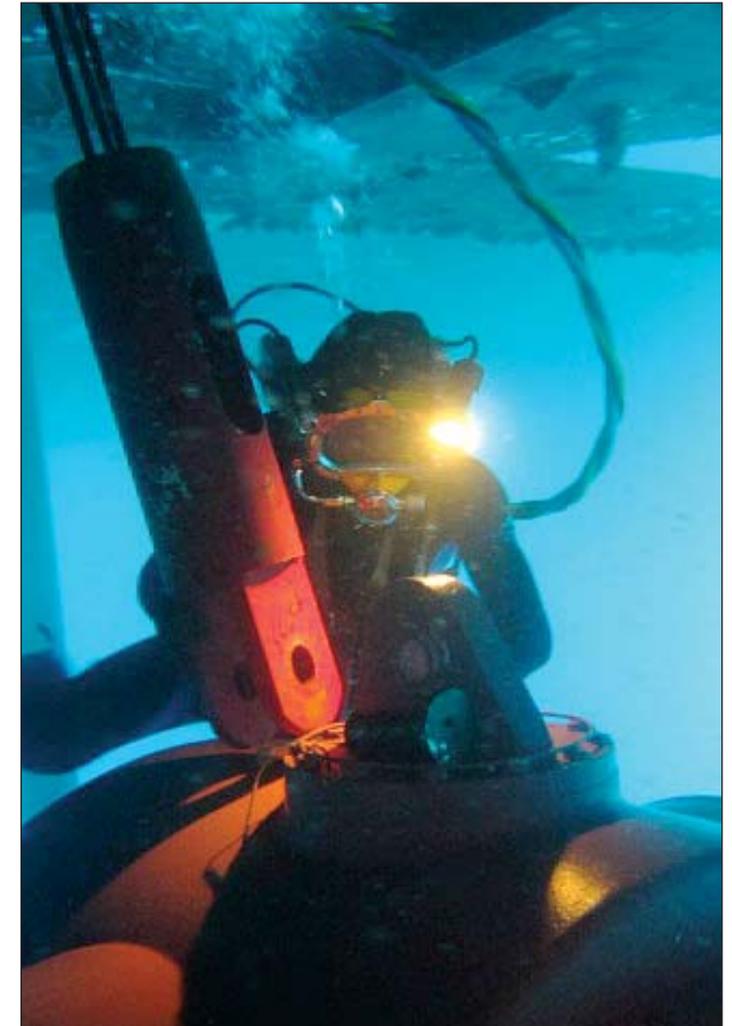
Hydrex diver/technician during reinstallation of azimuth thruster unit.
