Unprecedented repair in Dunkirk in 1991/1992

Hydrex repairs severely damaged bulbous bow of the *Ademontasa*

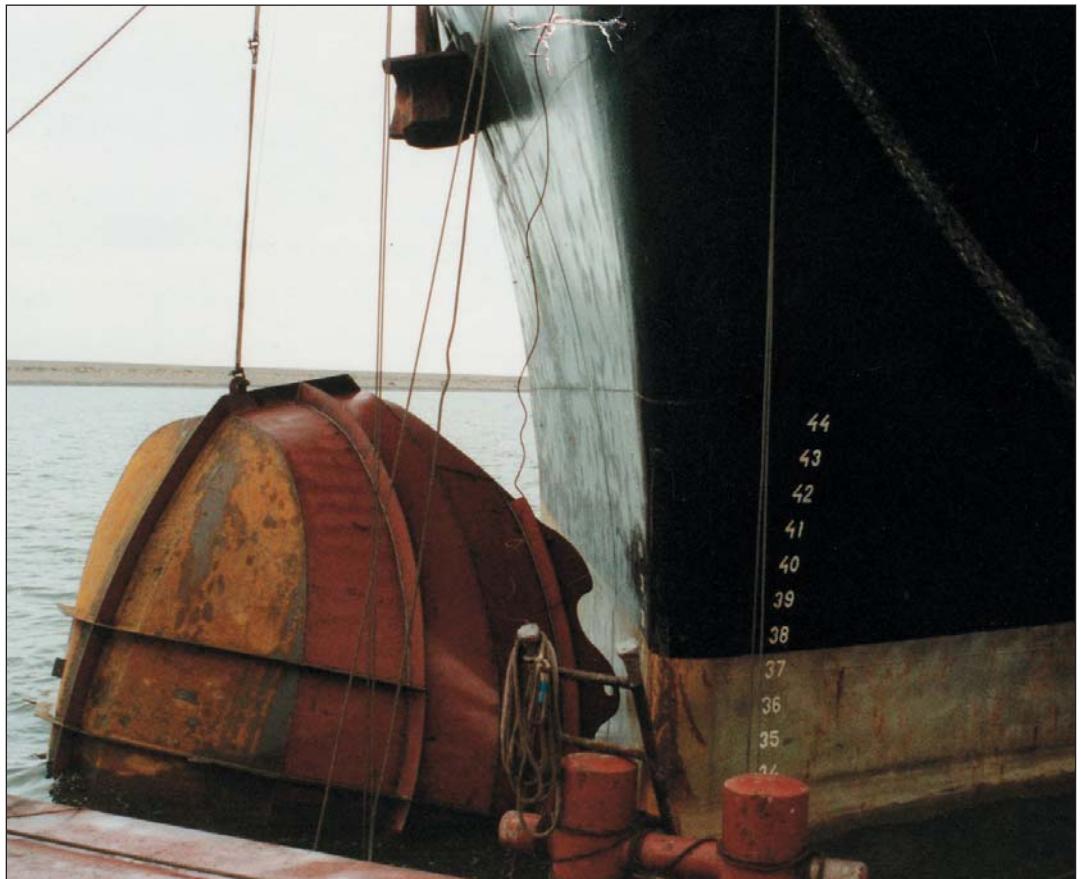
Hydrex took on the job of designing and constructing a shell to cover the damaged bulbous bow.

Our solution involved fitting a bulb doubler over the damaged bulbous bow of the *Ademontasa* and welding it into position. To ensure that this bulb doubler would fit perfectly, a temporary structure was set up inside the ship.

The divers built a rigid cage underwater which was welded over the damage. This template was then taken to the Arno shipyard in Dunkirk where the doubler was constructed. The building process took about six days.

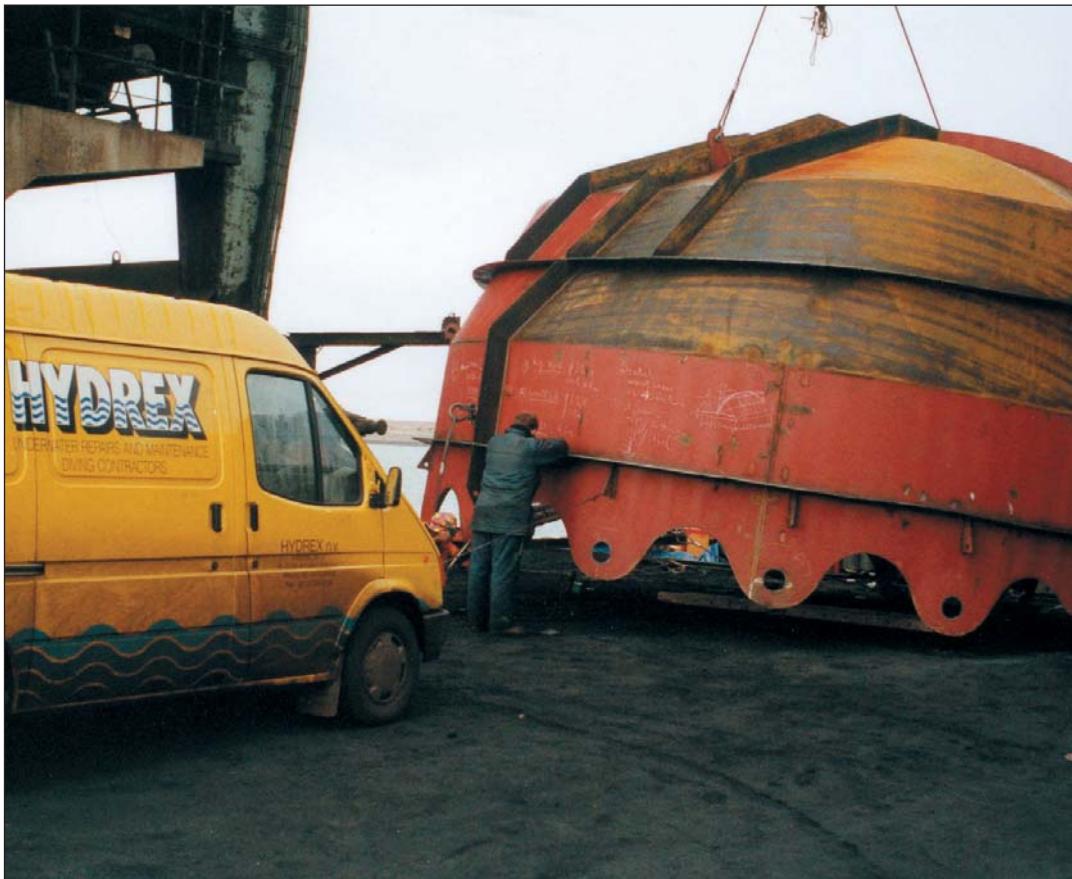
Four teams worked in shifts for 12 days and nights.

Four teams worked in shifts for 12 days and nights. First the plate was welded until the ship was completely watertight. Then a special concrete mixture was applied between the damaged bow and the bulb doubler. Finally, additional reinforcement beams were welded into place inside the ship.

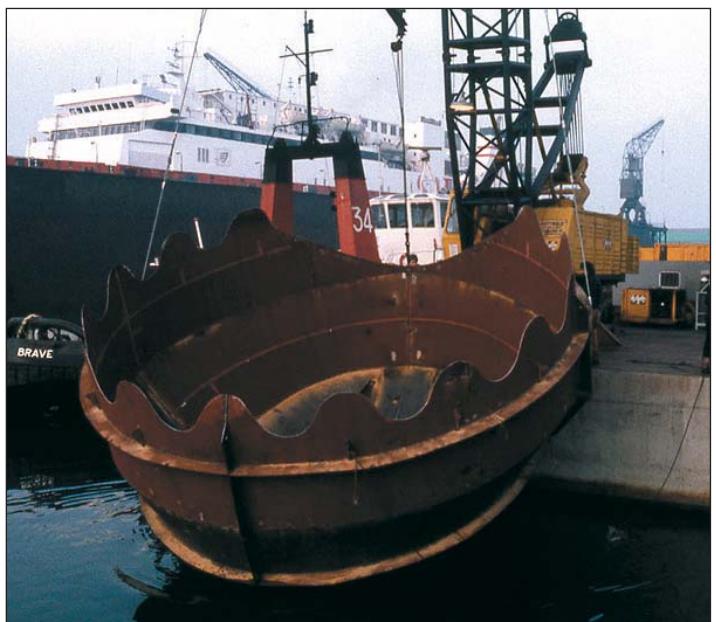
Hydrex took on the job of designing and constructing a shell to cover the damaged bulbous bow.

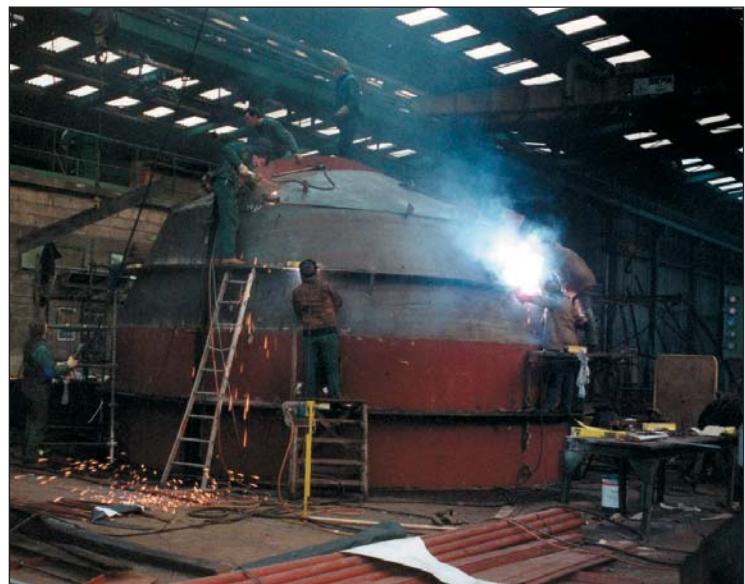
Constructing the replacement bulbous bow.

The new bow was made of 8mm thick steel and fitted with flaps to increase the flexibility and length of the welded seams. Thanks to the extra welding gaps in the flaps, the bulb doubler could be attached even more securely to the bow.

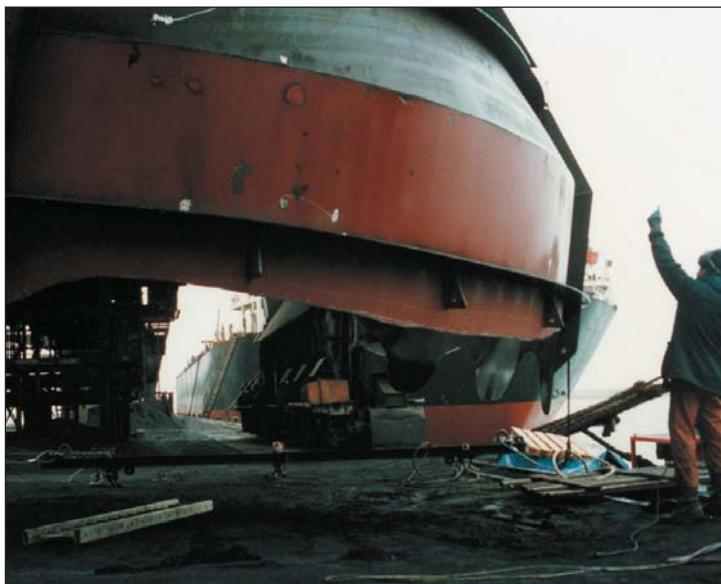
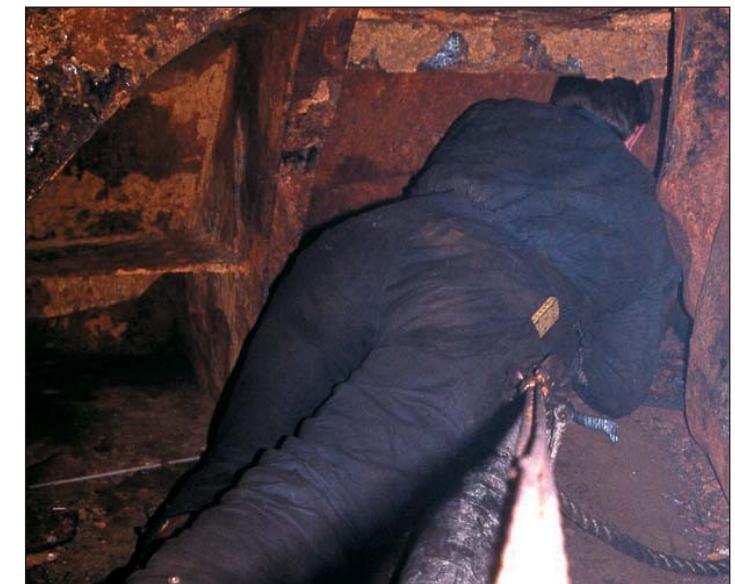
Additional reinforcement beams were welded into place.

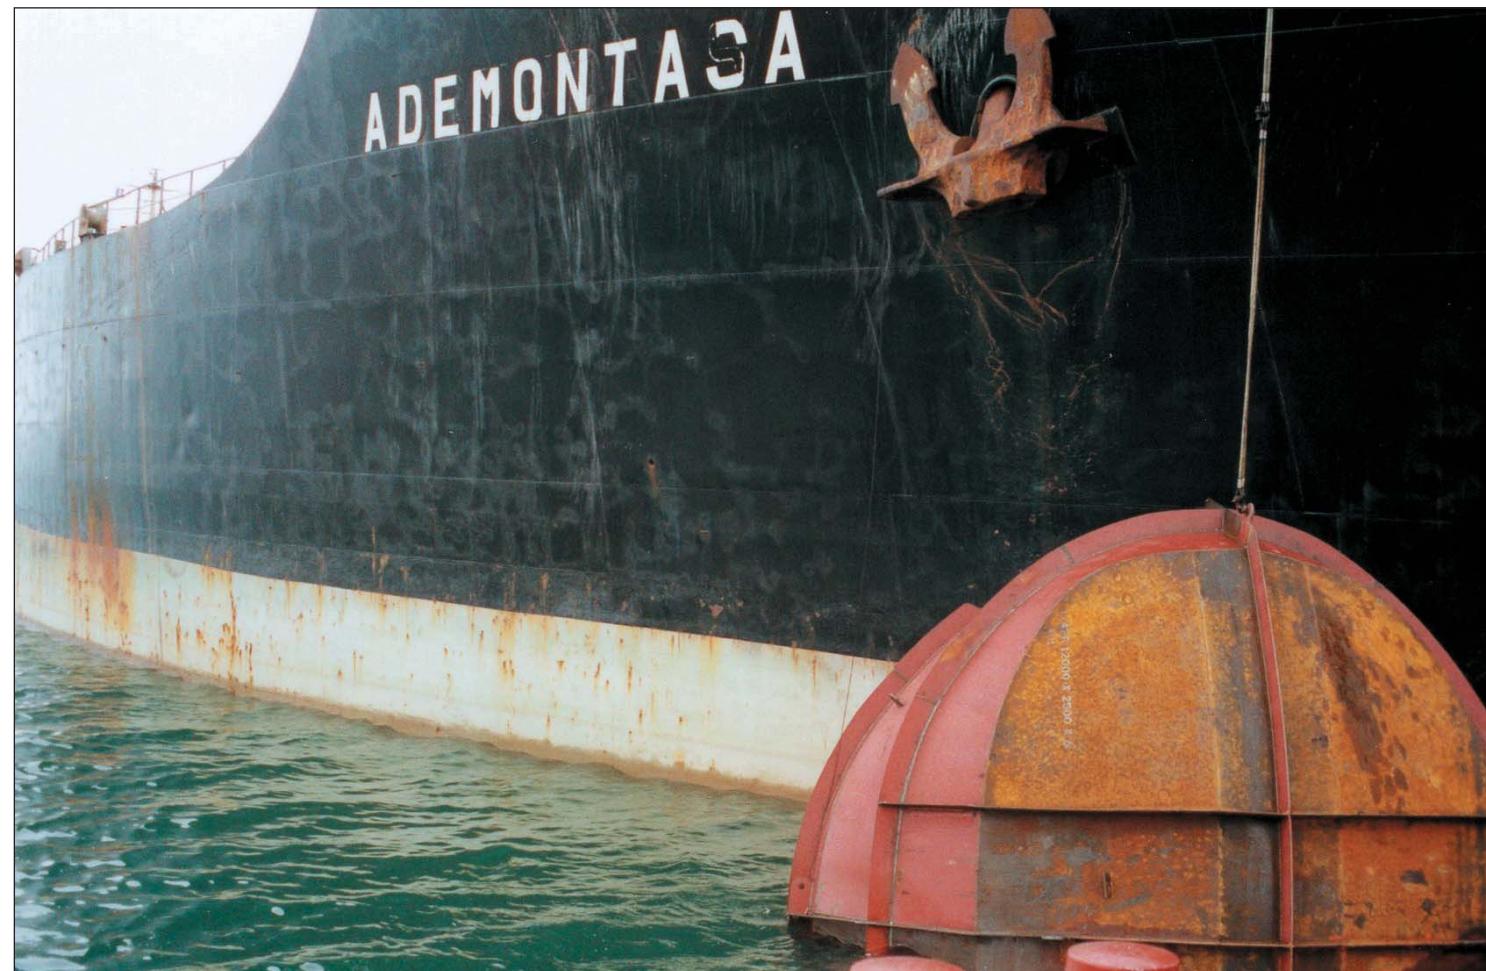
Putting it in place.
