500-ton, 70-meter long, 18-meter high drydock door repair in Cadiz

Major work done to render drydock operational

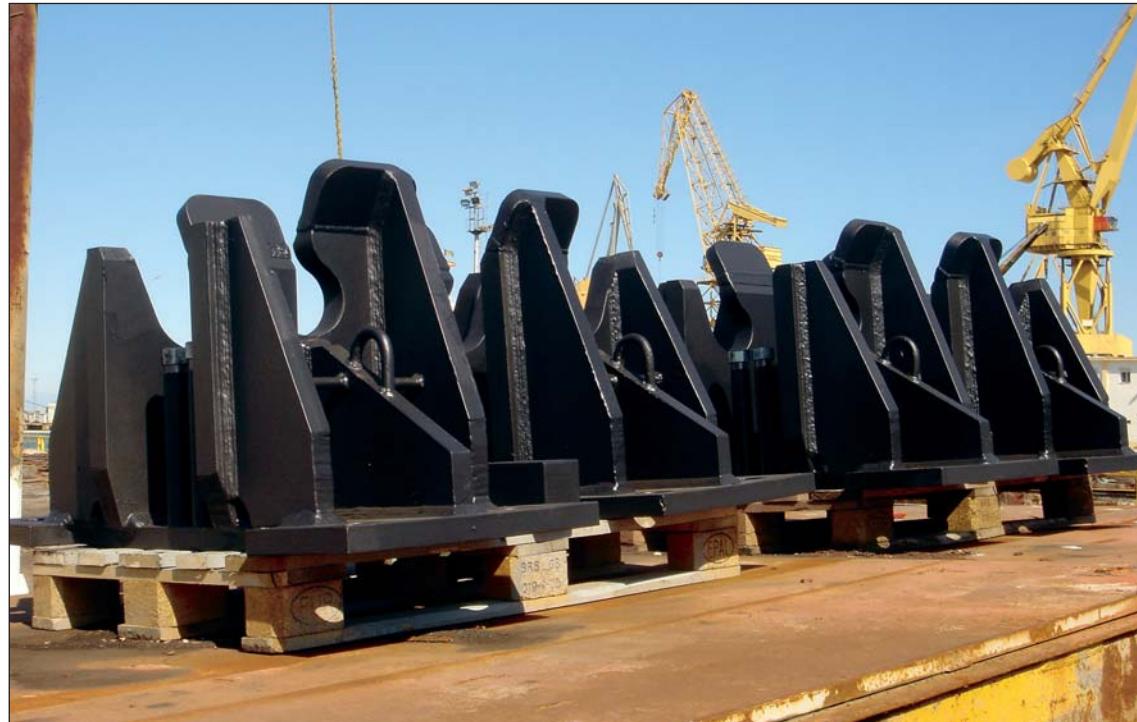
Some of the new hinges that were put in place under the drydock gate.

After all eight hinges were removed and brought to the surface our men spent hundreds of hours underwater gouging, cleaning, welding and preparing the positions for the new hinges. A new axle was put in place at the bottom of the gate. Through a detailed and complicated procedure (worked out carefully in advance) new hinges were then swiveled and rotated into place, with only millimeters to spare. These were positioned on the concrete foundations beneath the gate.

The divers had to work with very low space clearances. They had a work space of just one meter for this maneuver. As each hinge was correctly positioned, it was secured using special chemical anchors.

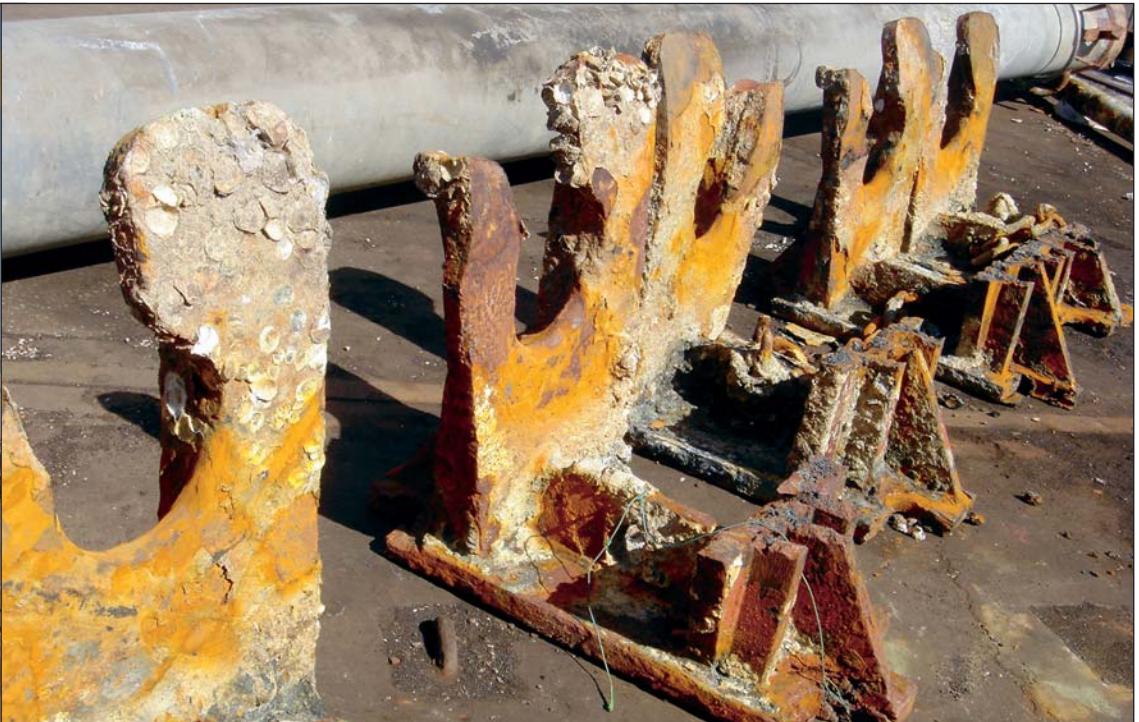
Examples of ones that were removed.

This gave enough room and visibility for the diving team to go down to the hinges and start the disengagement procedures to disconnect the hinges from the gate. What had actually happened over time was that the gate had sunk 60mm due to wear of the hinges and axle. The teams were then able to go into the work area, jack the door up to its original level and remove the old hinges.

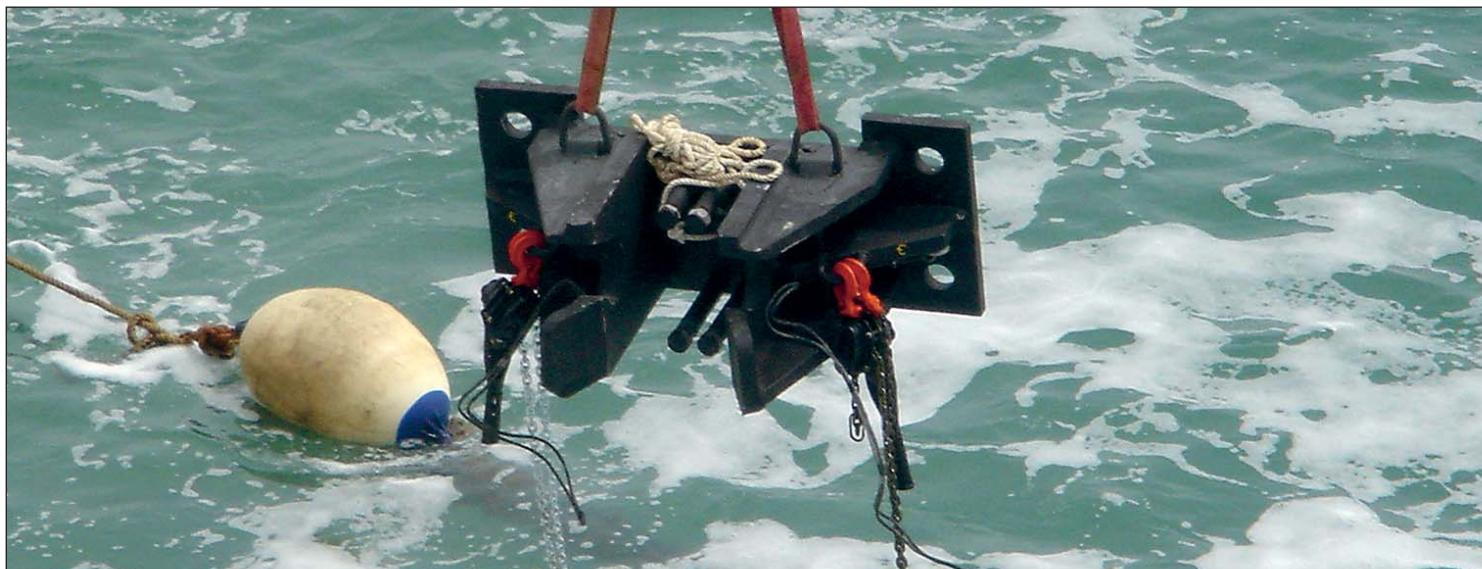
Lowering a new gate hinge into the sea.

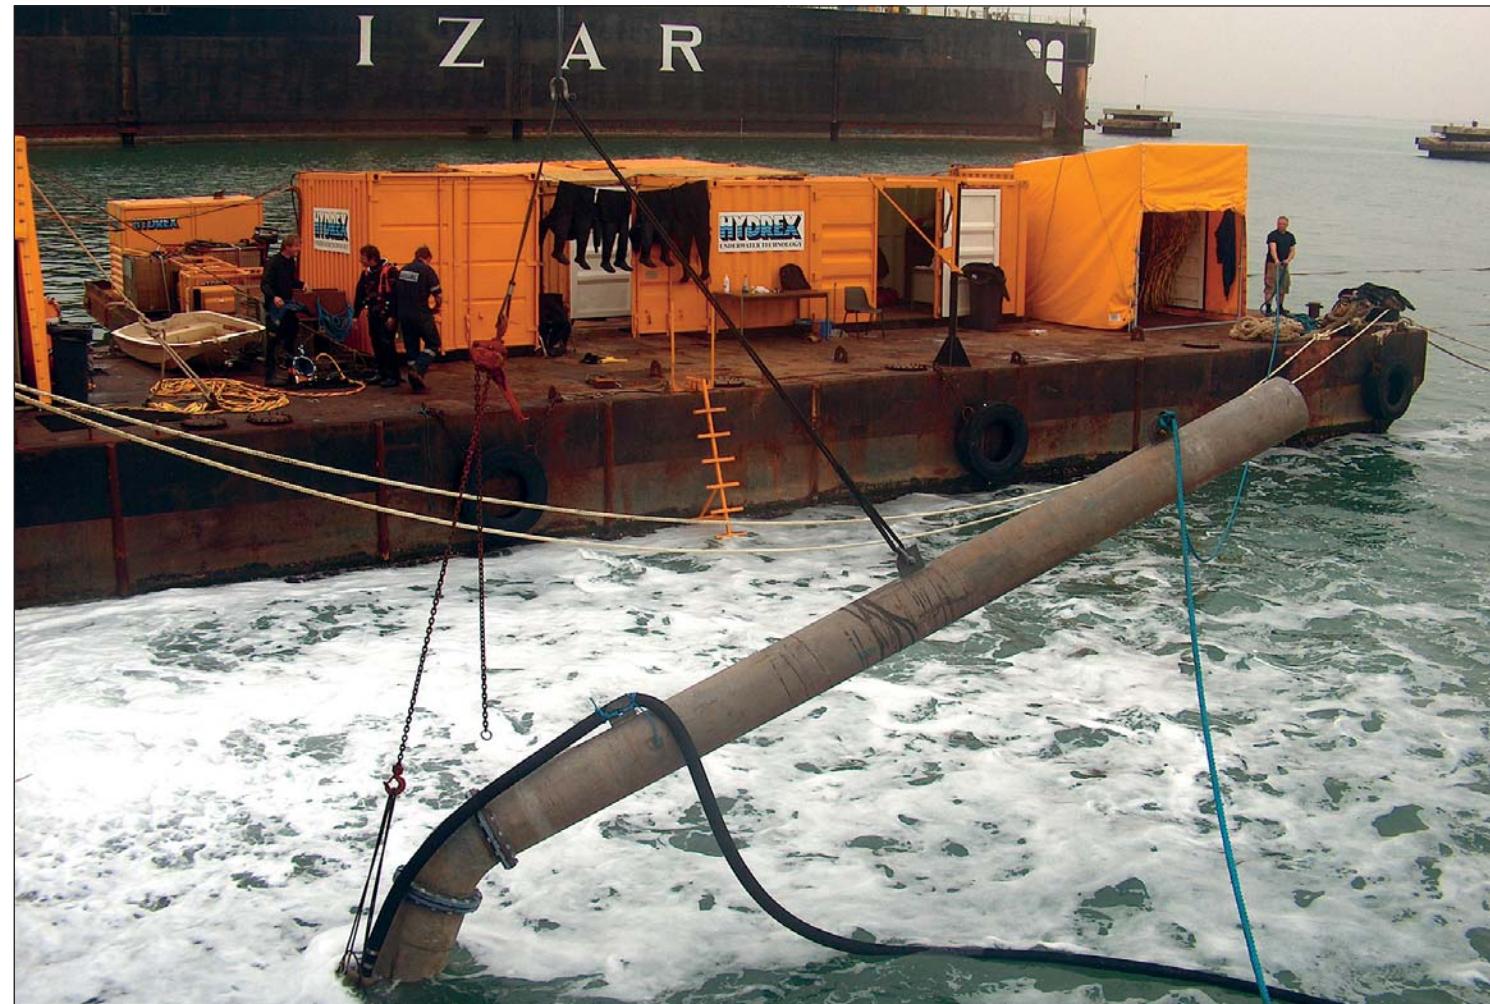
Dredging work that was necessary at the start of the project.

The preparations for the project were quite extensive. First the sea-bed in front of the gate hinges had to be dredged and all the accumulated debris and silt had to be removed. To do this a couple of dredging pontoons were established before the lock gate. With the use of divers, mobile cranes and hydraulic pumps all the excess material was then removed.
