A world's first in underwater repair: the insertion of a complete, prefabricated replacement hull section at anchor

Navios Sagittarius: behind the scenes at a remarkable salvage operation

In 2011 Hydrex was the chief subcontracting company for the inspection, planning and repair work when the bulk carrier *Navios Sagittarius* had run aground on the Tonneberg Banke, about 23.5 miles east of Frederikshavn, Denmark.

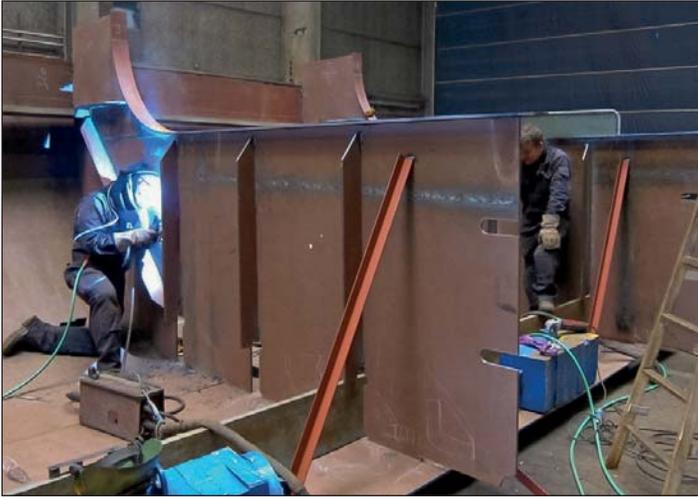
Fabrication of the section used to repair the 5 x 5 meter hole in the aft section of the hull, port side.

Using these measurements and the original drawings of the ship, the naval architects were able to produce final drawings from which a section and a doubler plate could be fabricated and installed. As fabrica-

tion of the section and the doubler plate was completed, preparation for installation began. In the case of the section it was necessary to cut through the hull plates where the hull was distorted and broken. Our divers proceeded to cut a hole in the hull about 5 x 5 meters in size.

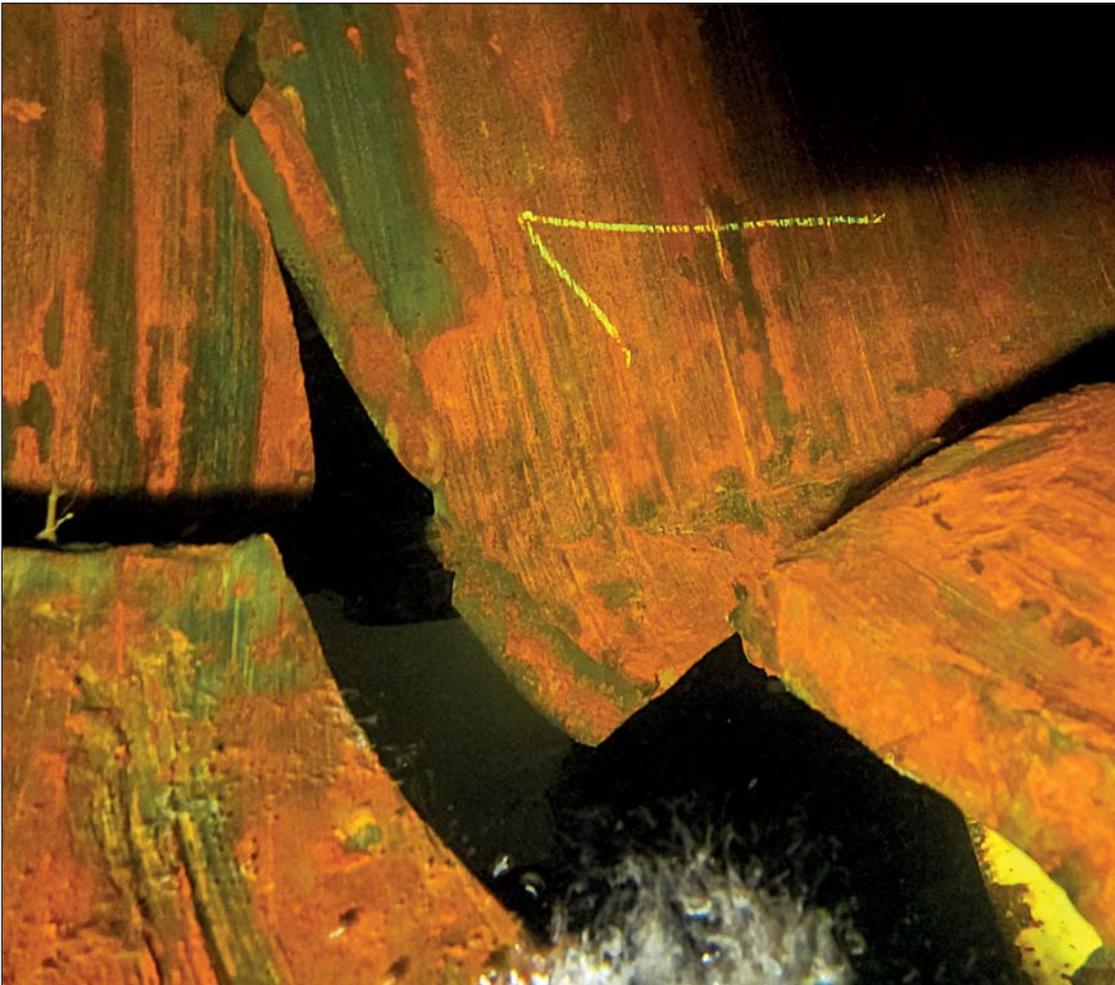
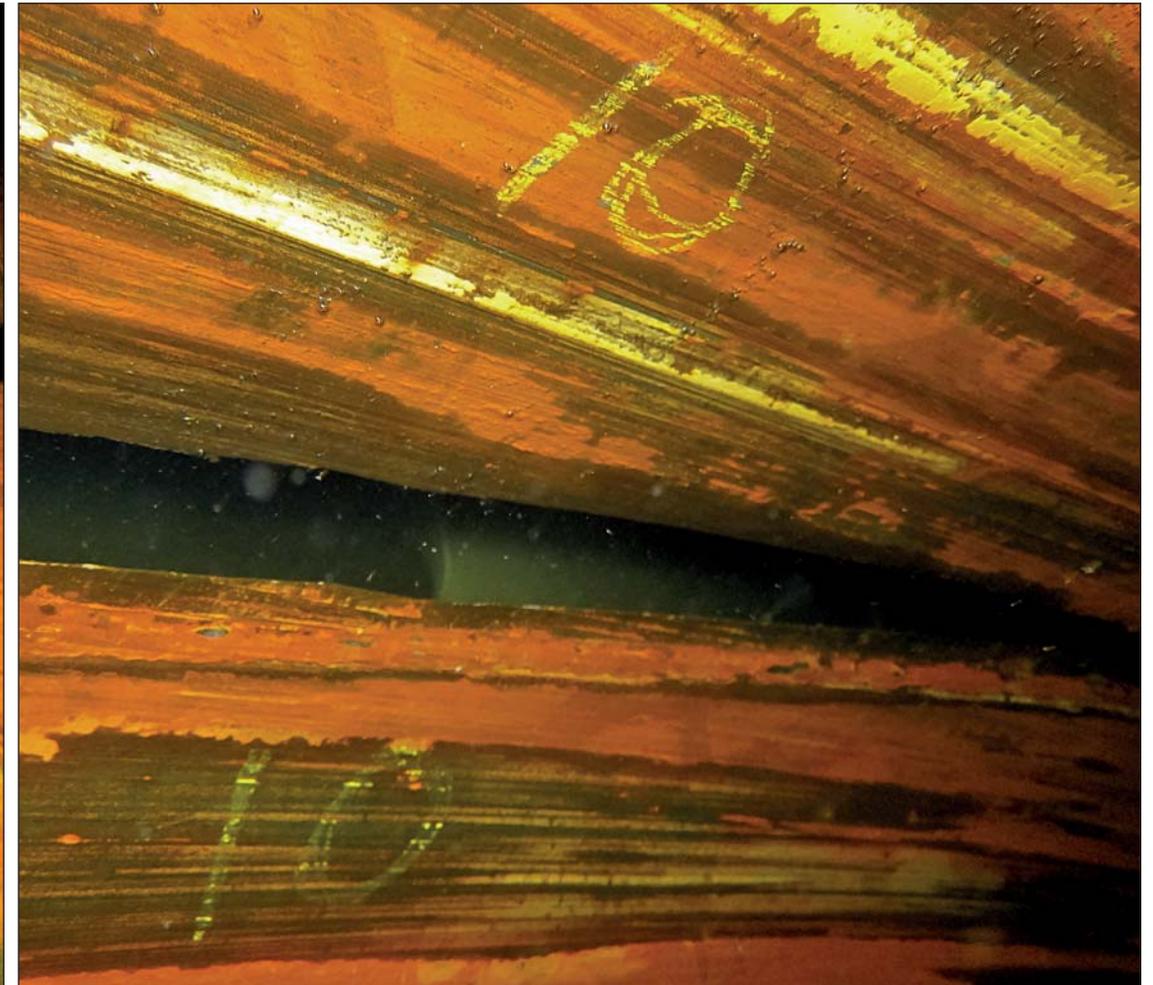
Our diver/technician team examined the hull, took measurements and photographed and videoed the damage. They reported two very large holes in the hull, one about 5 x 5 meters aft on the port side and the other about 8 x 1.8 meters near the forepeak on the port side, as well as many smaller holes, cracks and indentations.

Severe damage to the hull as revealed by the detailed video inspection carried out by Hydrex divers.

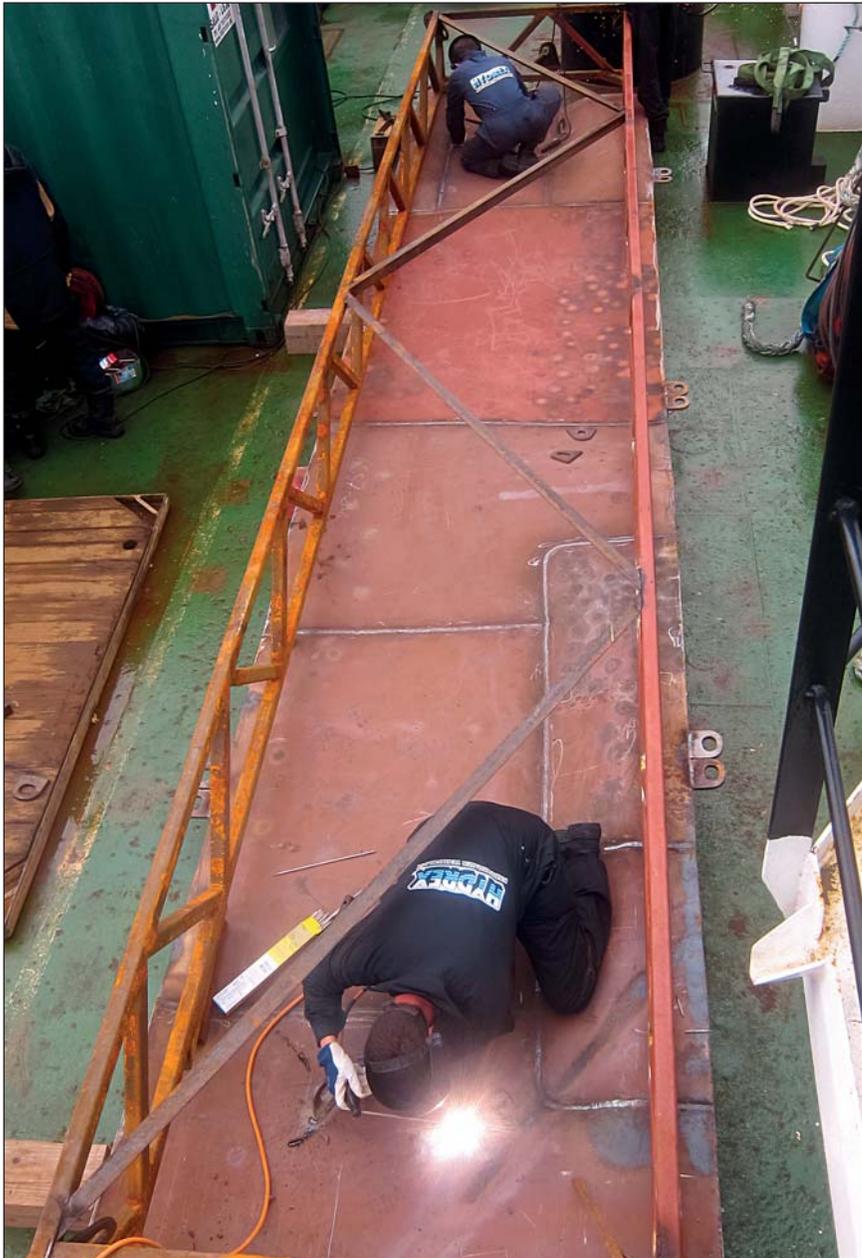
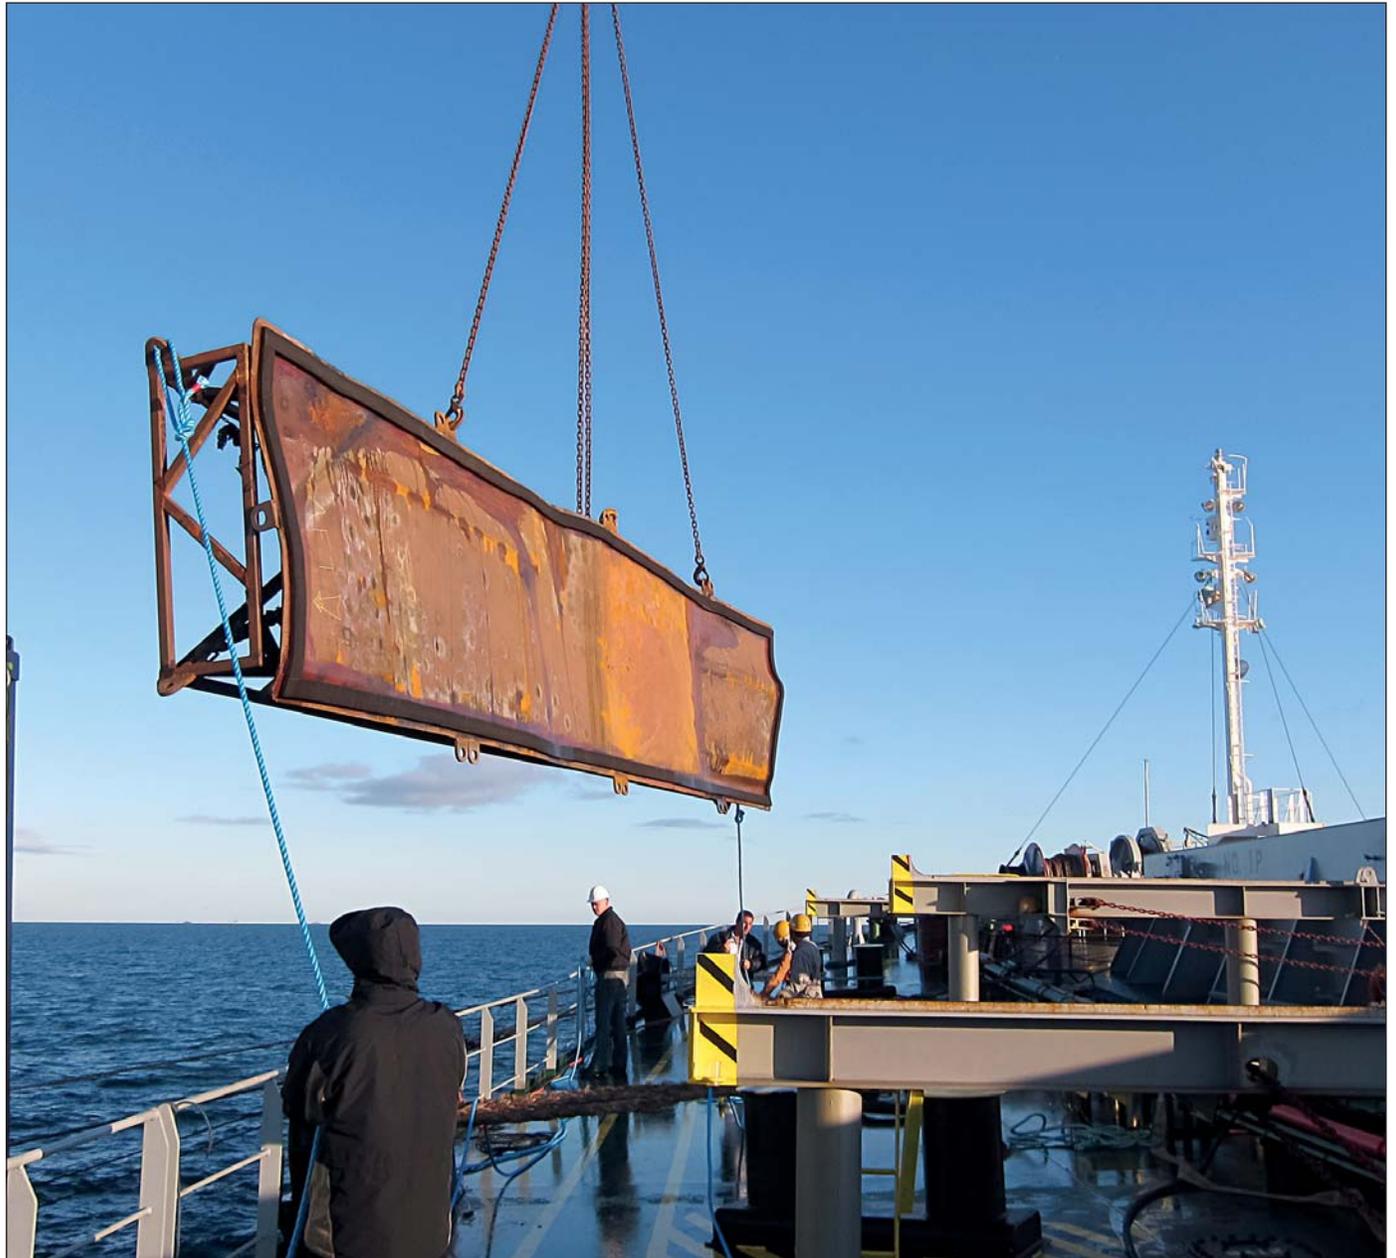
Preparing and lowering the doubler plate into the water so that it could be welded in place to repair the 8 x 1.8 m rip in the hull near the forepeak.

The prefabricated insert was lowered into the water and rigged into place with chain blocks. While work was going ahead with the section, another Hydrex team worked on the fabrication and installation of the 8 x 1.8 m doubler plate in the area of DBBT

No. 1. The frame was fabricated and used for measurement and then the plate itself was cut, preshaped and attached.

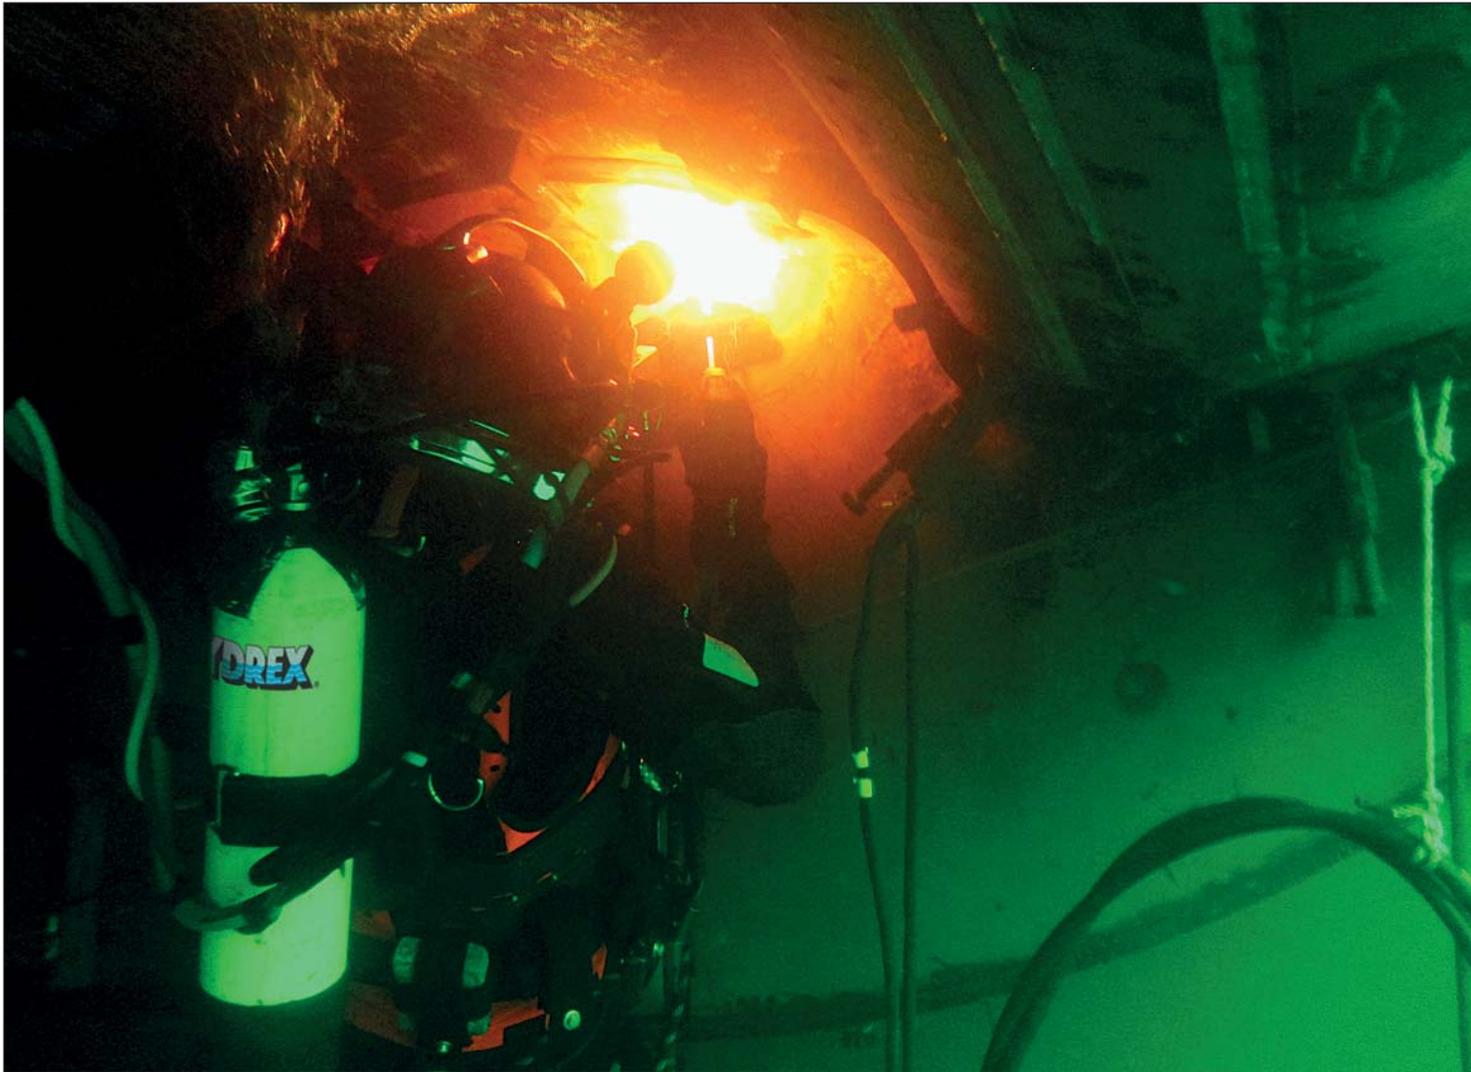
Repairs to smaller areas of damage where the hull was holed or cracked.

In addition to the repair of the two main areas of damage, there were many smaller holes and cracks

which had to be repaired so that the vessel could sail. These holes and cracks were being repaired while the work of designing and fabricating the section and large doubler plate was going forward.

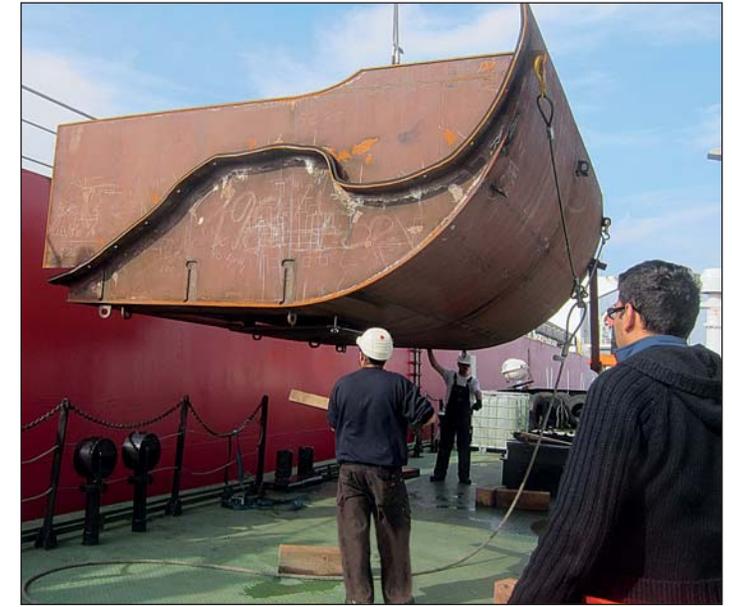
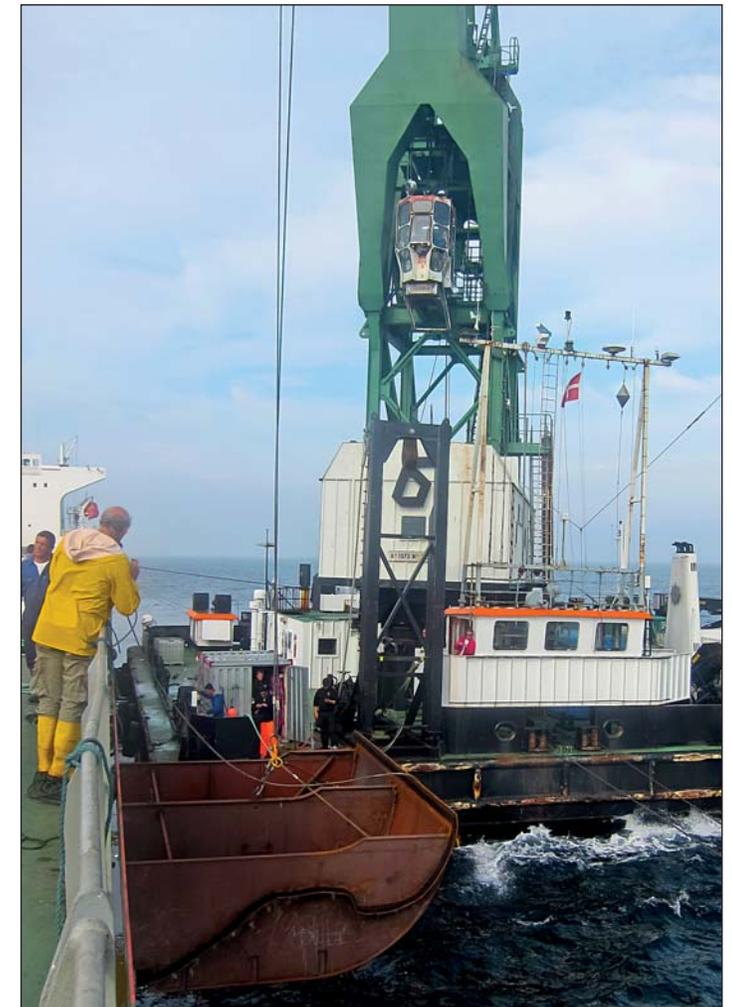
The finished section being lowered into the water and inserted into the cut-out in the hull using chain blocks.
