SORJ | SHIP AND OFFSHORE REPAIR JOURNAL

Volume 16 - Issue 3 - August / September 2018

Underwater Repairs

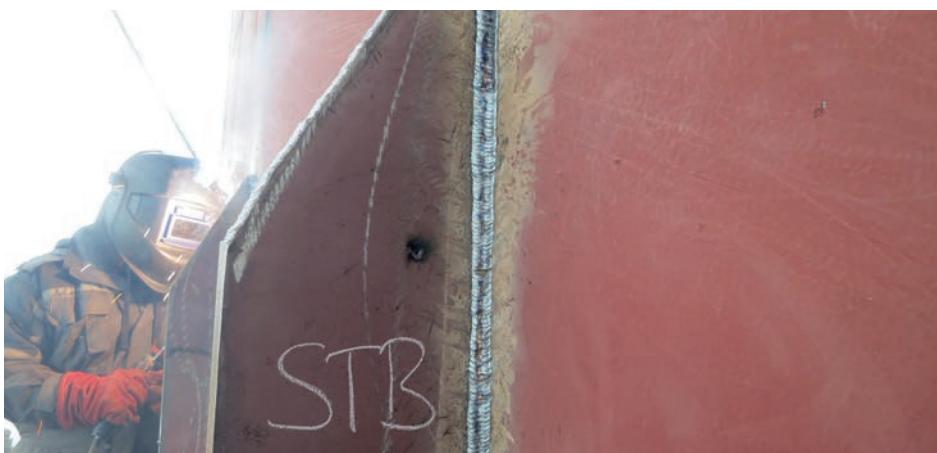
A Hydrex mobdock
