# Save the day

**The insertion of a complete, prefabricated replacement hull section in a badly damaged ship at anchor is believed to be a world-first in underwater repair**

David Phillips, Hydrex NV

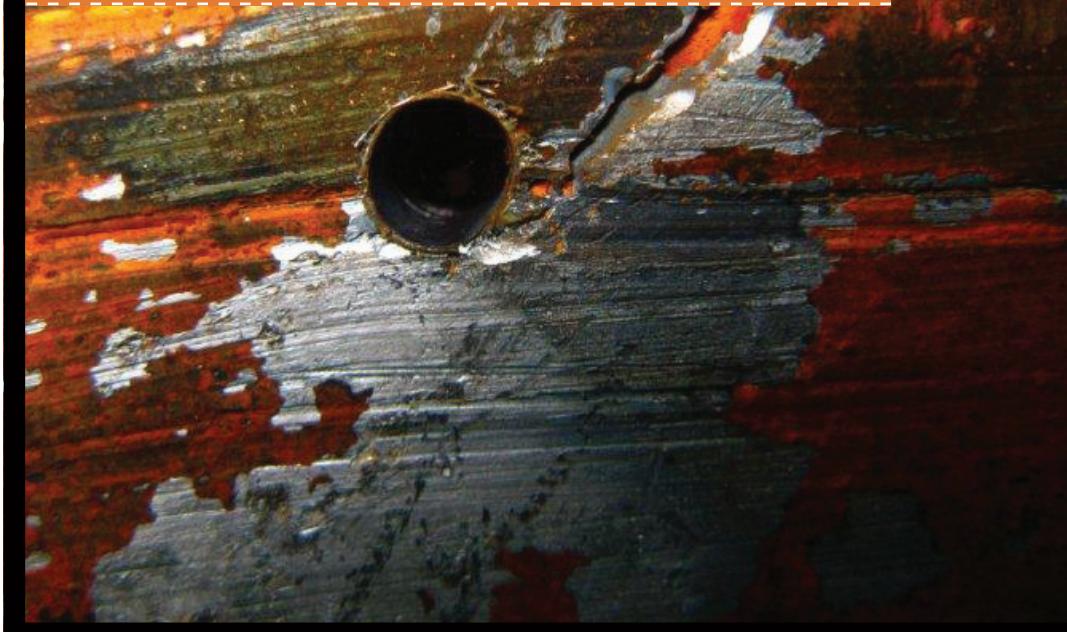
ABOVE LEFT: Hydrex divers carried out inspections on severe damage to the hull  
XXXXXXXXXX

The Hydrex divers examined the hull, took measurements, and photographed and videoed the damage. They reported two very large holes in the hull, one about 15 x 15 ft aft on the port side, and the other about 24 x 6 ft near the forepeak on the port side, as well as many smaller holes, cracks, and indentations. All in all, the damage was very severe and the divers sent this information, along with their suggestions for repair, to the Tsavliris naval architects team. Michalis Chourdakis, who manages C. N. Zachopoulos & Associates, the Piraeus, Greece-based marine surveyor and consultant engineer, headed the four-man team. Chourdakis also serves as technical consultant for Tsavliris, overseeing technical matters on the company's fleet of tugs, and also as naval architect in salvage operations where required. In this case, he worked on and oversaw all the necessary planning and engineering that was needed to repair the two main damaged areas of the ship.

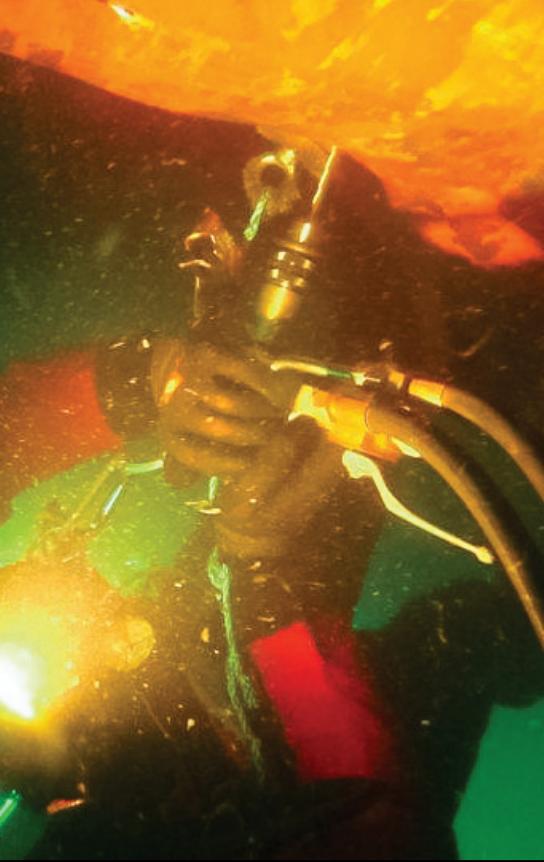
**BELOW LEFT:** Repairs to smaller areas of damage where the hull had holes or cracks

In addition to the repair of the two main areas of damage, there were also many smaller holes and cracks that had to be repaired so that the vessel could sail. These were repaired while the design and fabrication of the section and doubler plate was taking place.

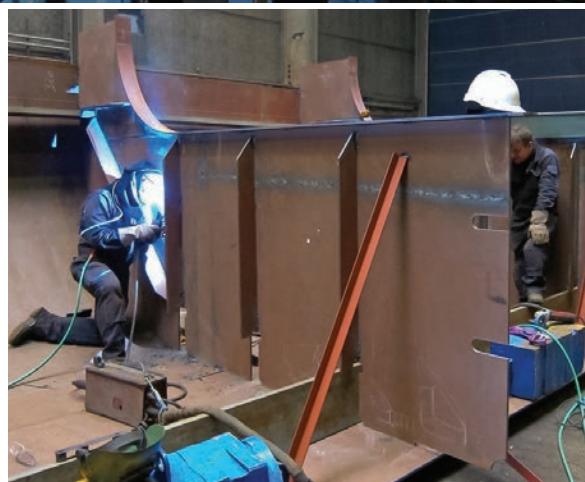
**BELLOW:** Fabrication of the section used to repair the 16.4ft x 16.4ft hole in the aft section of the hull, port side

Using these measurements and the original drawings of the ship, the naval architects were then able to produce final drawings from which a doubler plate could be fabricated and installed. Using these drawings, a section was prefabricated at the local dockyard to repair the large hole, and a doubler plate was constructed to cover the long damaged area, with three holes in the area of double-bottom ballast tank (DBBT) No 1. The steel used had to be 12mm thick, which is too thick for easy, rapid bending, so the plates had to be measured and cut to fit the hull as accurately as possible.
