WELDING *Journal*

March 2012

UNDERTAKING A COMPLEX UNDERWATER REPAIR

A damaged freighter needed repairs to stop a leak, prevent buckling, and keep cracks from spreading so the ship could sail to where she could unload

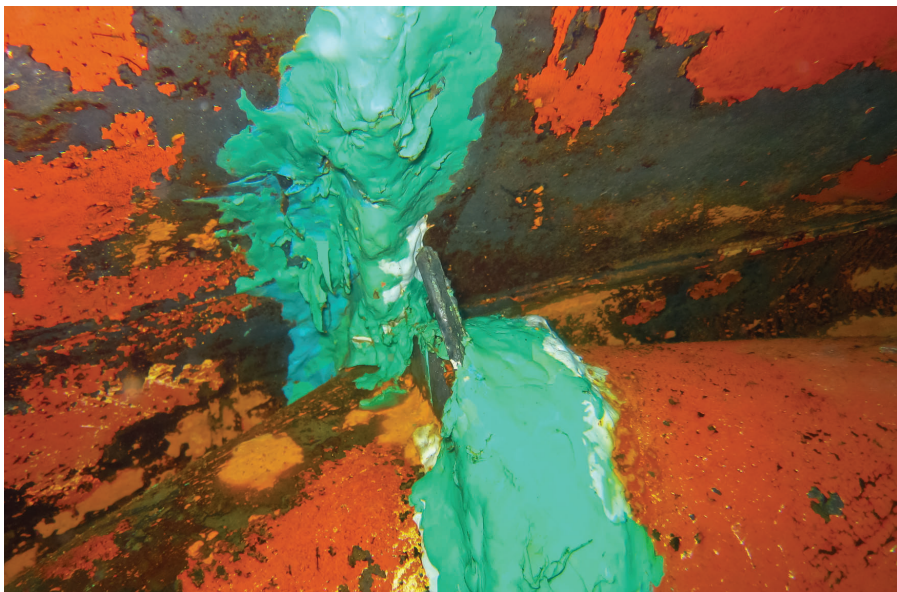
A local diving company in Egypt carried out temporary repairs using doubler plates and putty from the outside and cement boxes on the inside — Fig. 3. The ship then resumed its voyage to China. However, one week after sailing from Suez, the ballast tanks flooded again and a vertical crack developed on the starboard vertical side shell plating, on the aft part of the area damaged by the grounding and just forward of the bulkhead between DBBTs 2 and 3, and cargo holds 3 and 4 — Fig. 4.

*Fig. 3 — (Top) The buckled hull and the previous attempt at repairs.
Fig. 4 — (Bottom) Close-up showing the severity of the long, vertical crack discovered in the hull.*

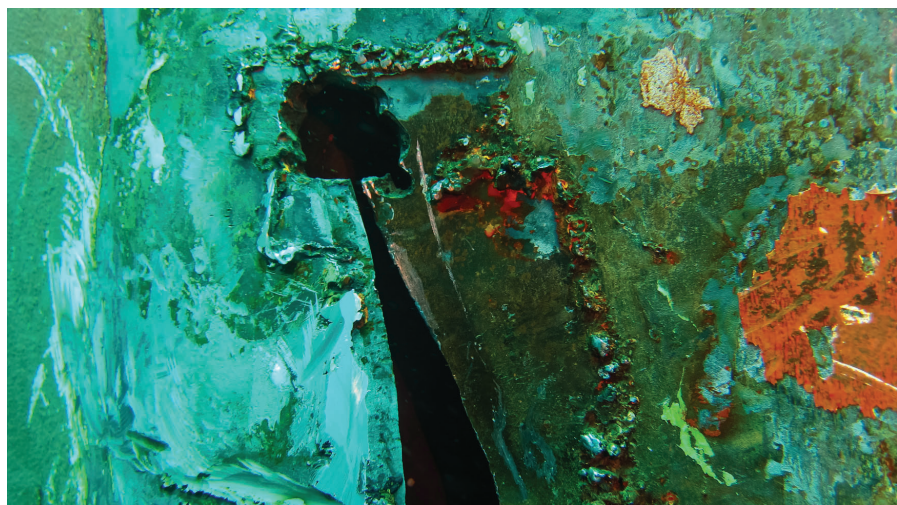
The approximately 1300-mm-long

crack had an average uneven gap of 100–200 mm. Had it propagated upward, the crack would have caused cargo holds 3 and 4 to flood, which could have been catastrophic for the vessel and her cargo.

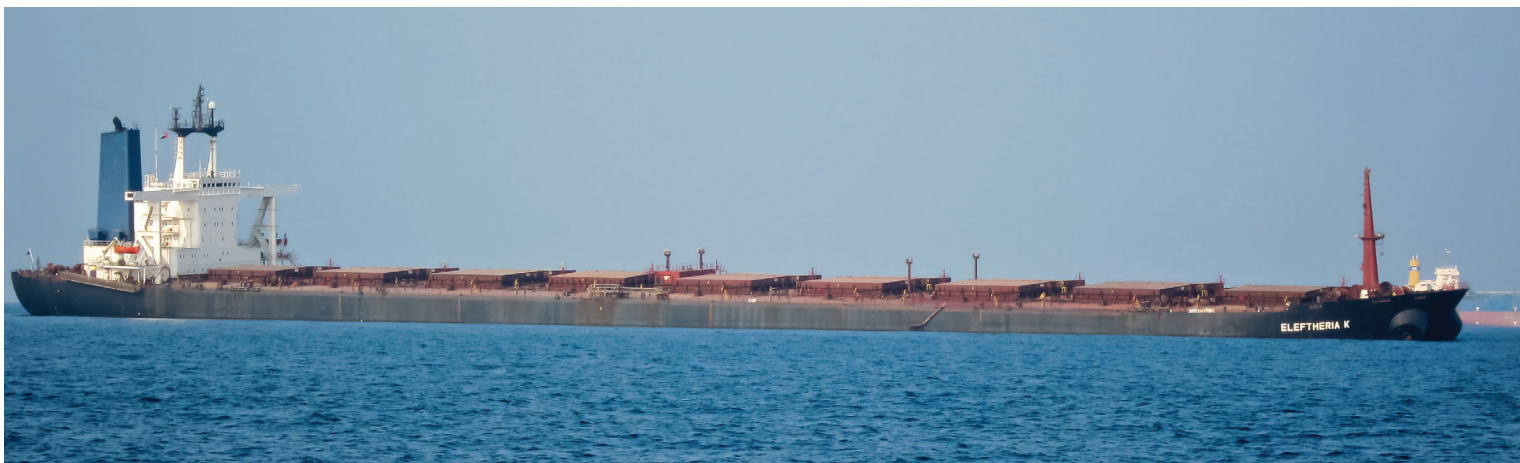
ballast tanks (DBBTs) 1, 2, and 3. The damage was extensive, covering about 85 m along the hull. The grounding caused severe indentation of the bilge strake, opening seven holes and cracks along the damaged area resulting in the flooding of ballast tanks 1, 2, and 3 — Fig. 2.

Fig. 2 — The ship at anchor near Fujairah, UAE. The ship has a severe list to starboard due to the leaks and flooding of the ballast tanks.

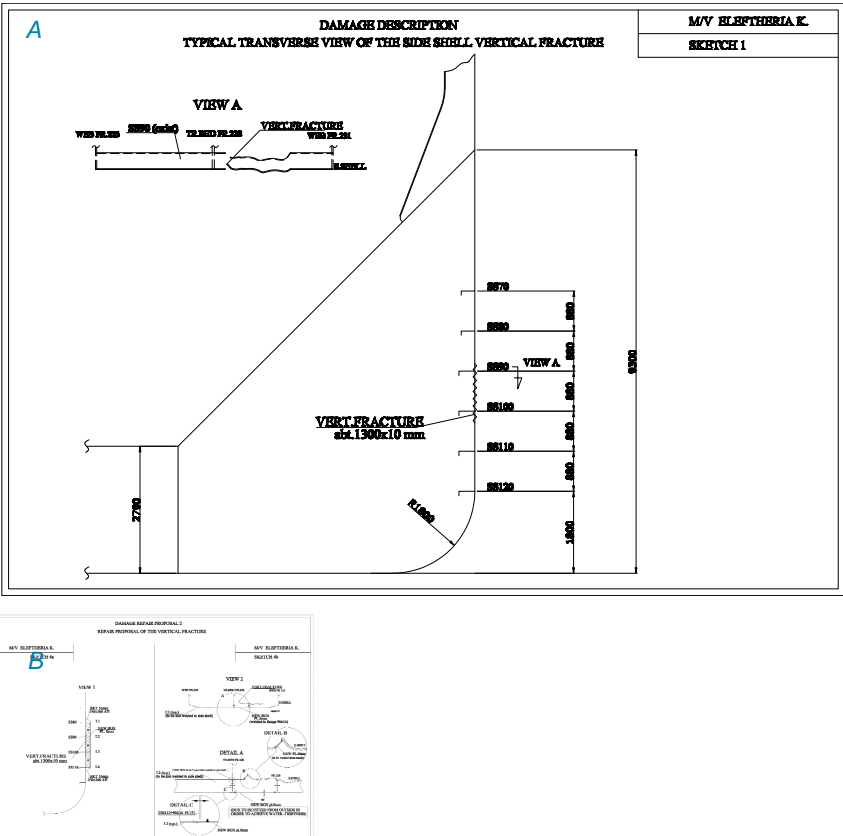
Fig. 5 — Sketches of the damage and repair proposal: A — Transverse view of the side shell vertical fracture; B — repair proposal for the vertical fracture.

The report stated in part: “On the side shell plate starboard side and in the area of the double-bottom ballast tank No. 2 starboard found a vertical crack of approximate dimensions 1300 × 10 mm located between frames No. 228 and 229 and on the first plate after the bilge plate. Double-bottom ballast tank No. 2 starboard is flooded — Fig. 5.

- To stop the crack and avoid propagation, drill adequate crack-arrest holes on the shell plate at both ends of the crack — Fig. 6.
- To reinforce the damaged area, fit four angle bars and weld them externally on the shell plate in line with the existing double-bottom tank's side longitudinals covering two web frame spaces.
- Extend the stiffening longitudinally from frame 225 to frame 231.
- Fit same-size angle bars and weld them vertically and in line with frames 228

and 229. These would be extended one side longitudinal up and down from the crack's ends — Fig. 6.

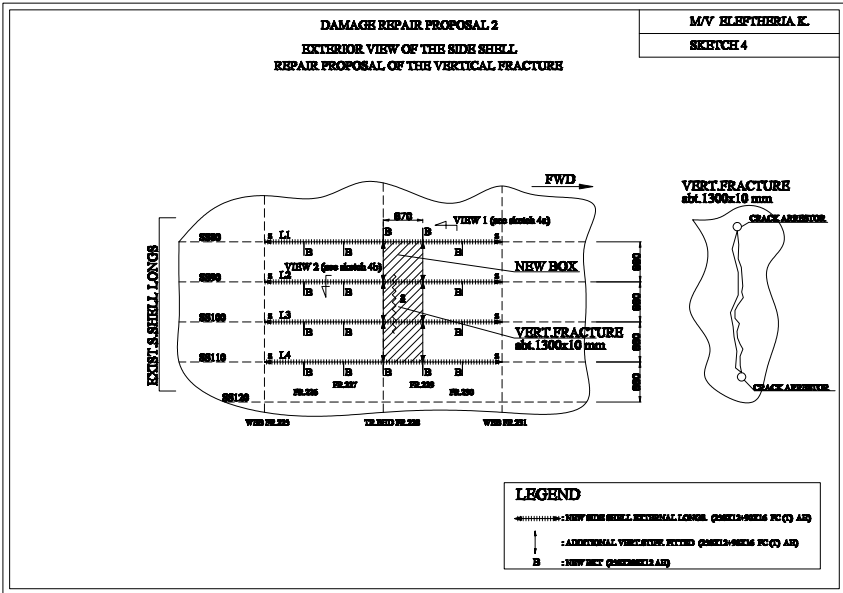
Fig. 6 — Exterior view of the side shell repair proposal for the vertical fracture.

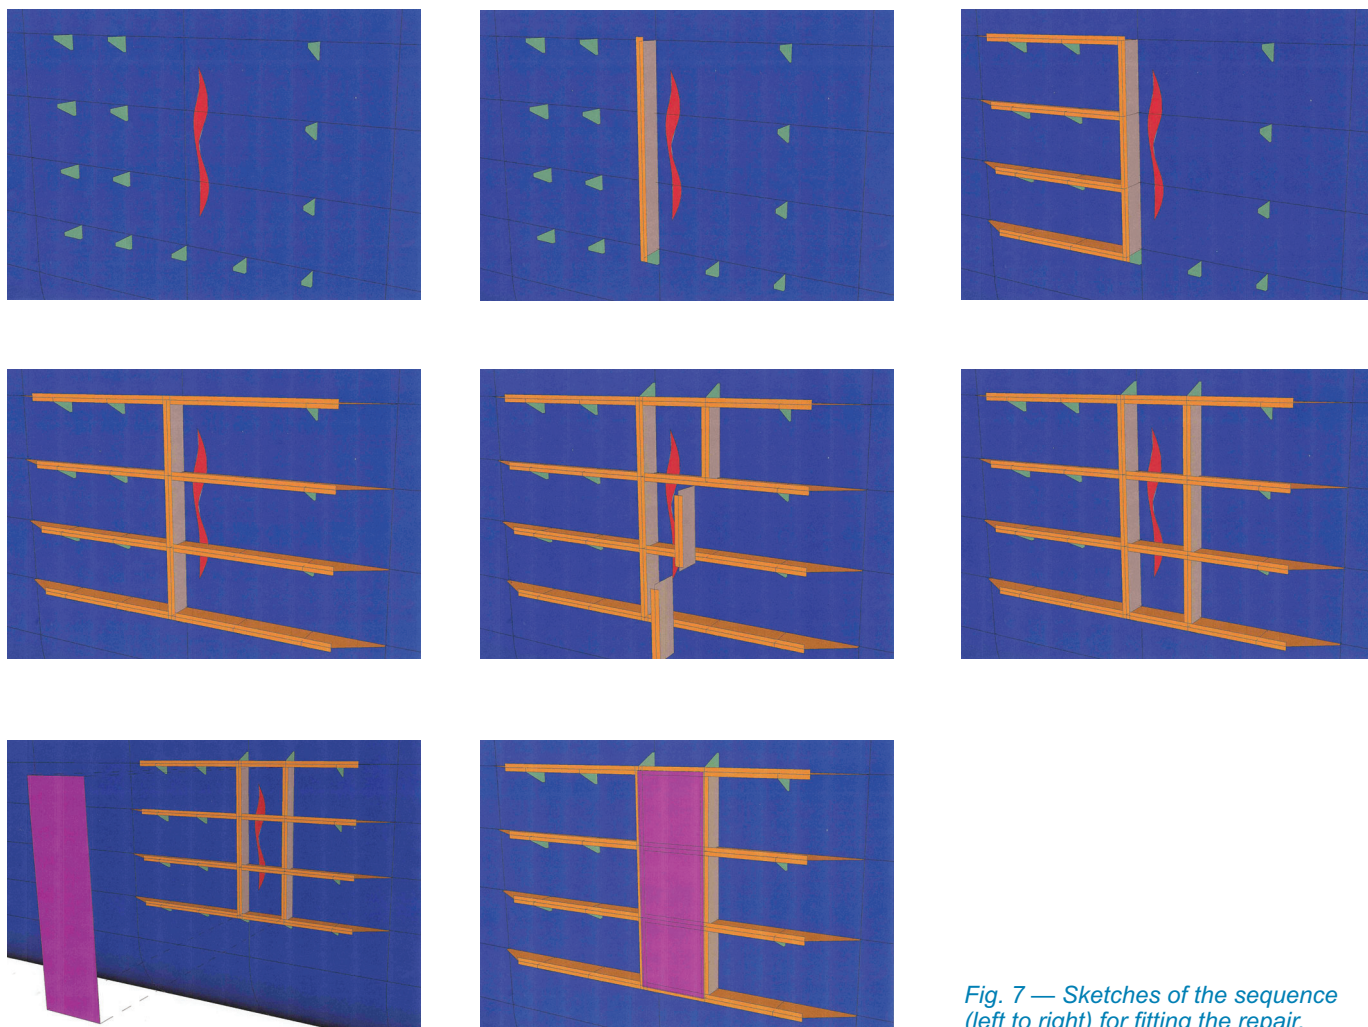
Fig. 7 — Sketches of the sequence (left to right) for fitting the repair.

Three-dimensional fitting sketches show how the repair was planned to go forward — Fig. 7.

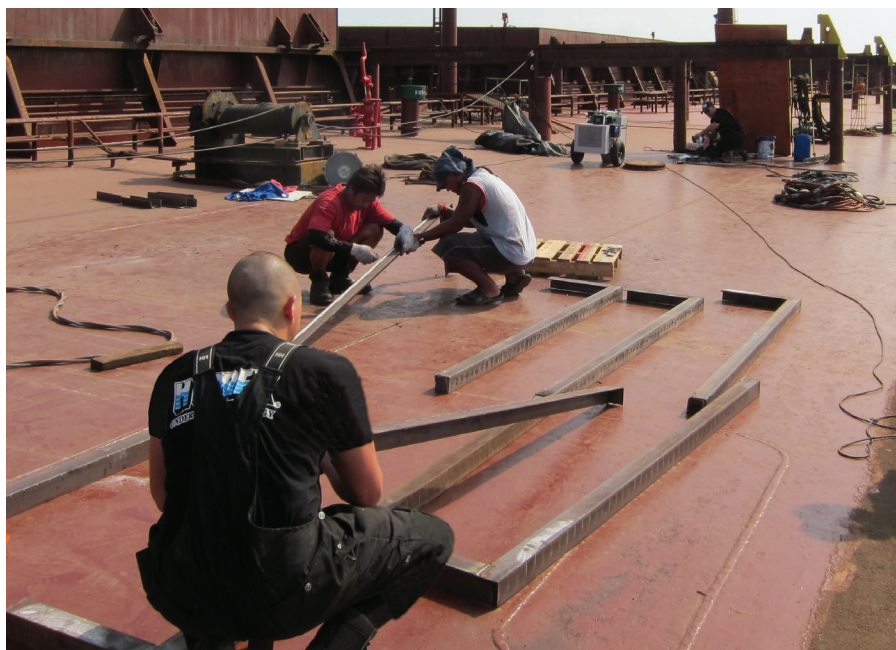
Fig. 8 — (Top) Construction of the initial frame on the deck of the freighter.

so that accurate measurements could then be made and plates cut and welded in place. Hydrex welders working with subcontractors on the deck of the *Eleftheria K* constructed the frame — Fig. 8.

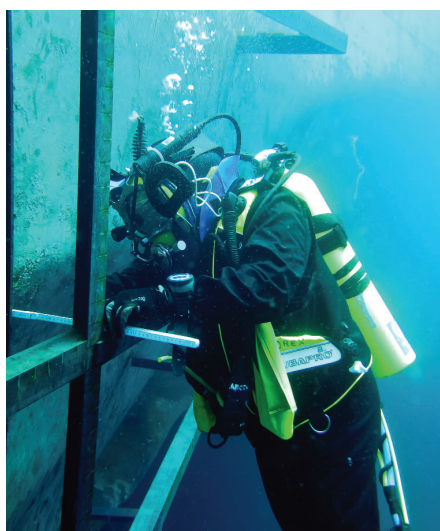
Fig. 9 — (Bottom left) The distorted shape of the hull was carefully measured in relation to the frame, with measurements taken every 5 cm, so the plates that would become the structure of the box could be accurately cut to fit.

With the frame in place, measurements could then be taken so that the sides of the cofferdam could be cut to the shape of the badly buckled hull and then fitted — Fig. 9. Joos explained, “A good fitting makes it much easier to weld. Under the water, a gap of 1 cm is a lot harder to weld than a gap of 3 mm. If you go over 1 or 1.2 cm, then you have to build up. So about 1 cm is the limit. Some welders can handle a 1 cm gap. A good fit makes it much easier. If you have a zero gap, it saves hours and hours of welding time.” With the ship out of service until the repairs could be completed, the old adage, “time is money,” took on a whole new meaning.

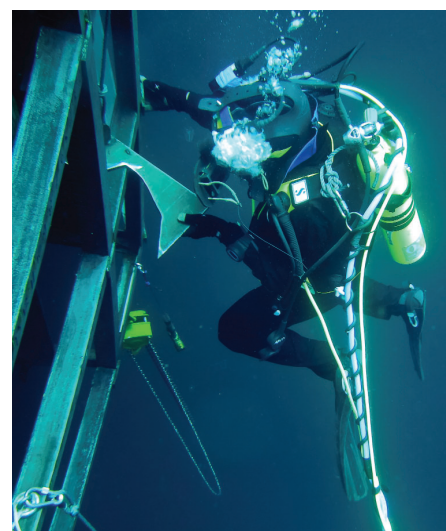
Fig. 10 — (Bottom right) The plates were lowered down the side of the ship so they could be fitted accurately to the damaged hull before being welded into a watertight box on deck.

The plates were cut on deck, then lowered and tacked to the hull so they could be adjusted to ensure a close fit before being welded to the box — Fig. 10.

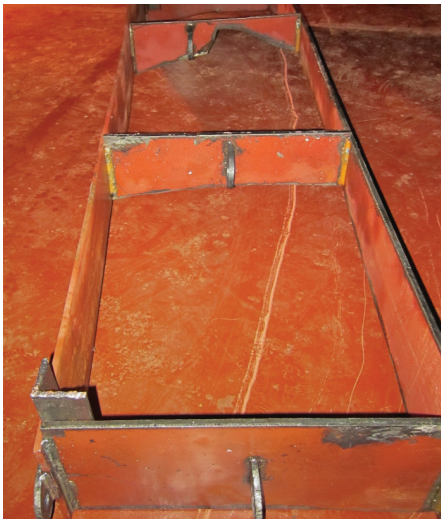
Fig. 11 — (Left) The 300 × 60 cm box fabricated on deck prior to being lowered into the water and welded to the hull.

After the plates were fitted, the 300 × 60 cm box was constructed on deck — Fig. 11. This was done because surface welding is somewhat faster than underwater welding.

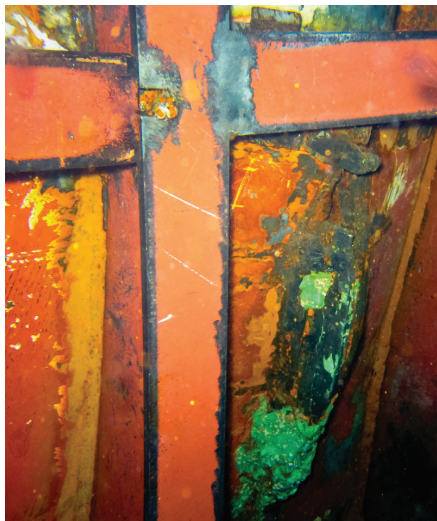
Fig. 12 — (Right) Close-up showing the box in position over the crack.

The finished box was then lowered into the water and welded to the frame and the hull, inside and out, three passes through-

out — Fig. 12.

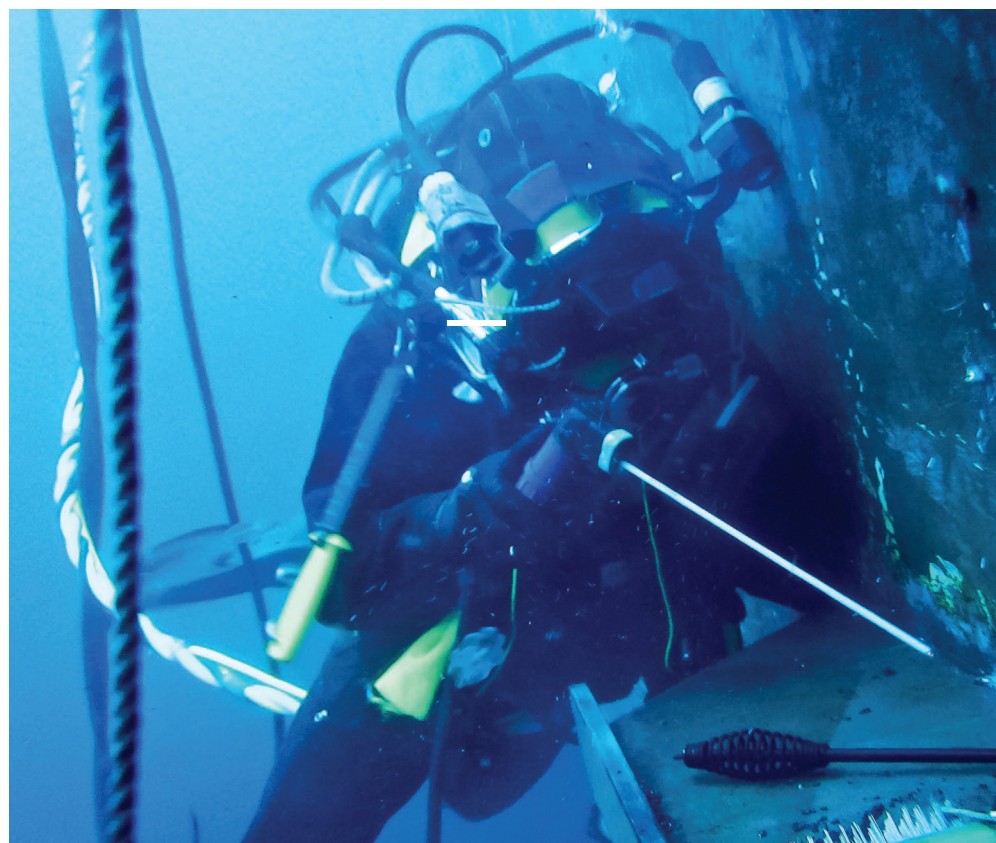
Fig. 13 — Strip welding the longitudinal stiffeners in place on the shell plate.

Once the box was in place, the stiffeners were ready to be welded onto the hull extending fore and aft from the cracked hull area. The stiffeners were fabricated on deck, then lowered into position and tack welded in place. They were then strip welded with a 15-cm strip every 15 cm, top and bottom of the stiffeners — Fig. 13.

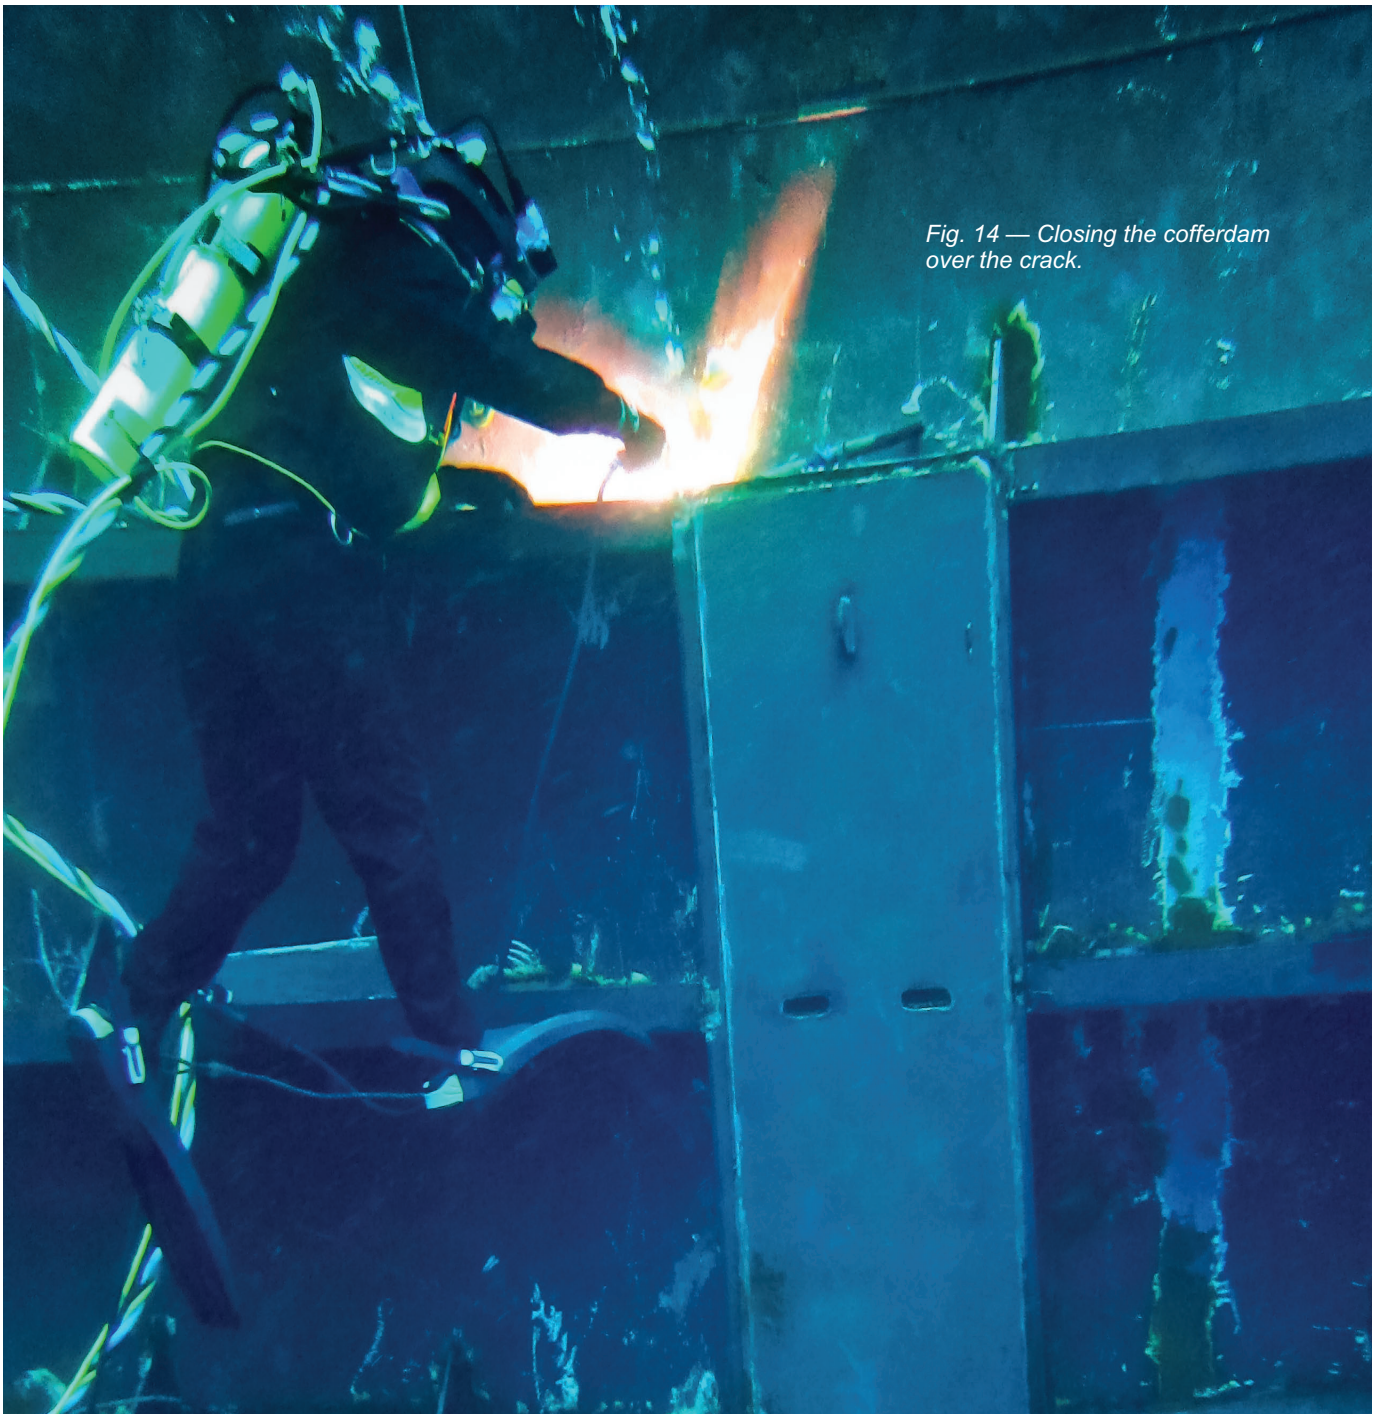
Fig. 14 — Closing the cofferdam over the crack.

The next step was to close the cofferdam by welding a plate on top of the box that had already been welded to the hull and the frame. When the cofferdam was sealed, the crack was no longer open to the sea — Fig. 14.

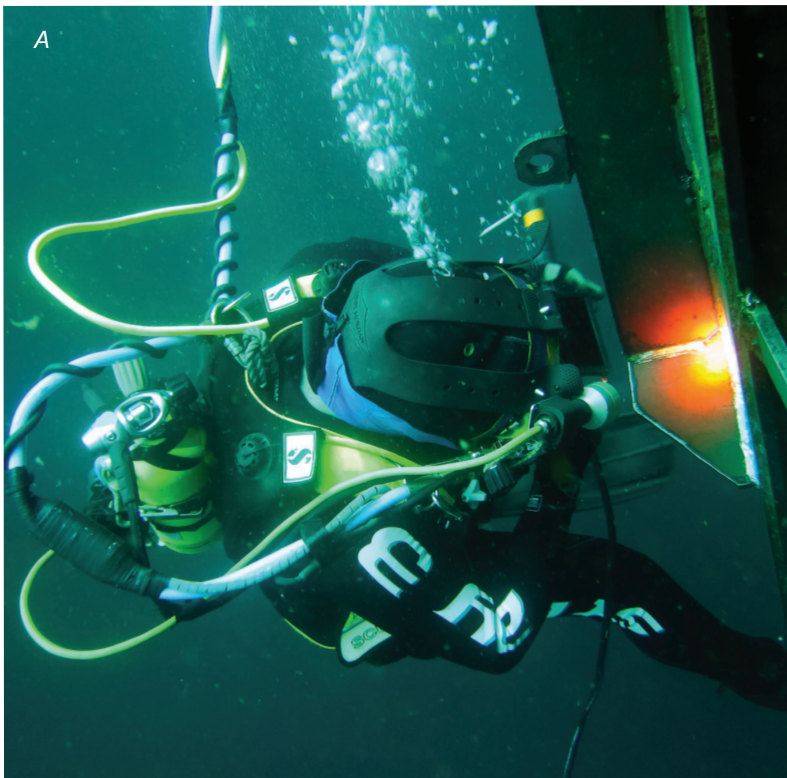
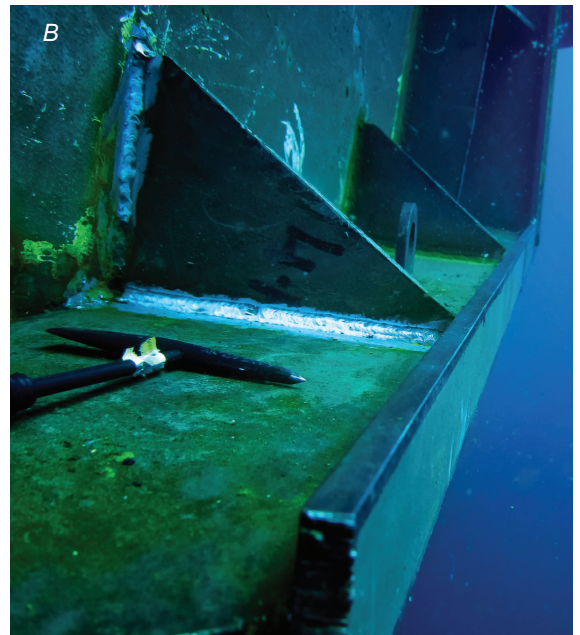
Joos recalled the problems encountered when ballast tanks 1, 2, and 3 were deballasted — Fig. 15. “When we started pumping, unfortunately some cracks

broke. Nobody knew what was inside — how many longitudinals were still attached on the inside — so we put additional stiffeners and then tried to pump again. Again, we had a few minor cracks. Because the depth of the vessel was 24 meters on the bottom, there was a huge amount of pressure forcing inward. The full structure needed to resist the pressure. We had a few cracks again so we decided to stop and put in some additional stiffeners in more layers to get more strength on the welds. The third time we started deballasting everything went okay. There was no further leak.”

Fig. 15 — A — Additional reinforcement was added to the repairs to ensure the welds would hold up when the ballast tanks were emptied; B — a close-up of the reinforcement.

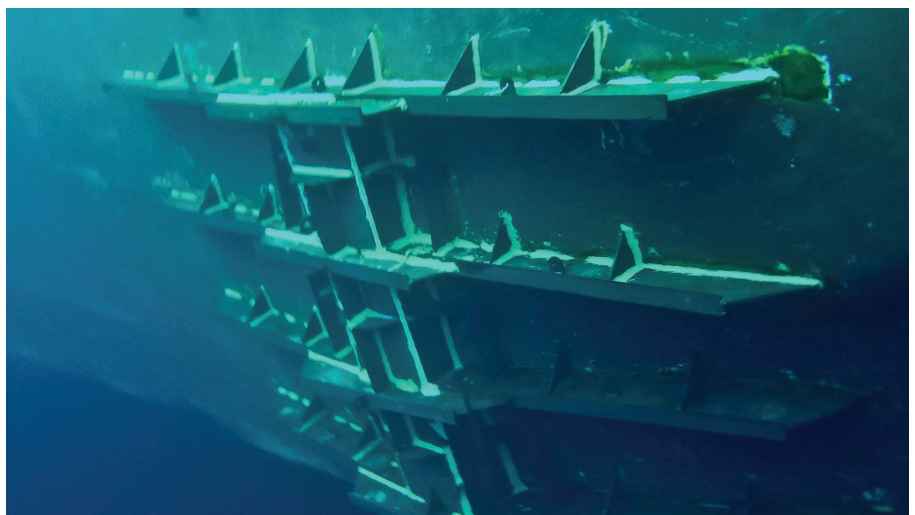
Fig. 16 — The finished repair. The welds were protected with epoxy to prevent corrosion.

Finally, just 27 days after work began, the repair was finished with all stiffeners and brackets in place and welded. Epoxy was applied to prevent the welds from rusting — Fig. 16.
