Emergency hull repair on ferry *Texelstroom*

Underwater stern tube seal repair on container ship in Algeciras

KEEPING SHIPS IN BUSINESS

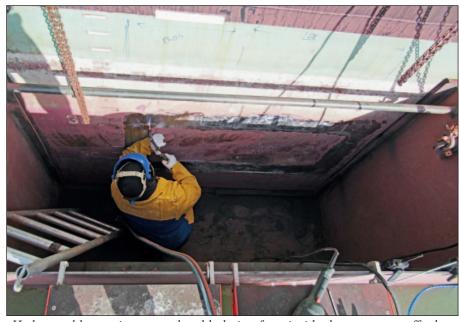
Hydrex welder cutting away the old plating from inside the open-top cofferdam.

The team then installed the opentop cofferdam over the damage and created a dry environment in which to work. They cut away the old plating and installed the new insert.

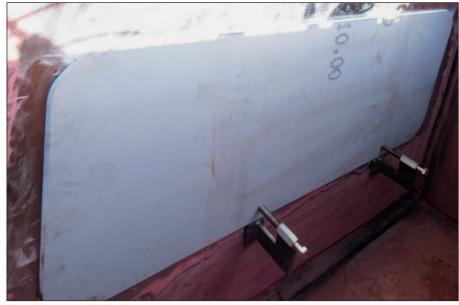
Fitting the new insert plate.

On Friday morning our team arrived in the port of Texel with the cofferdam and all the needed equipment. The repair started with a detailed inspection of the damage from both sides of the hull. In consultancy with the superintendent of the ferry and the surveyor from the classification society it was agreed to install an insert repair measuring 1500mm x 700mm.

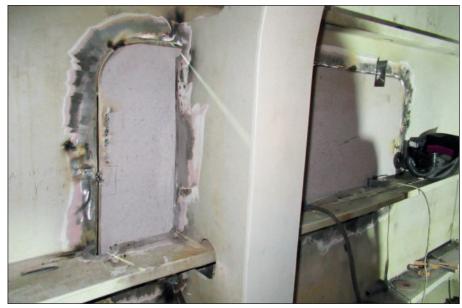
New insert seen from inside the vessel prior to welding.

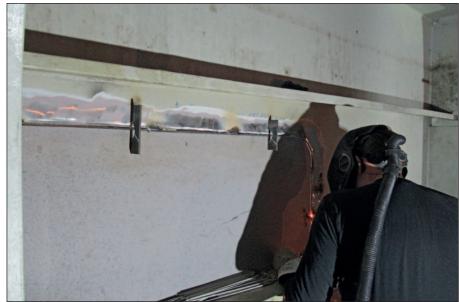
Welding the insert from the inside.

Our men secured the insert with a certified weld both from inside the vessel and inside the cofferdam.

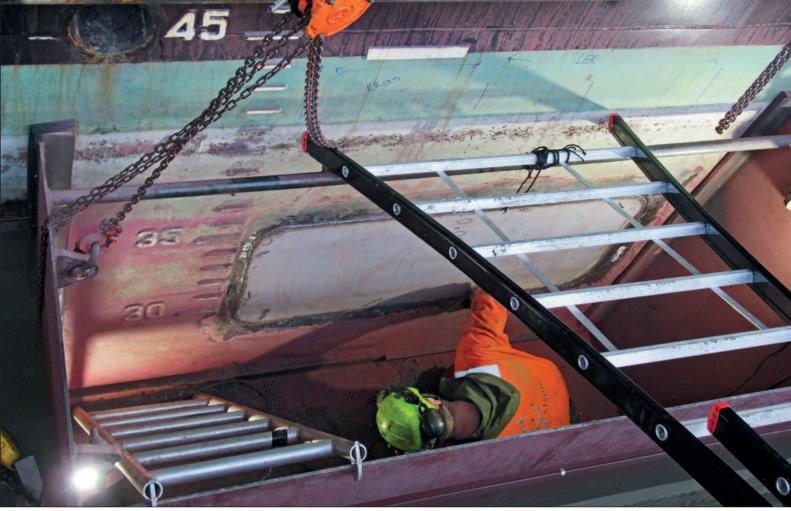
The open-top cofferdam allowed the weld inspector access to the waterside of the affected area.

Ultrasonic testing was performed by an independent inspector and the repair was approved by the classification society as permanent. On Sunday morning, the cofferdam was removed and a final leakage test was successfully conducted. This concluded the operation.

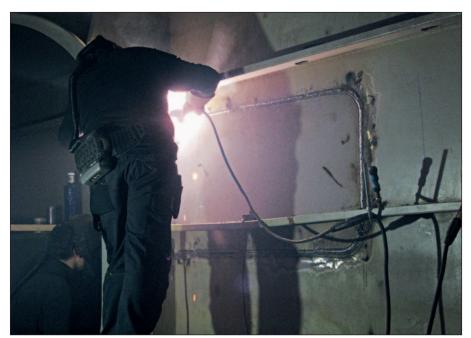
The insert was welded by our certified welders.

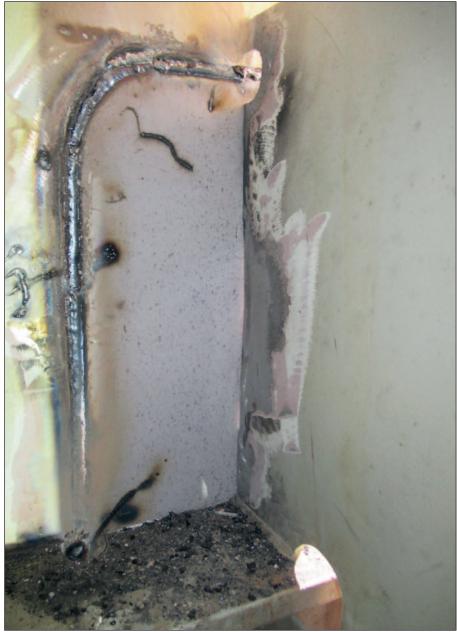
Insert after being welded from both sides.

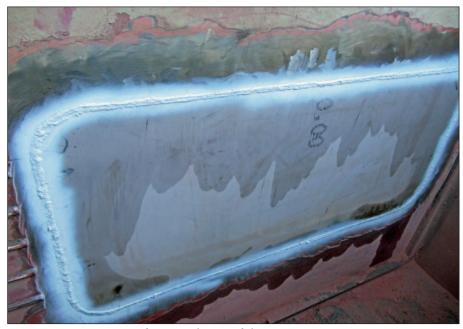
Permanent new insert after completion of the repair.

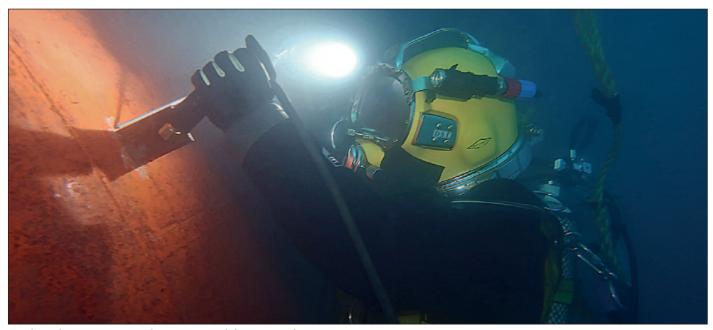
Hydrex diver preparing the rope guard for removal.

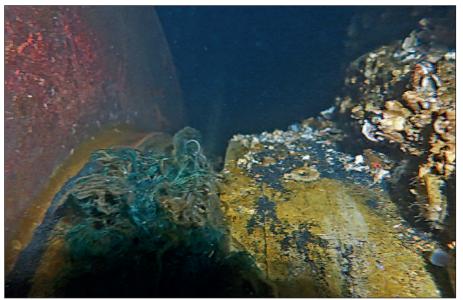
The operation started with a thorough underwater inspection of the stern tube seal assembly and removal of the rope guard. This revealed that a rope had become entangled around the stern tube seal assembly and had caused the oil leak.

Fishing net tangled around the stern tube seal assembly, causing an oil leak.

Our divers removed the rope during the inspection. They then cleaned the assembly and installed the flexible mobdock. By doing this they created a dry underwater environment so that they could work in drydock-like conditions.

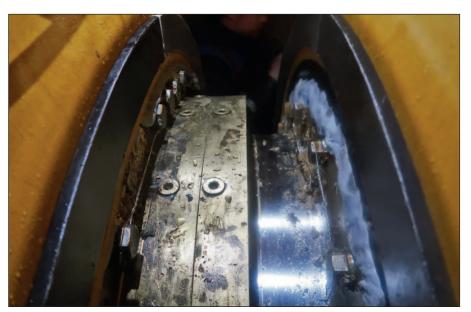
Seal assembly prior to the repair.

brought to the surface to be cleaned. After cleaning the entire assembly, the divers removed the first seal and replaced it with a new one which was bonded. They then did the same for the other seals.

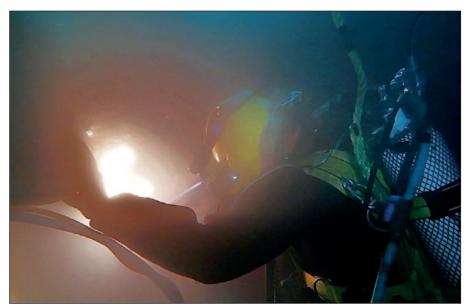
First the rope guard was removed by our team, then our flexible mobdock was installed.

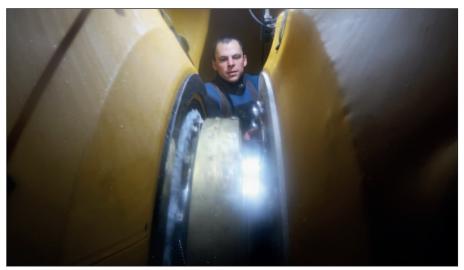
One of our diver/technicians working inside our flexible mobdock.

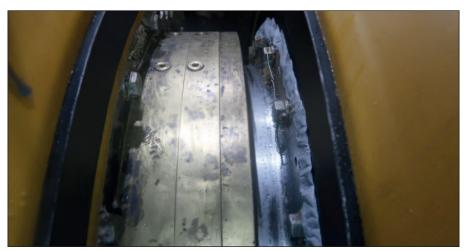
Stern tube seal assembly after the seal replacement.

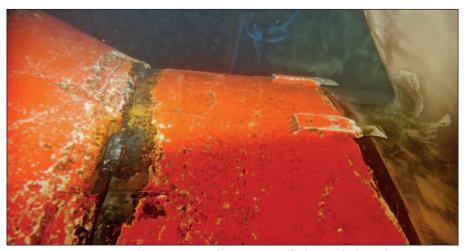
The rope guard was reinstalled, concluding the operation.
