TESO asked Hydrex to repair ferry Texelstroom after being damaged by a storm.

Emergency hull repair

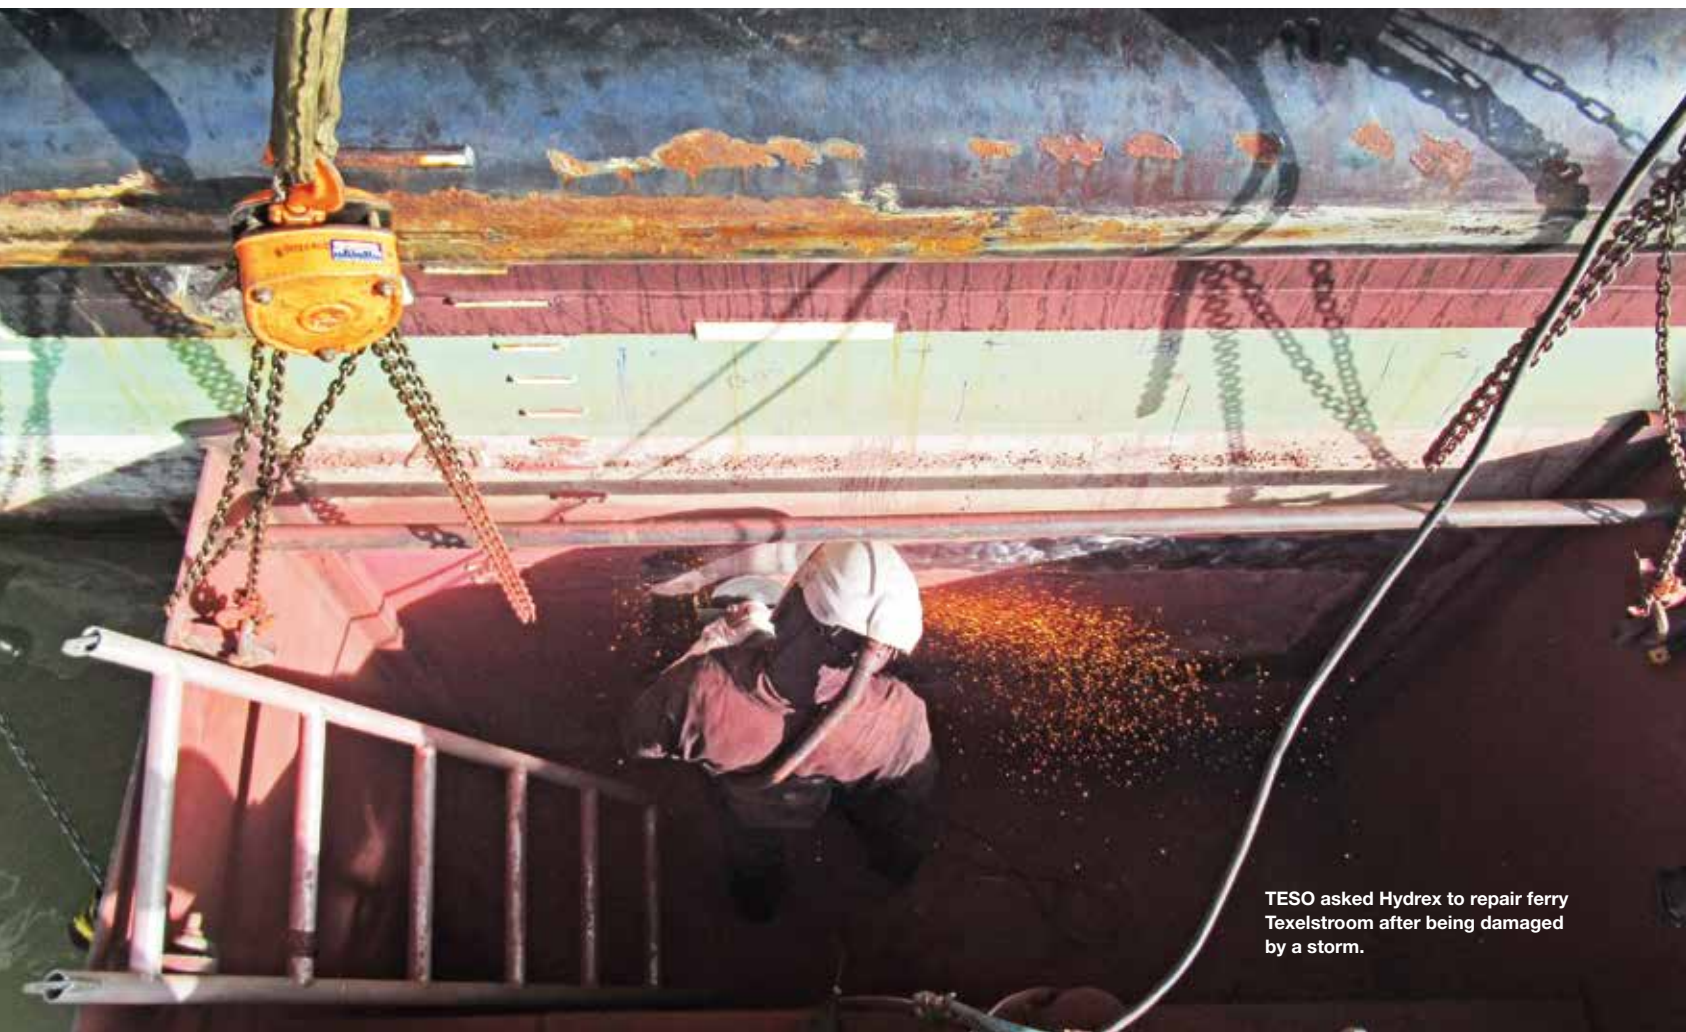
When the vertical side of the ferry Texelstroom was damaged during storm Eunice, earlier this year, a leak in the ballast water tank prevented the ship from sailing. Because this happened at the start of a busy school vacation period, it was essential that a fast on-site solution was found to keep the downtime for the ship as short as possible.

The team then installed the open-top cofferdam over the damage and created a dry environment in which to work. They cut away the old plating and installed the new insert. Hydrex secured the insert with a certified weld both from inside the vessel and inside the cofferdam.

Ultrasonic testing was performed by an independent inspector and the repair was approved by the classification society as permanent. On Sunday morning, the cofferdam was removed and a final leakage test was successfully conducted. This concluded the operation.

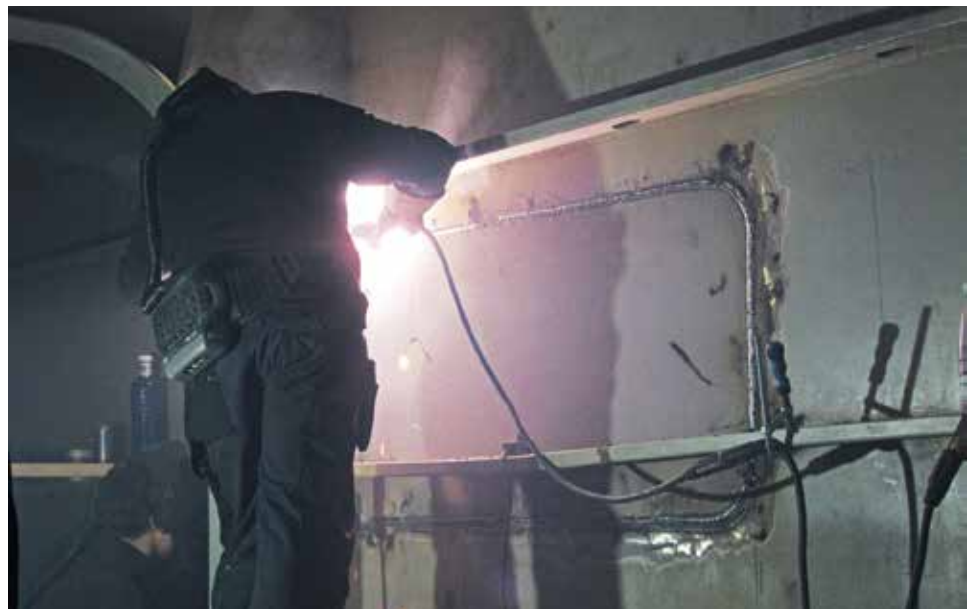
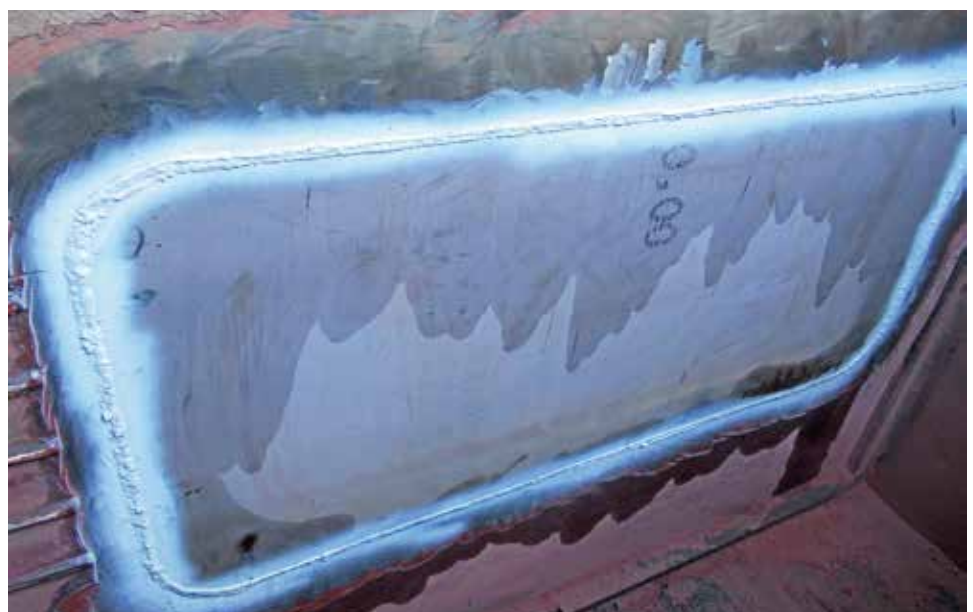
Hydrex secured the insert with a certified weld both from inside the vessel and inside the cofferdam.

On Friday morning the team arrived in the port of Texel with the cofferdam and all the needed equipment. The repair started with a detailed inspection of the damage from both sides of the hull. In consultancy with the superintendent of the ferry and the surveyor from the classification society it was agreed to install an insert repair measuring 1500mm x 700mm.
