Scrubber overboard pipe operations on sister vessels in Denmark

Rudder repairs in Zeebrugge, Dunkirk and Le Havre

# Scrubber overboard pipe operations on sister vessels in Denmark

# Rudder repairs in Zeebrugge, Dunkirk and Le Havre

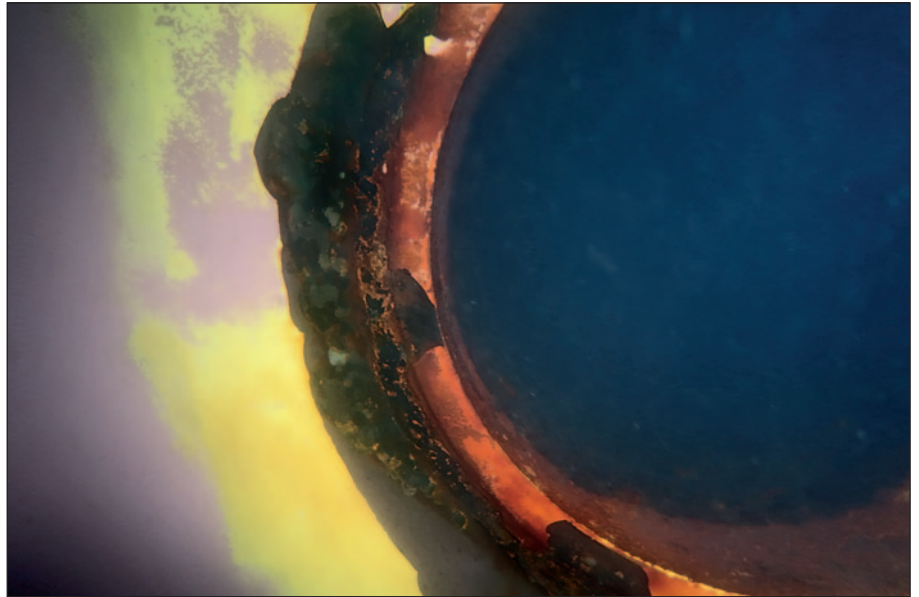
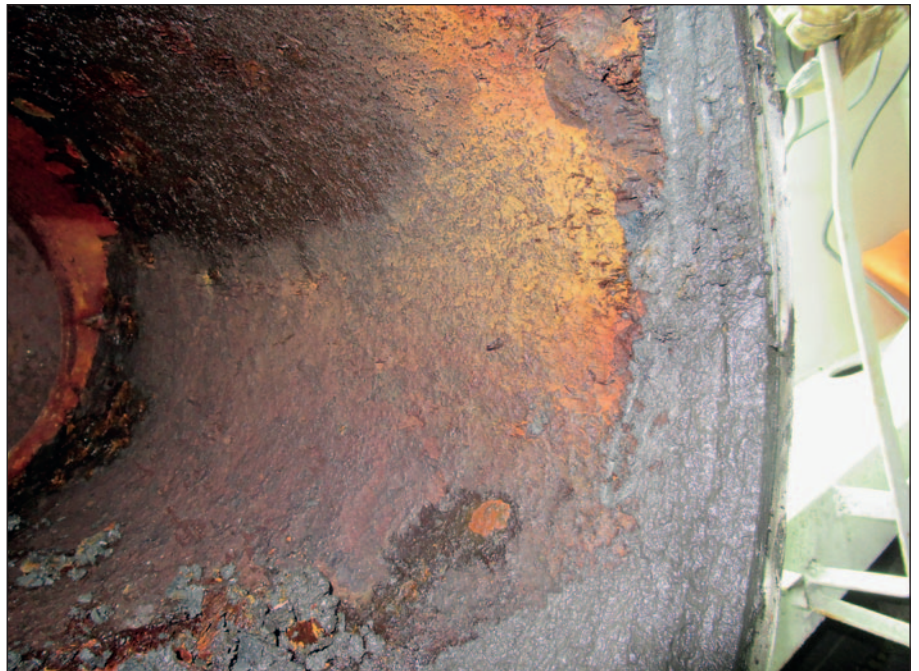
This revealed that two of the pipes needed to be completely replaced. As the corrosion on the third scrubber overboard pipe was not yet severe, a

*Corroded scrubber pipe seen from the waterside and the onboard side.*

full replacement was not needed.

Because of the location of the damaged parts of the pipes, welding work on the inside shell plating of the hull was needed. As a result, the outside of the overboards could not be sealed off with a simple patch. Custom cofferdams were designed and constructed at our workshop.

After the installation of the cofferdams, the team cut away the old pipes. The shell plating was then prepared for the installation of the replacement part. New pipes had also been constructed at our workshop in

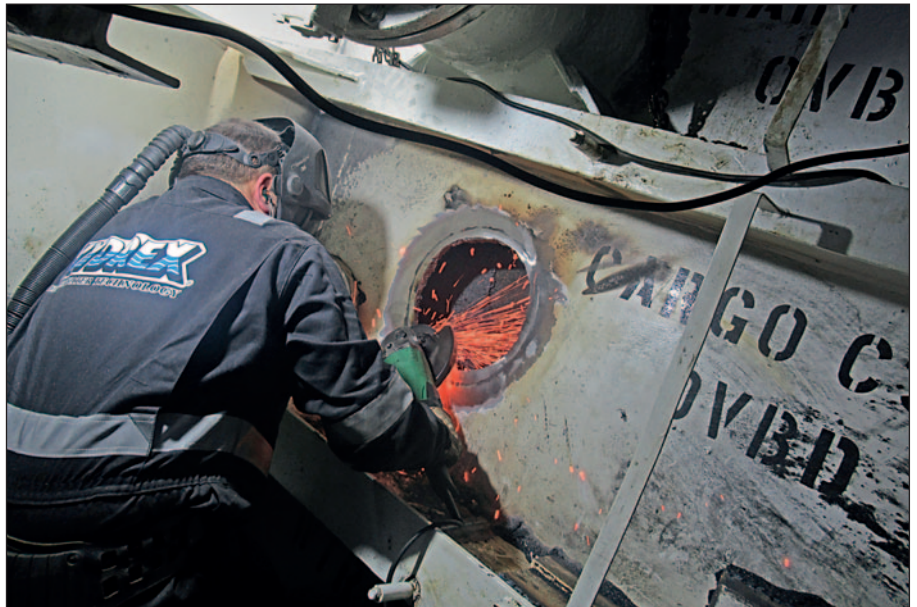
*One of our men preparing the edge for installation of new pipe.*

Antwerp. The pipes were then positioned and secured with a full penetration weld. Next an independent inspector carried out NDT testing of the welding work.

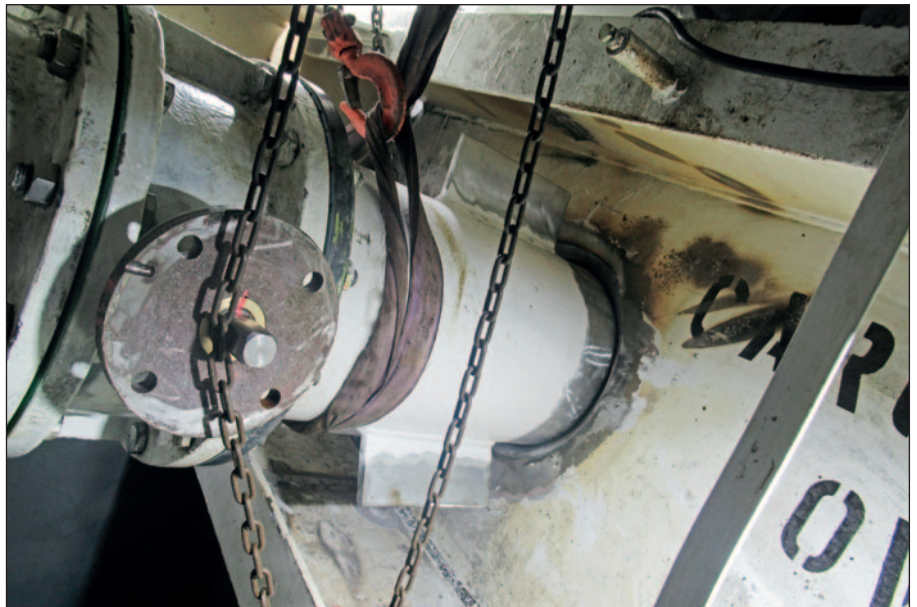
*New pipe fitted and ready for welding.*

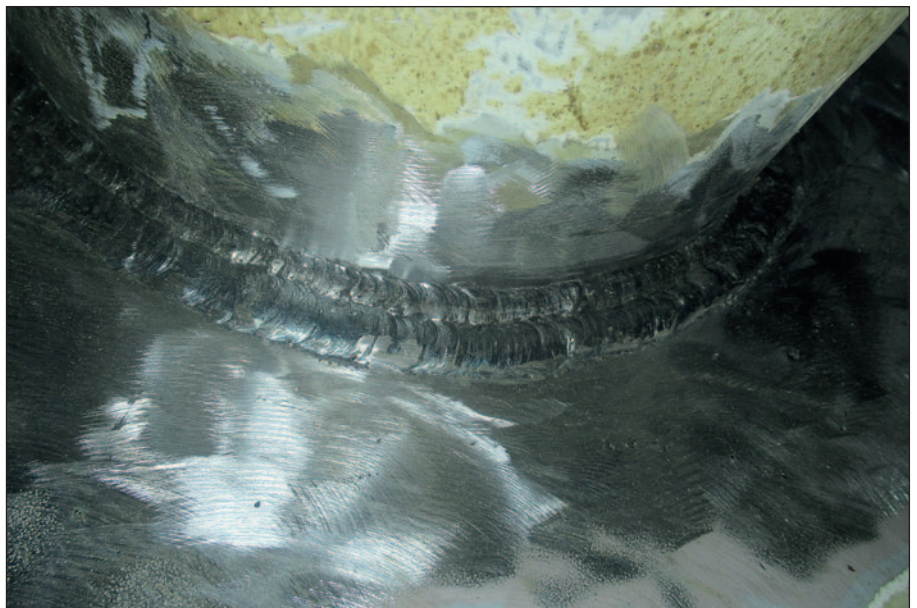
*All welding work is done following our class approved procedures.*

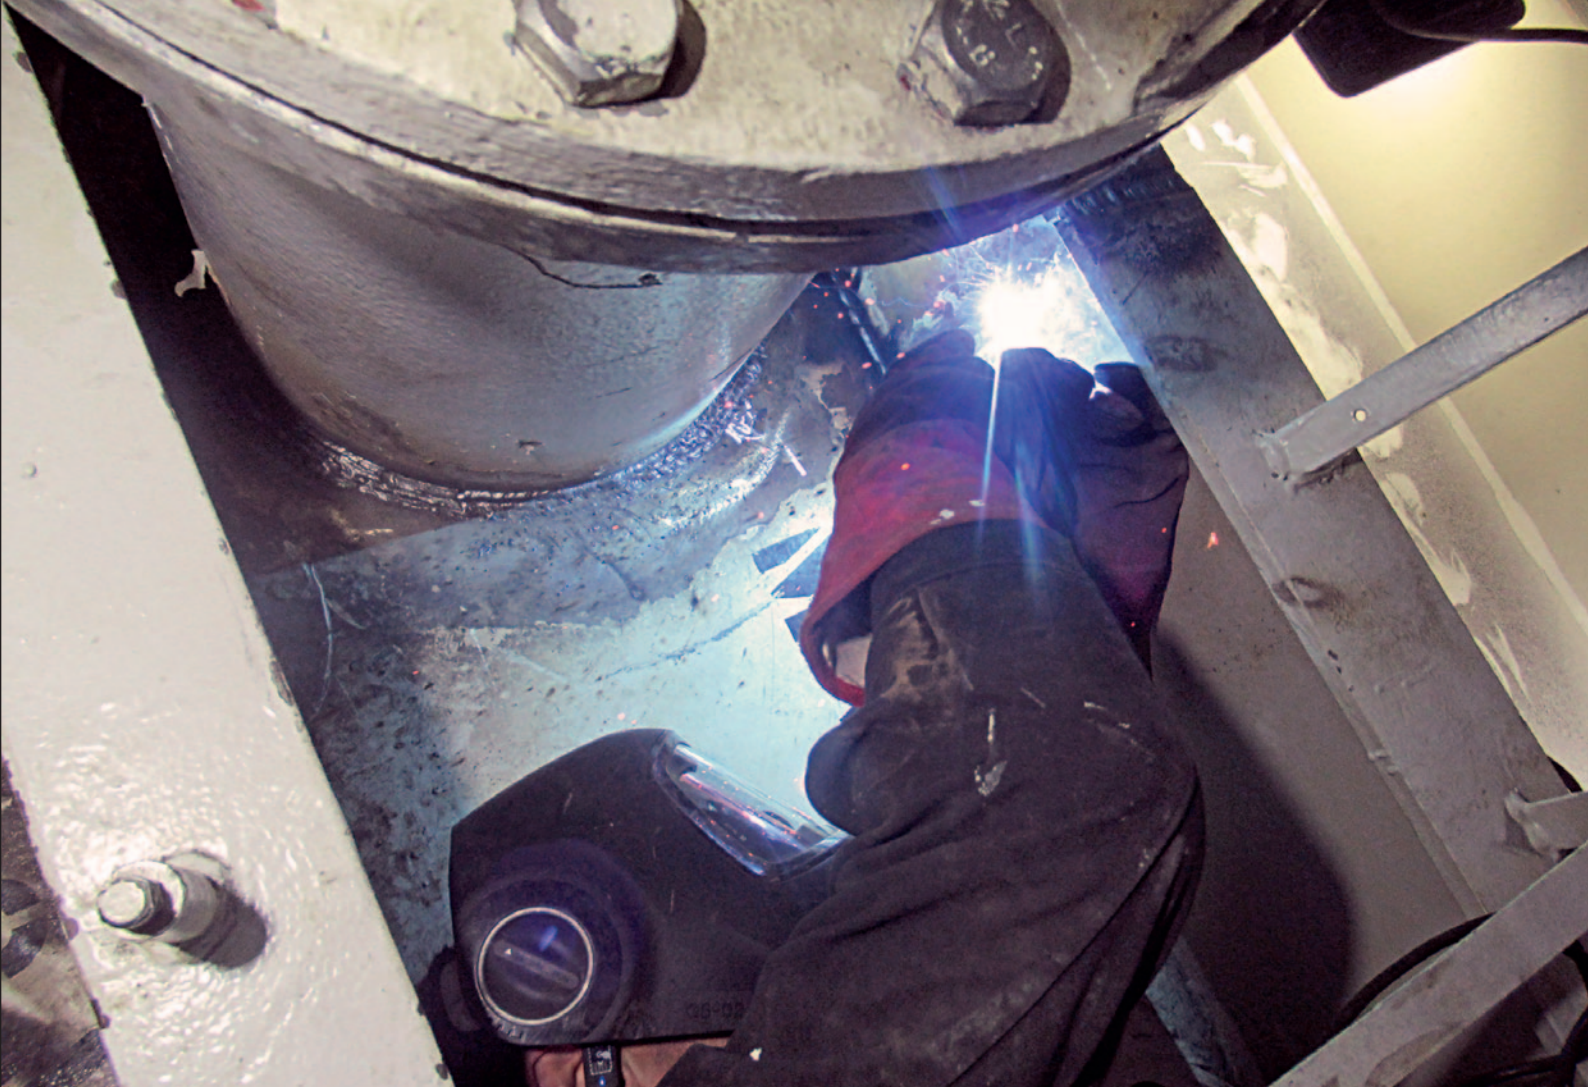
*Hydrex welder working on the frame next to the new pipe.*

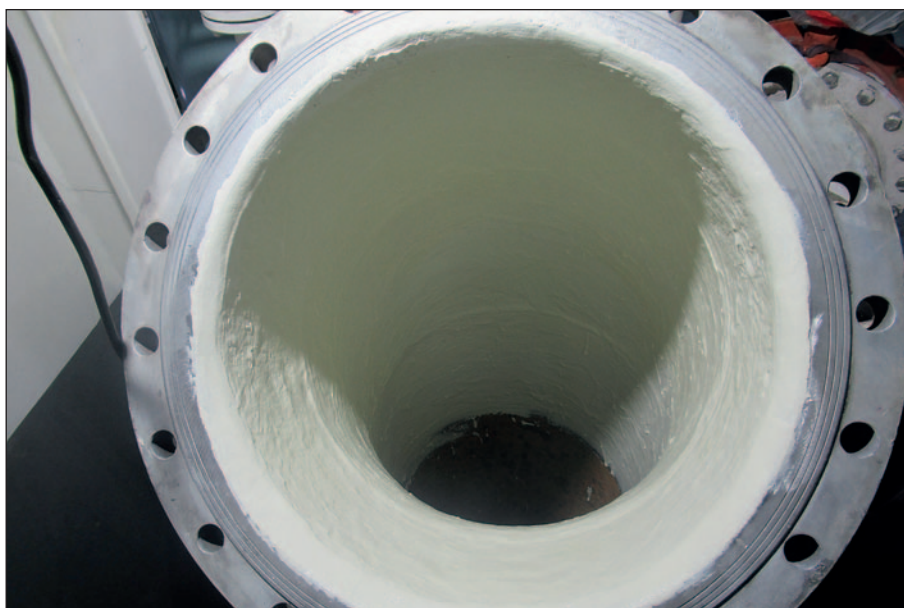
*The inside of new/repaired pipes is protected with a unique corrosion resistant coating.*

To prevent both the new and the repaired pipes from corroding, the inside was coated with Ecospeed. This product is produced by Hydrex's sister company Subsea Industries. Ecospeed is highly chemically resistant. Considering the nature of the process taking place inside a scrubber, this is essential for lasting protection of the pipe. Ecospeed should also be used to protect a newly installed scrubber system from day one.

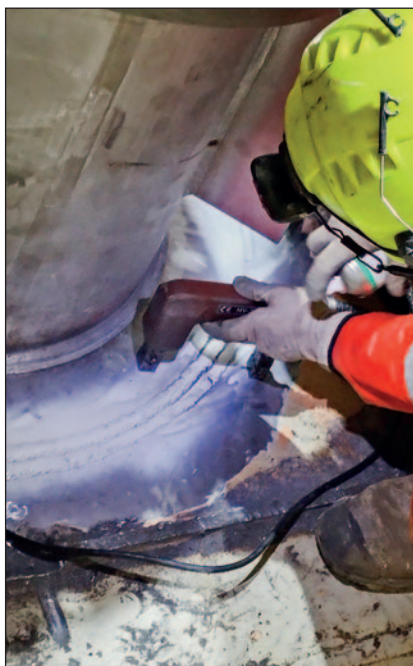
*Independent inspector checking the welds.*

When the welding was complete the surface was cleaned and a Magnetic Particle Inspection (MPI) was carried out by an independent inspector.

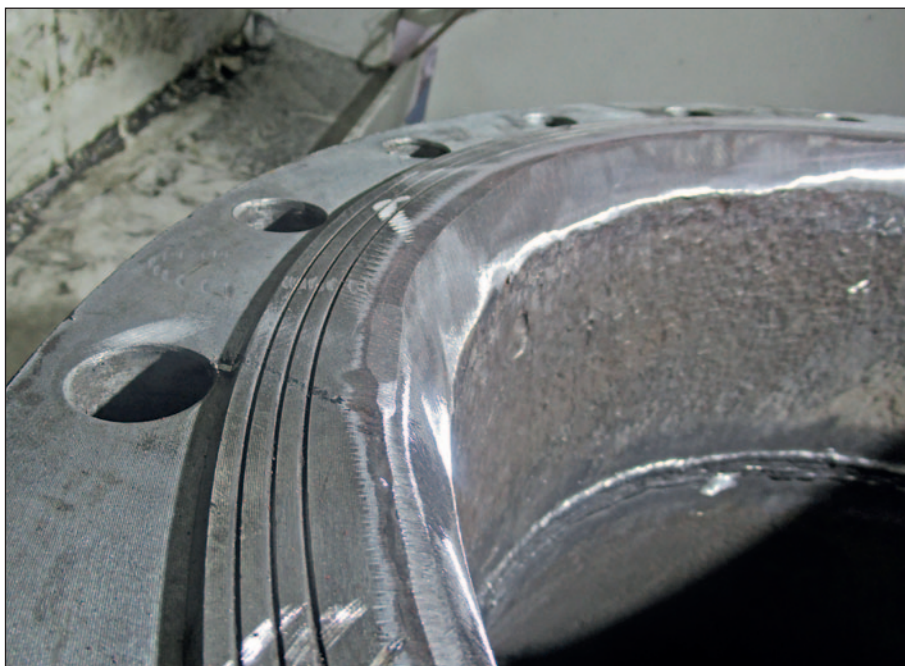
Luckily the corrosion on the scrubber overboard pipes of this vessel was less severe. A full replacement of the four pipes was not needed.

*The affected area of the less severely corroded pipes was ground out.*

Our diver/welders repaired the pipes using the same procedure as on the first ship. The inside of these pipes was also coated with Ecospeed to keep them safe from further corrosion.

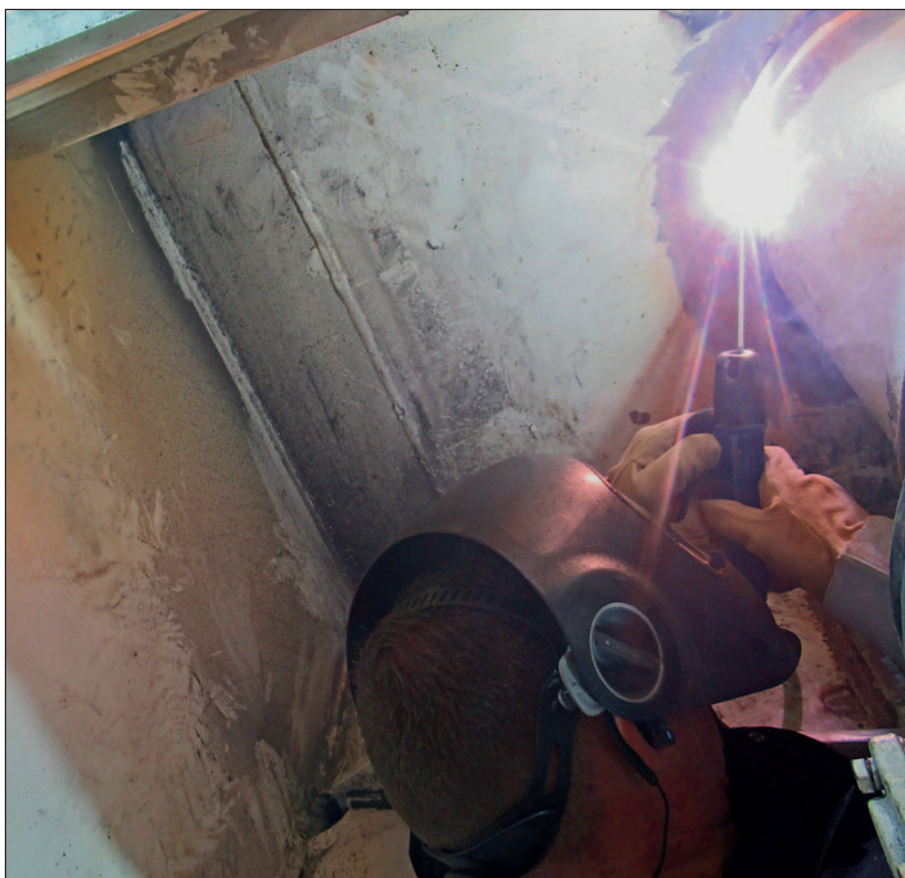
*Hydrex certified welder carrying out a full penetration weld on a scrubber pipe.*

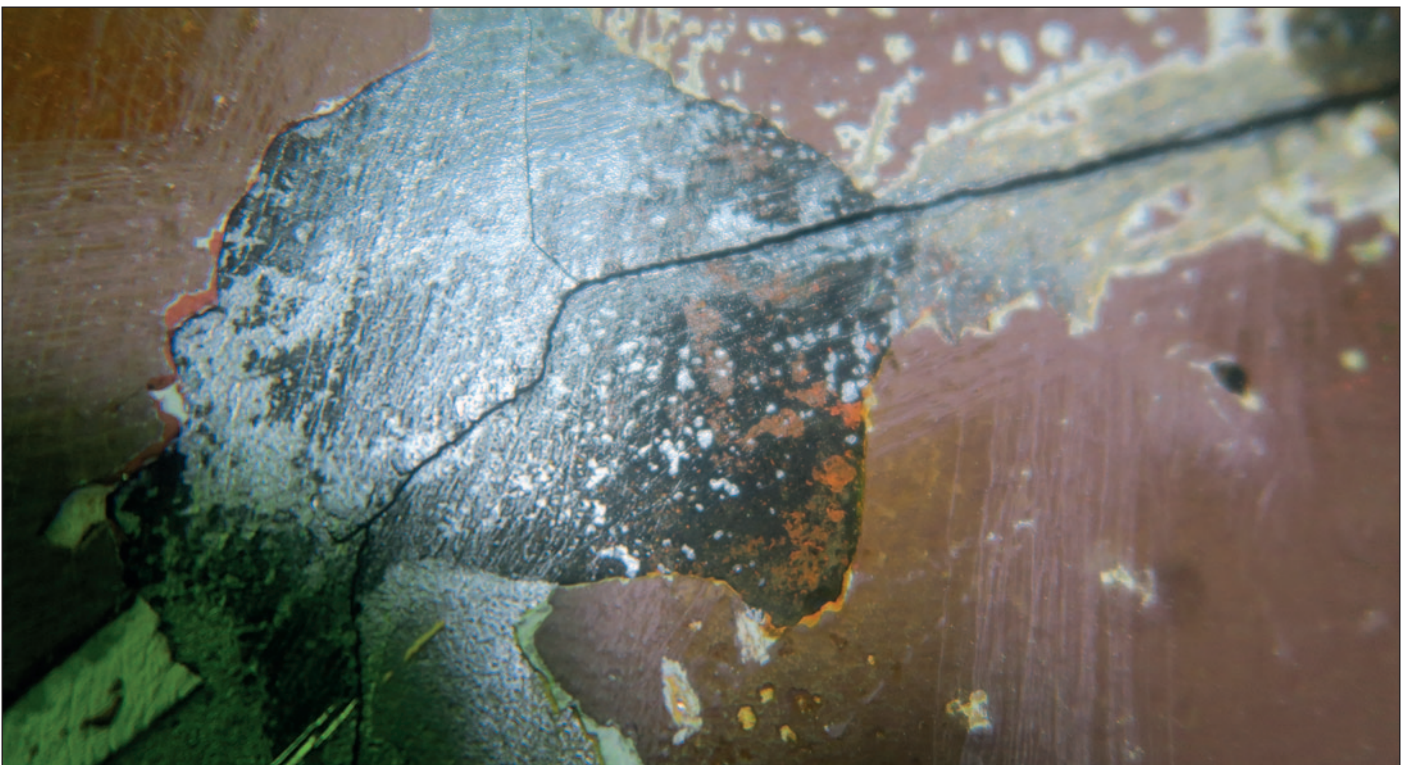
A 230-meter ro-ro ship in Zeebrugge had suffered cracks on both sides of the rudder flap. On the starboard side a branching crack was found

while a single crack was present on the port side.

*Branching crack on rudder of ro-ro ship.*

Our divers first drilled arrests on all extremities of the cracks to prevent

them from spreading. They then positioned C-shaped plates over the crack arrests and secured these with wet welding.

This allowed the owner to sail his ship without having to worry about the condition of the rudder. He can have a permanent repair carried out during the ship's next scheduled drydock visit at a more convenient time and location.

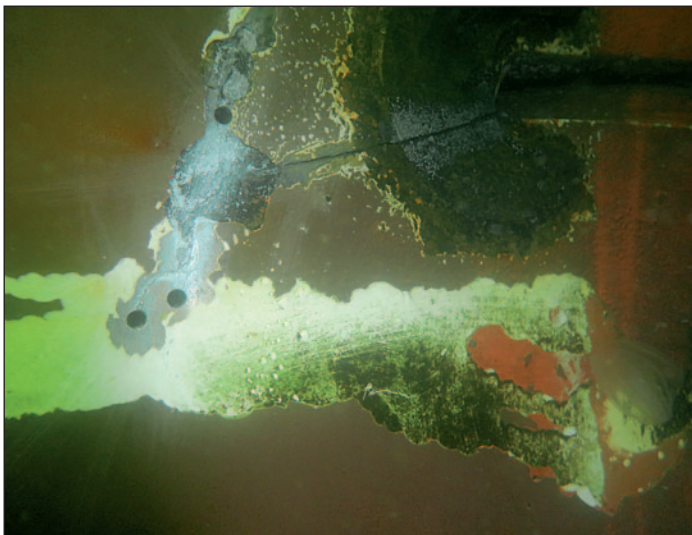
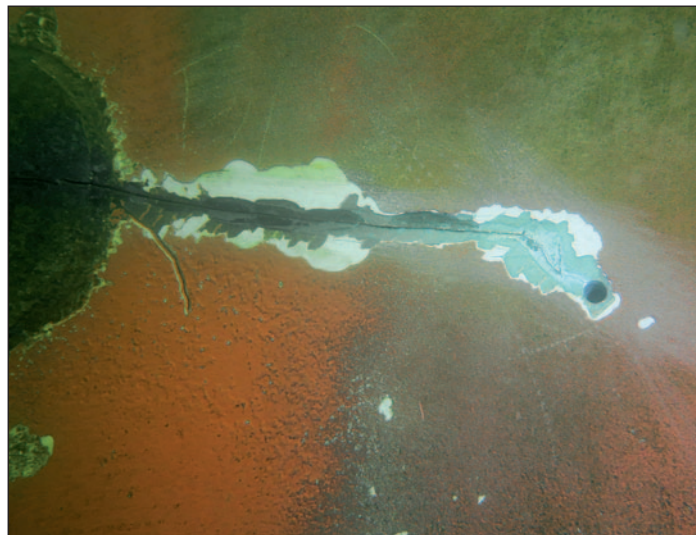
*Crack arrests were drilled on the extremities of the cracks on both sides of the rudder.*

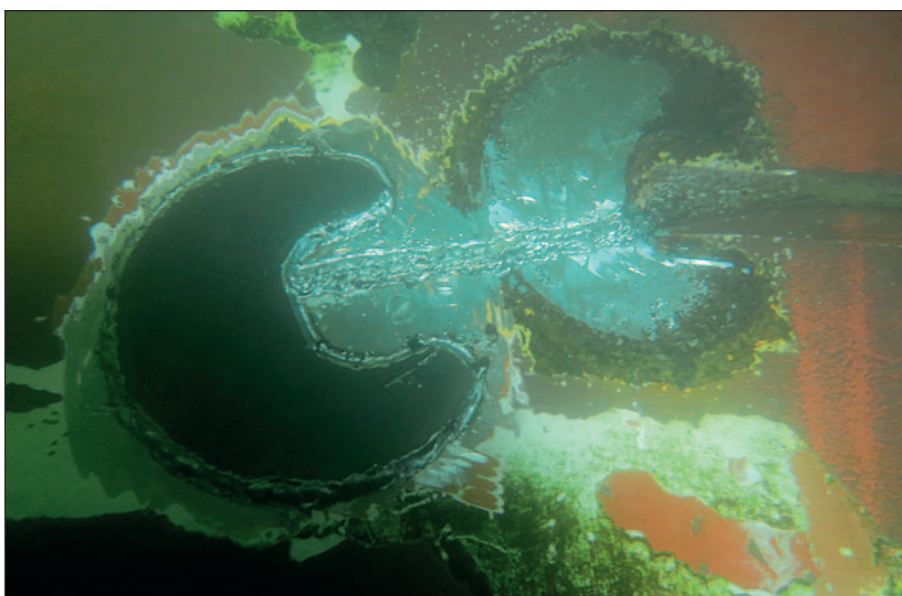
*C-shaped plated welded over the crack.*

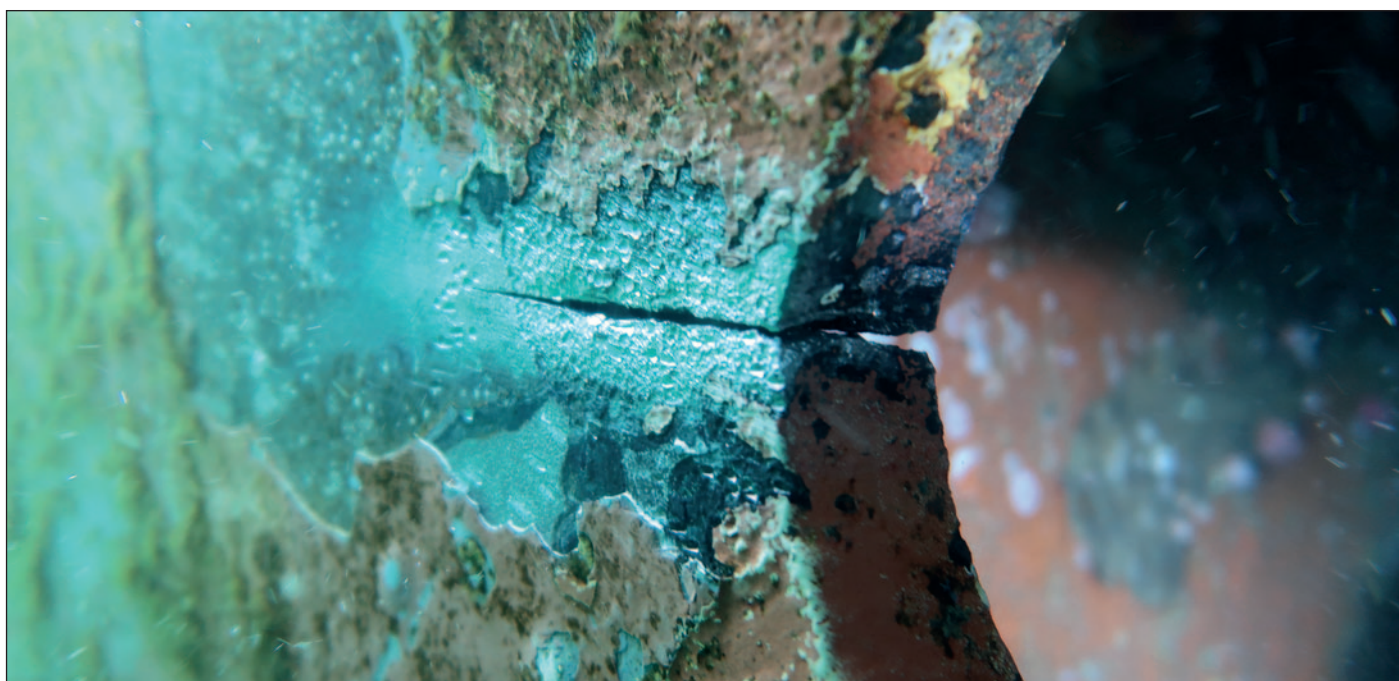
On two 229-meter sister bulker ships in Le Havre and Dunkirk respectively, cracks were found on the upper pintle corner of the hinge that connects the rudder flap to the main rudder blade. Fortunately these cracks could be repaired by grinding them out after a crack arrest had

*Crack on rudder of bulker in Le Havre.*

been drilled. The affected area was then filled with welding.

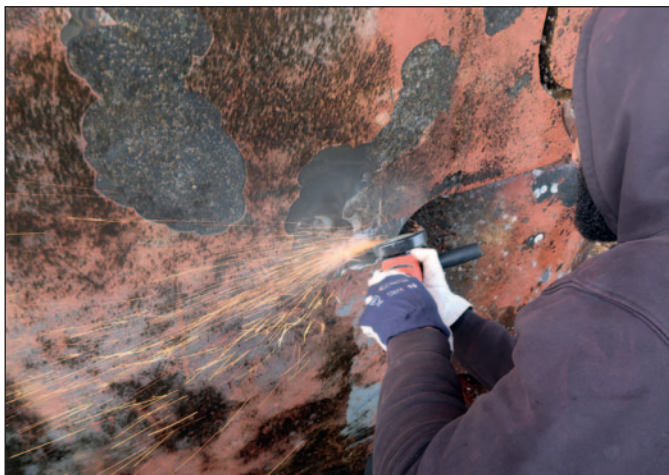
*Hydrex technician grinding out the crack in Le Havre on the trimmed vessel.*

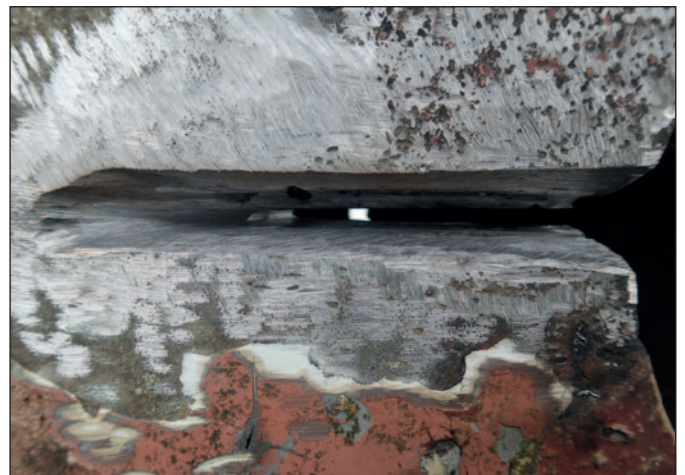
*Ground out crack, ready to be filled.*

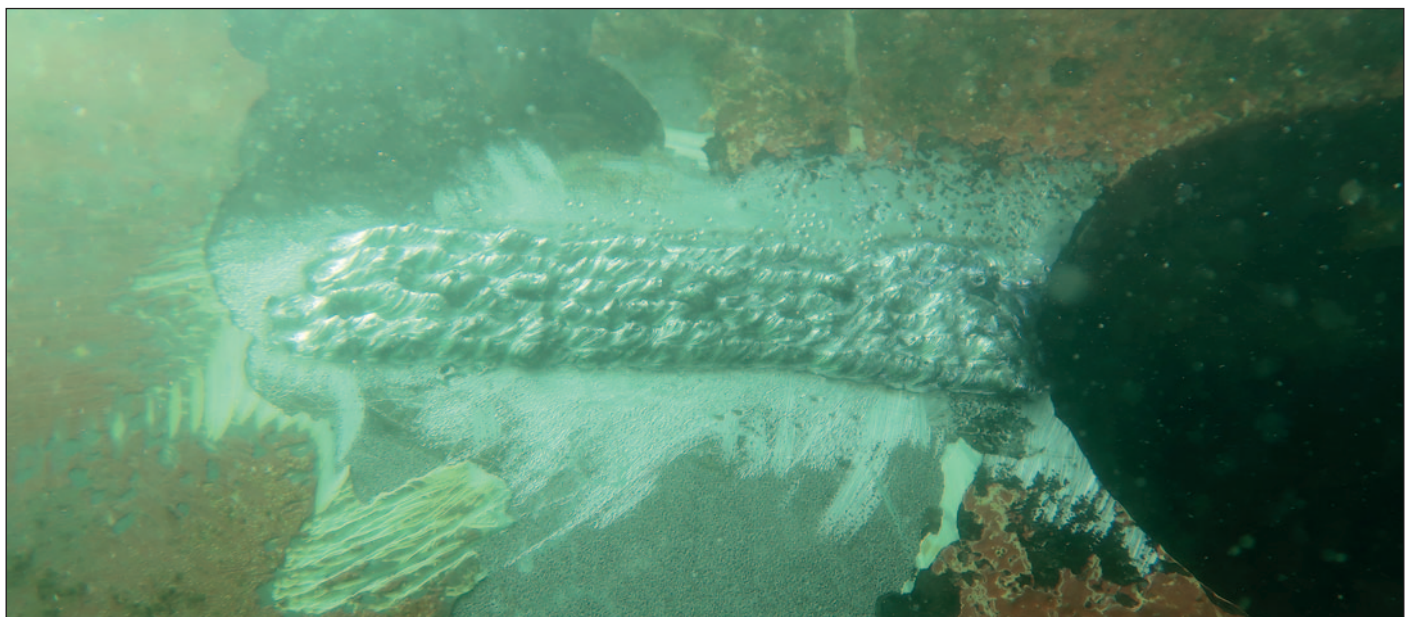
*Welding was used to fill cracks on two sister vessels after they had been ground out.*
