Looking back at 2023

# Looking back at 2023

## **45-ton cofferdam repair after a severe grounding**

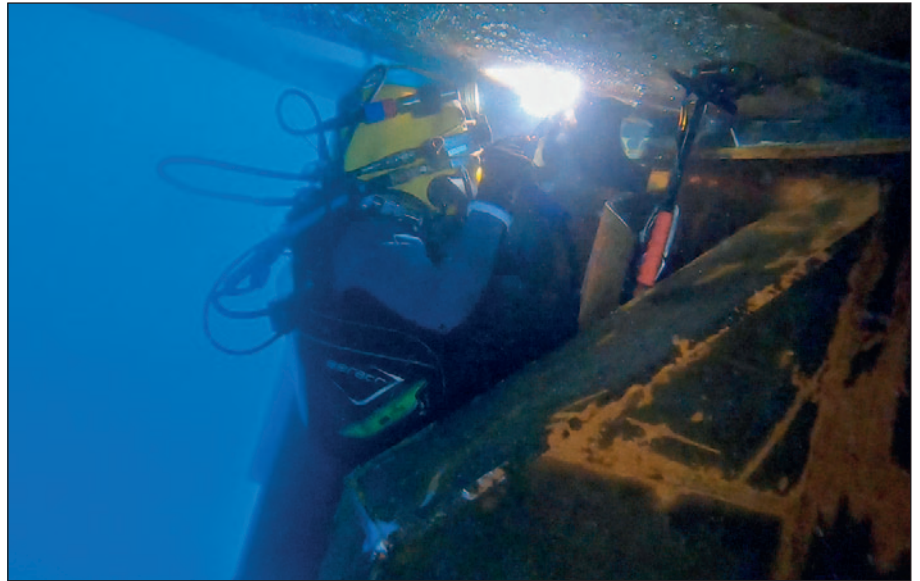
*Welding the cofferdam in place.*

modification, the massive, 45-ton cofferdam was lowered into position by crane and secured against the hull.

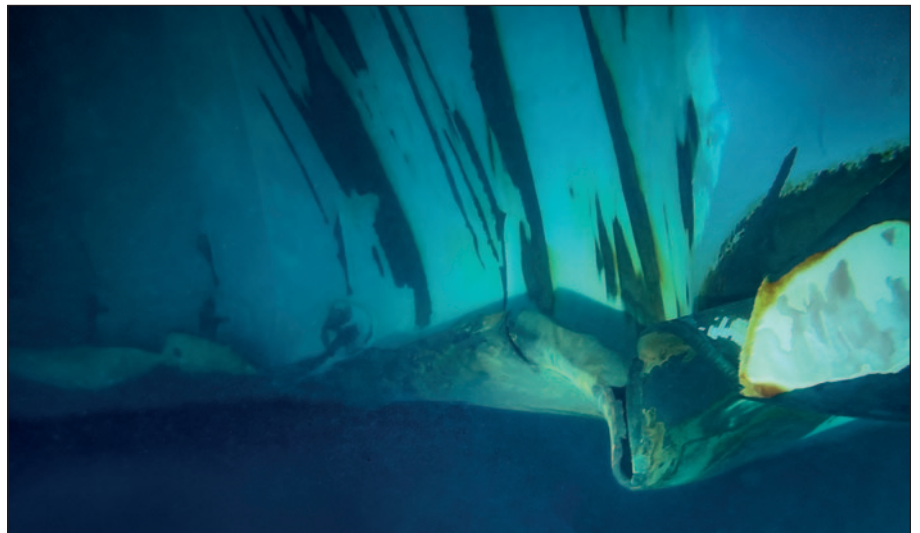
When a fully laden bulk carrier suffered heavy damages from a grounding in Suez, the owners and management's first thought was to call Hydrex. In this case the ship was carrying a valuable cargo and every day she was out of action represented a huge loss to the owners.

*Severe damage to the hull from the grounding.*

The pressure of the water was, however, too much for the structurally weak hull which started to cave in under the force. It became clear that the ship had suffered too much internal damage to permit the water ballast tanks to be fully pumped out. This was not something that could have been predicted or remedied with the ship afloat.

Based on the initial inspection and rough measurements, a plan was proposed to carry out precise measurements of the hull where the large damage occurred so that a cofferdam could be designed which would then be installed to make the hull watertight so that the water ballast tanks could be pumped out.

In order to reinforce the bulkhead between the water ballast tanks, a new plan was proposed to build cement boxes and pour concrete to provide enough strength for the bulkheads in between the ballast tanks. But WBT 2 port could not be emptied. Part of the plan, therefore, was to lighten the ship as necessary until the class-required draft could be achieved.

With the cement boxes in place, the cofferdam was fully secured, and successful sea trials were conducted. The cofferdam remained firmly in place until it could be removed when the ship was in drydock and permanent hull repairs could be carried out.

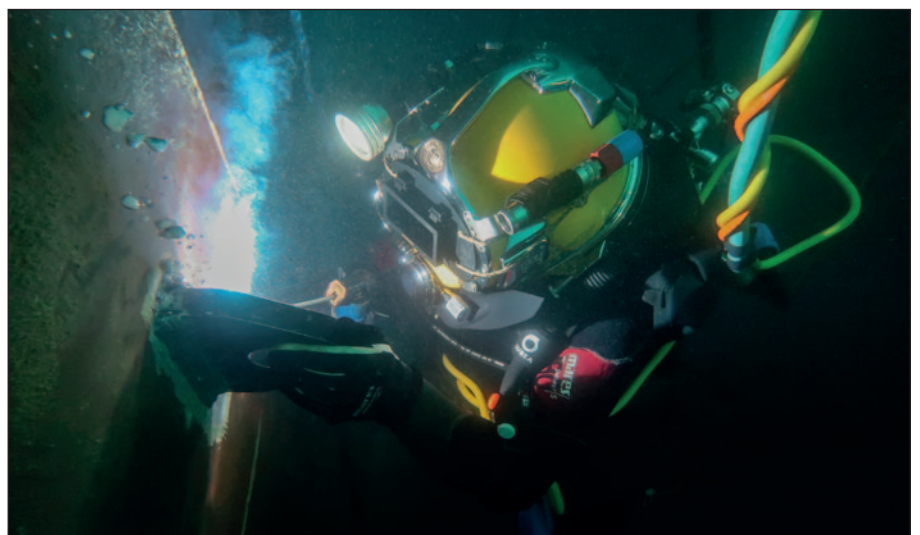
*Welding padeyes on the hull.*

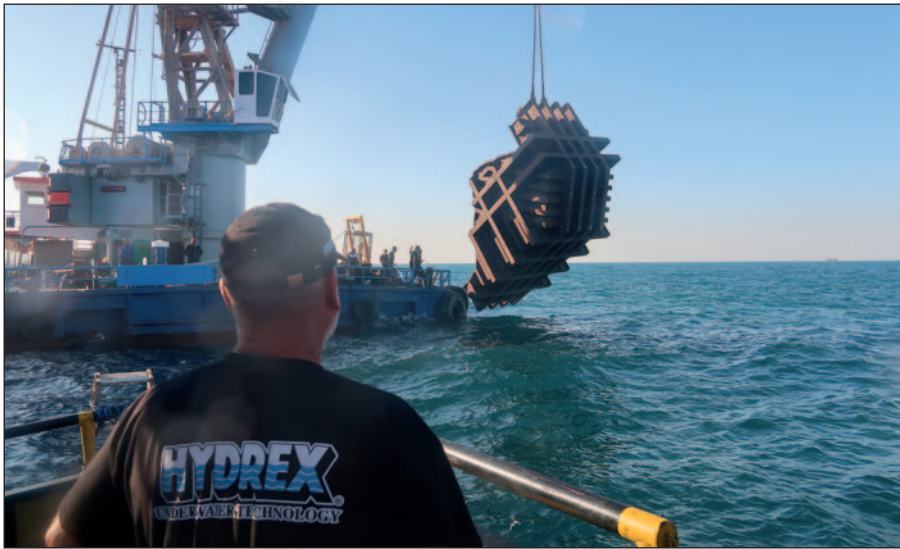
*Crane barge moving the cofferdam into position.*

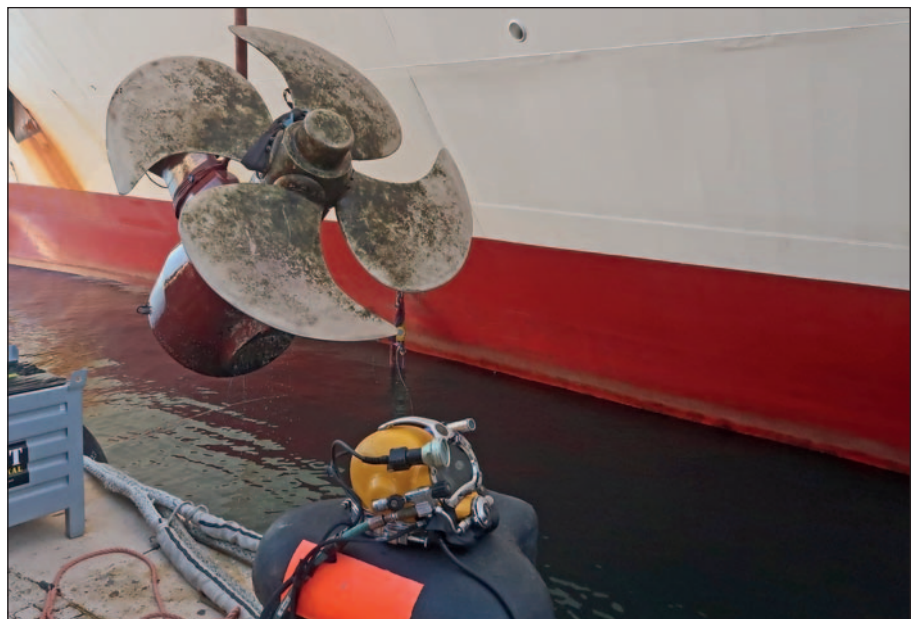
*Thruster unit brought to the surface.*

The next step was to secure the gearbox with hoisting equipment. The team then disconnected the unit from the engine room and removed it from the thruster tunnel. It was then brought to the surface where it was overhauled by the OEM's technician, with assistance of our diver/technicians.

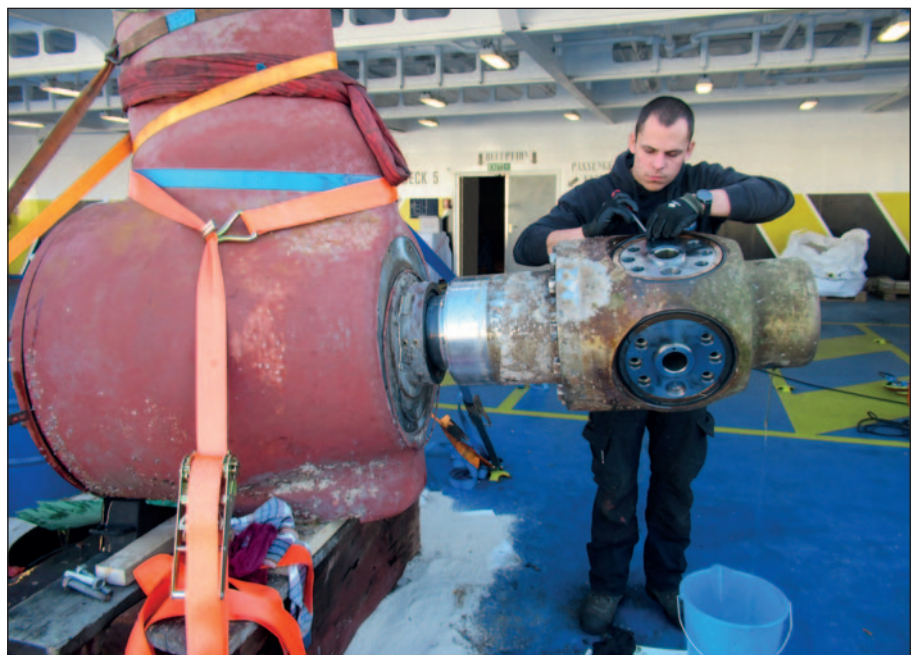
*Hydrex technician during overhaul of the thruster.*

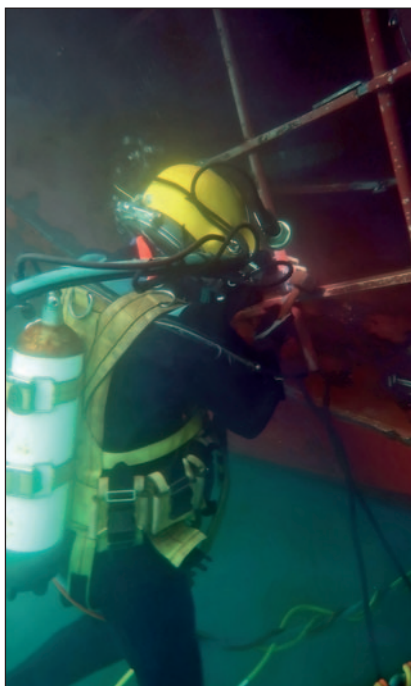
*Hydrex diver working on the tunnel grids.*

The divers first action was to take off the external thruster tunnel grids to provide access for removal of the unit. Next pad eyes were welded inside the tunnel to hoist the thruster unit up and down.

The operation ended with the removal of the pad eyes and the reinstallation of the thruster tunnel grids.

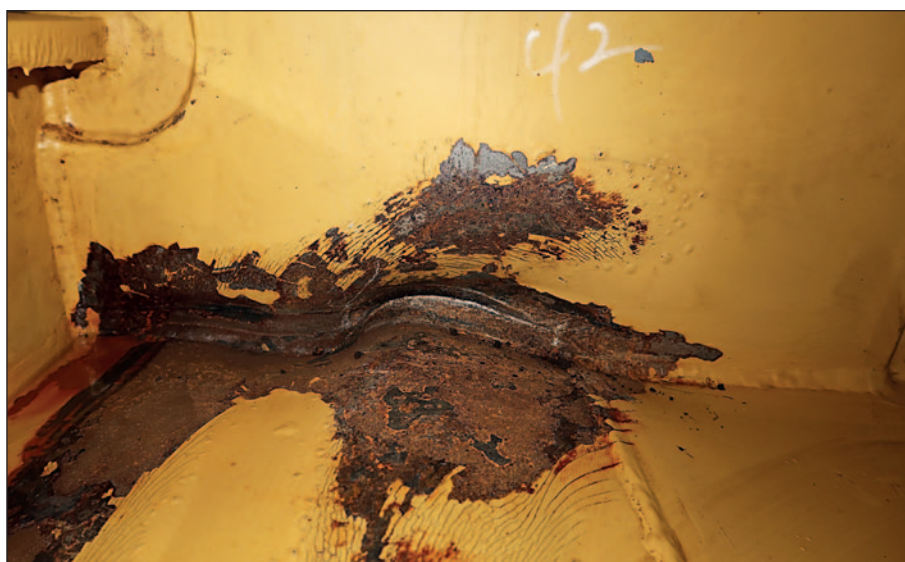
After arriving on site, the team first performed an on-board and underwater inspection of the damaged area. This revealed a large L-shaped crack in the ballast water tank of cargo hold 2. In close communication with the superintendent of the vessel and the attending class surveyor, it was decided that a 1000 x 820 mm insert would need to be installed.

*Crack in bottom plating after grounding.*

The divers started the operation by installing the cofferdam on the waterside of the affected plating. To be able to access the crack in the ballast water tank from the inside, the team made an opening in the bilge hopper covering the crack. A frame and support brackets were also removed.

This allowed our diver/technicians to cut away the crack and the surrounding area. The new plate was then inserted into the hull and secured using full penetration welding following our class-approved procedure.

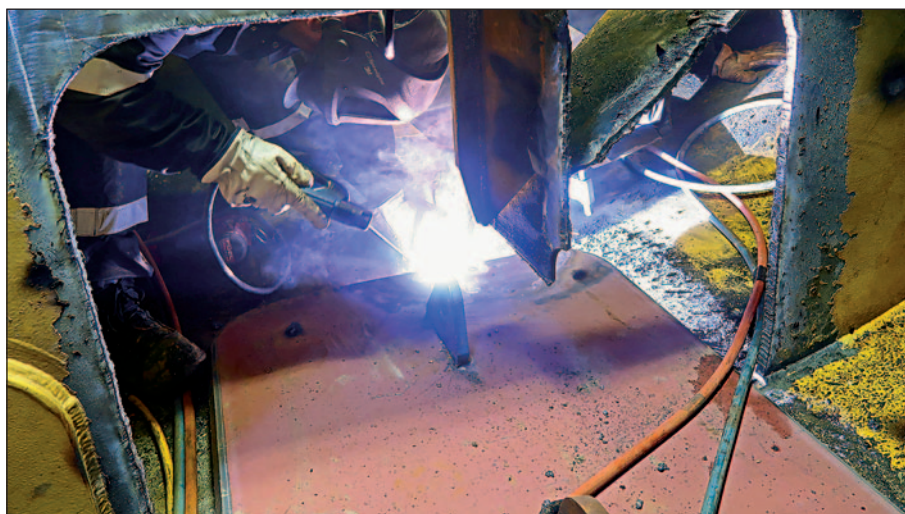
*Hydrex welder securing the new insert plate.*

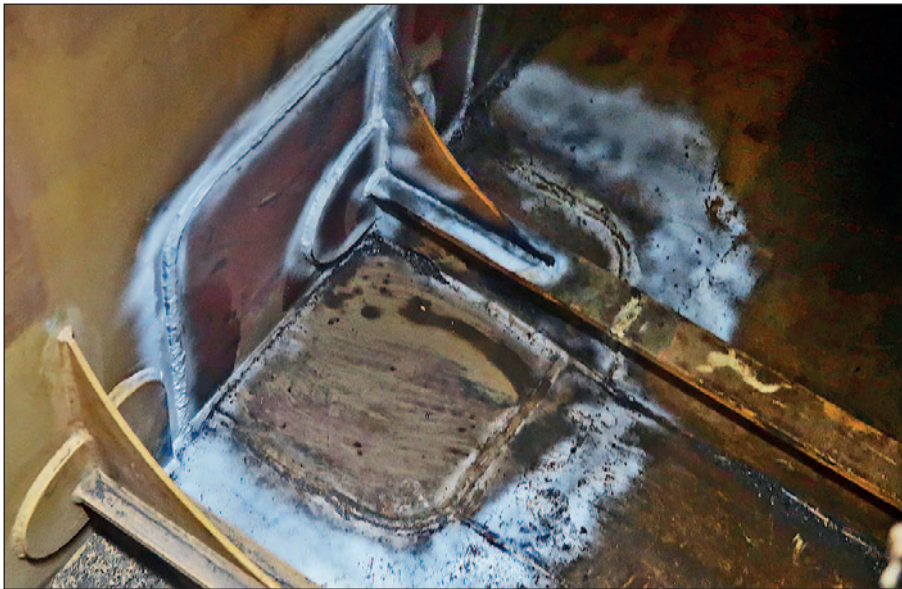
*Completed insert repair with frames, brackets and split hopper plate repositioned.*

The next step was the reinstallation of the frame and support brackets. A new insert was then positioned in the bilge hopper. This plate was welded following the same class-approved procedure.

An independent NDT inspector approved the insert repair, and the classification surveyor who was present during the operation gave it a green light.

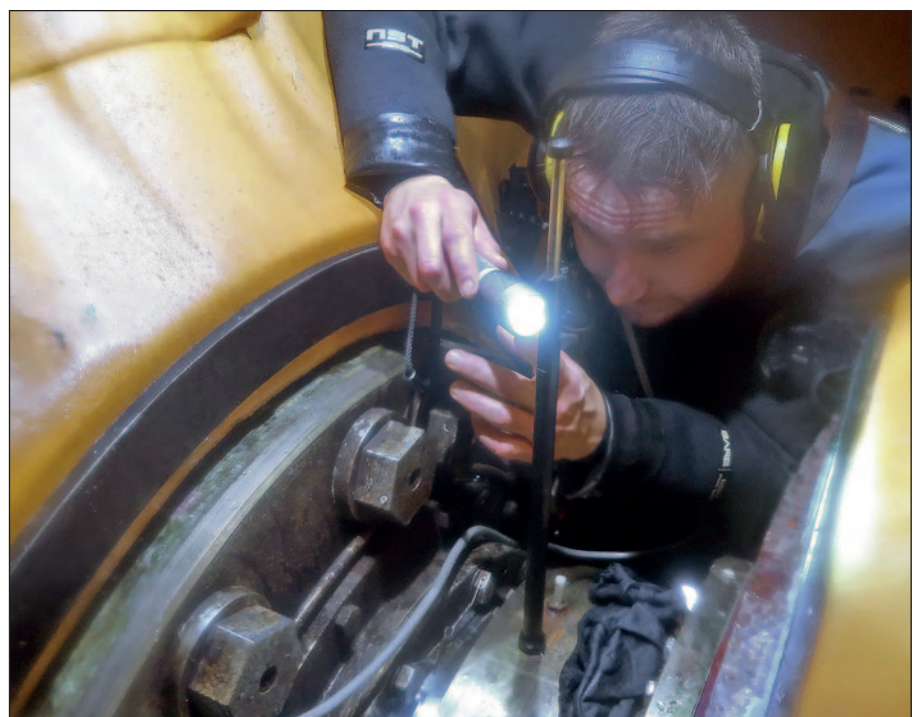
*Hydrex diver/technician taking shaft wear down reading.*

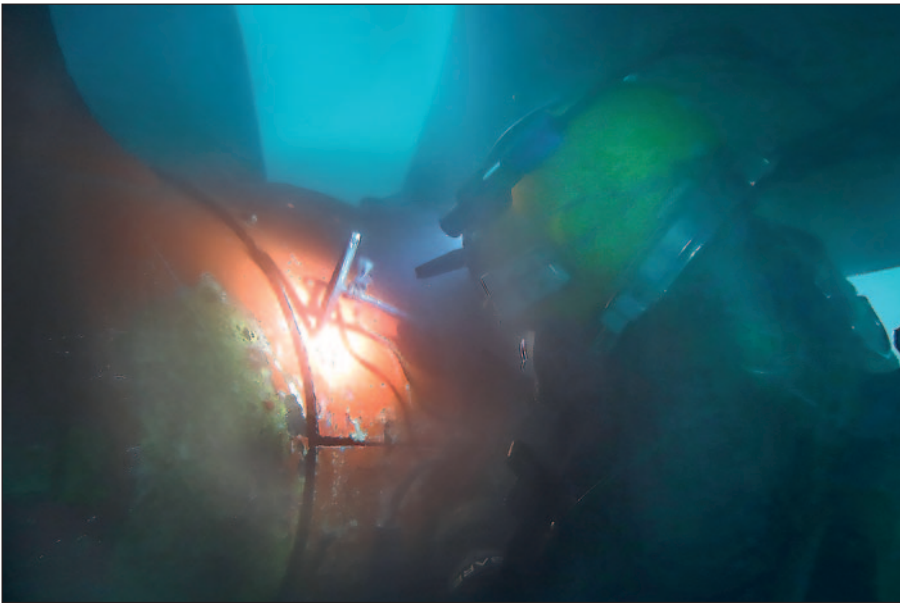
*Reinstalling the rope guard.*

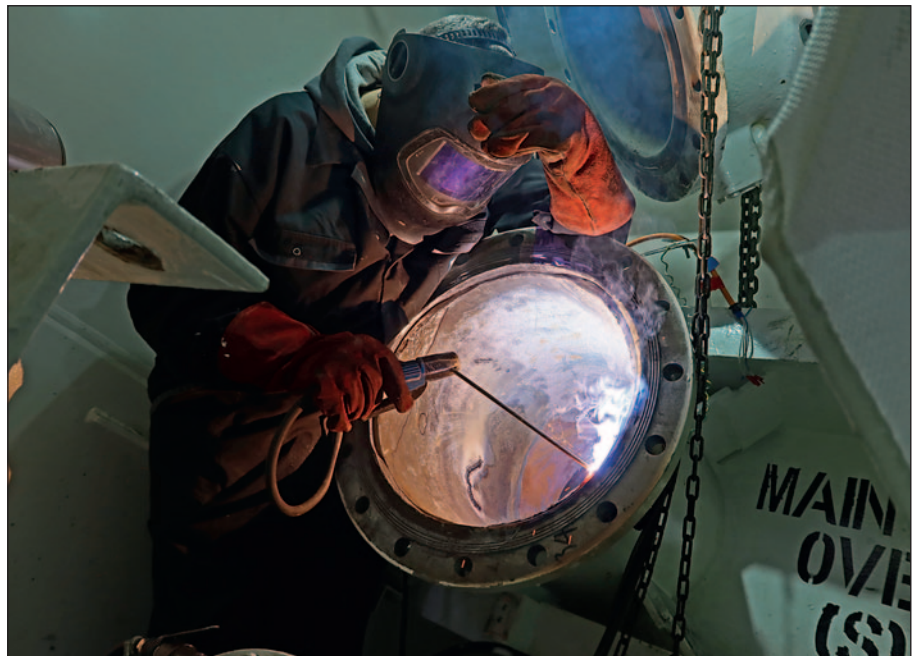
*Hydrex welder during scrubber pipe repair.*

After the installation of the cofferdams, the team cut away the old pipes. The shell plating was then prepared for the installation of the replacement part. New pipes had also been constructed at our workshop in Antwerp. The pipes were then positioned and secured with a full penetration weld. Next an independent inspector carried out NDT testing of the welding work.

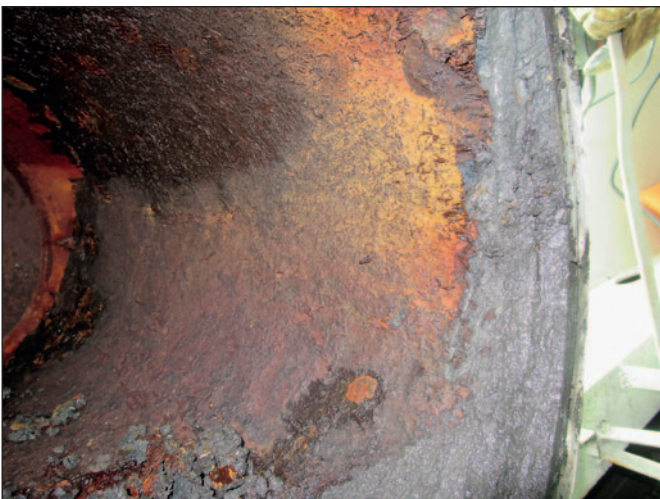
We performed scrubber overboard pipe repairs on two 298-meter LNG carriers in Munkebo, Denmark. In total seven corroded pipes were repaired. On five pipes the corroded areas of the scrubber pipes were

*Corroded scrubber pipe seen from the onboard side.*

Our diver/welders then sealed off the outlet of the final overboard pipe. The team ground away the corroded area before rebuilding it back to its original thickness.

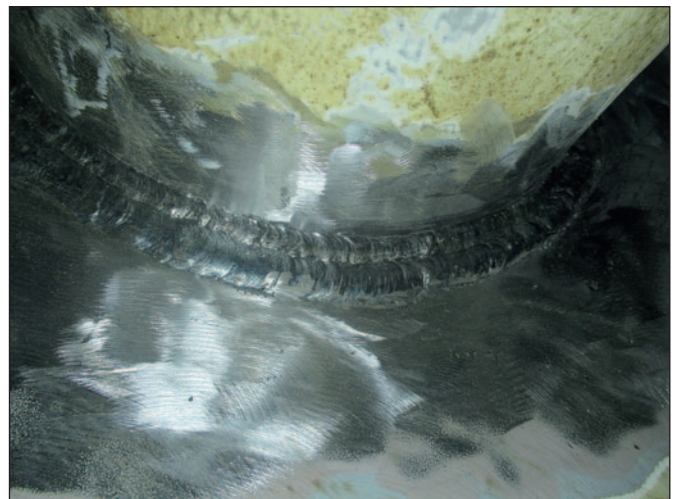
*All welding work is done following our class approved procedures.*

When the welding was complete the surface was cleaned and a Magnetic Particle Inspection (MPI) was carried out by an independent inspector.

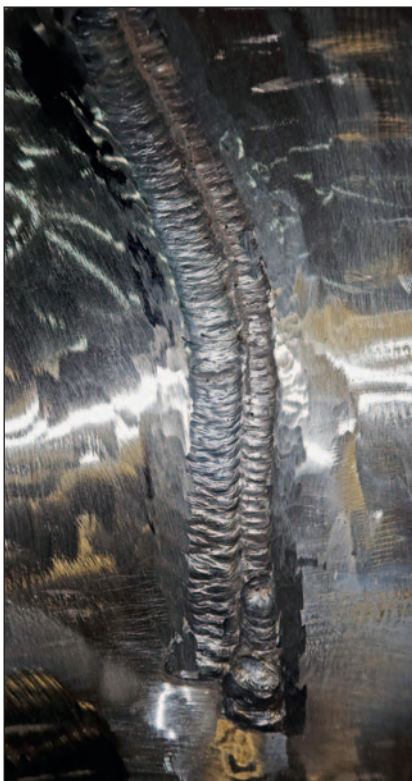
*The crack after being filled up with a full penetration weld.*

site, the team first performed an on-board and underwater inspection of the damaged area. This revealed a crack measuring 232 mm just behind the start of the landing plate of the bilge keel section.

The bilge keel and landing plate were then partially cropped to allow for the installation of a cofferdam on the outside of the hull over the damage. The team could then work on the crack inside the ballast tank without water ingress. The crack was ground out over its entire length and filled with our class approved full penetration welding.

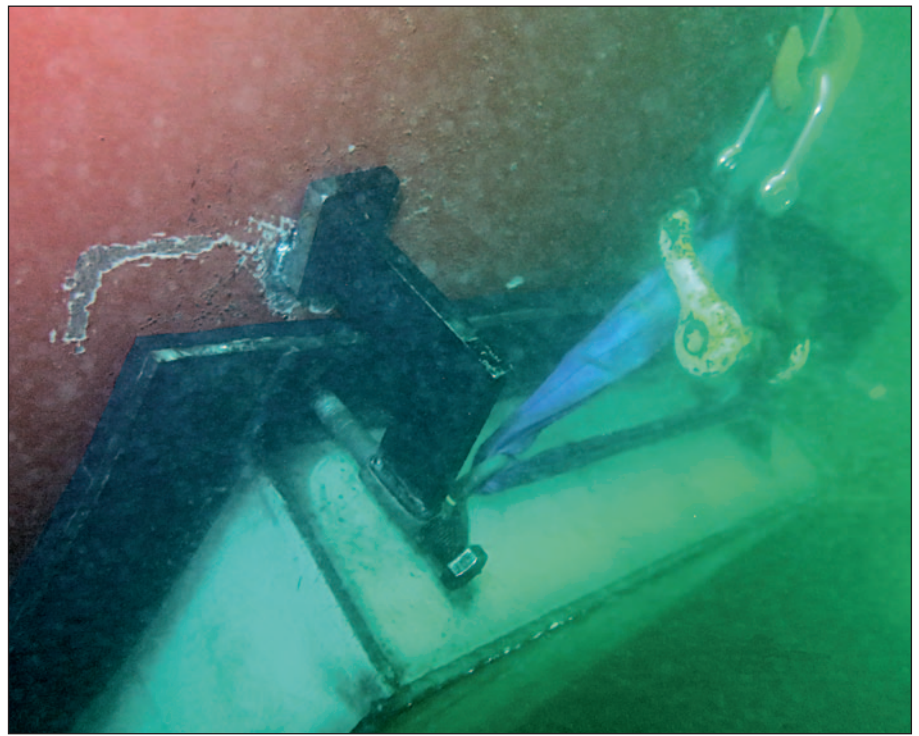
*Cofferdam installed over crack on 360-meter bulker.*

Next the cofferdam was removed and the bilge keel was further adapted to the correct shape. The cropped landing plate was fully welded and closed again.

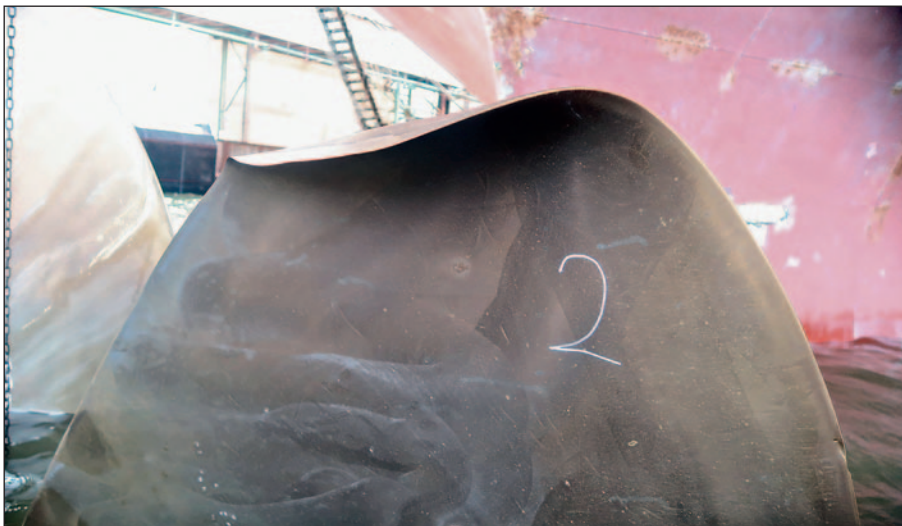
When the propeller blades of the bulker were damaged as a result of impact with ice, a fast on-site solution was needed to restore the propeller's balance with a minimal loss of efficiency. This would avoid an extended off-hire period to go to drydock.

*One of the five bent propeller blades of the bulker.*

The team used the information acquired during the inspection to calculate and determine the ideal cutting lines. They then cropped the damaged blades and ground the edges to give them the correct shape.

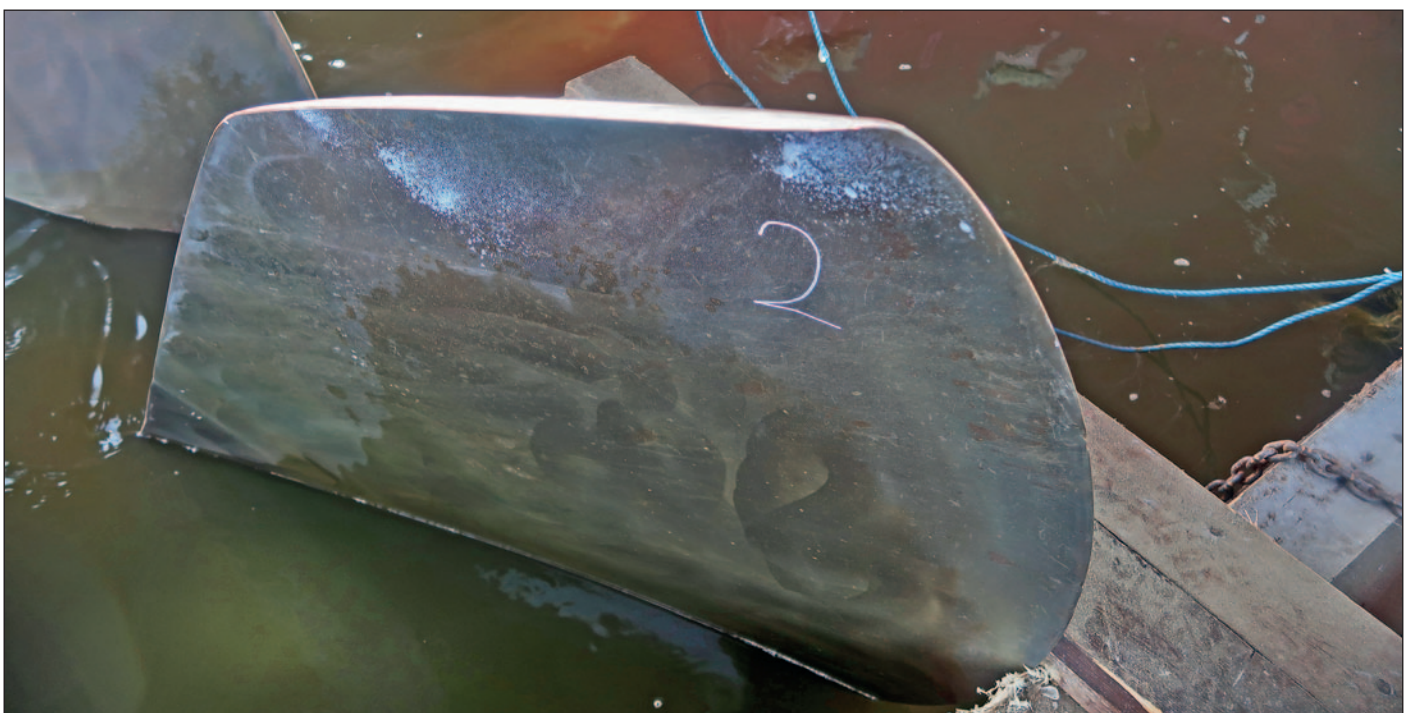
*One of the cropped blades after grinding the edges. This is done for maximum efficiency.*

When the cropping was complete, the blades were polished to make sure that any remaining loss of efficiency would be minimal.
