Underwater hull repairs save time and money

Underwater bow thruster removal and reinstallation in Zeebrugge

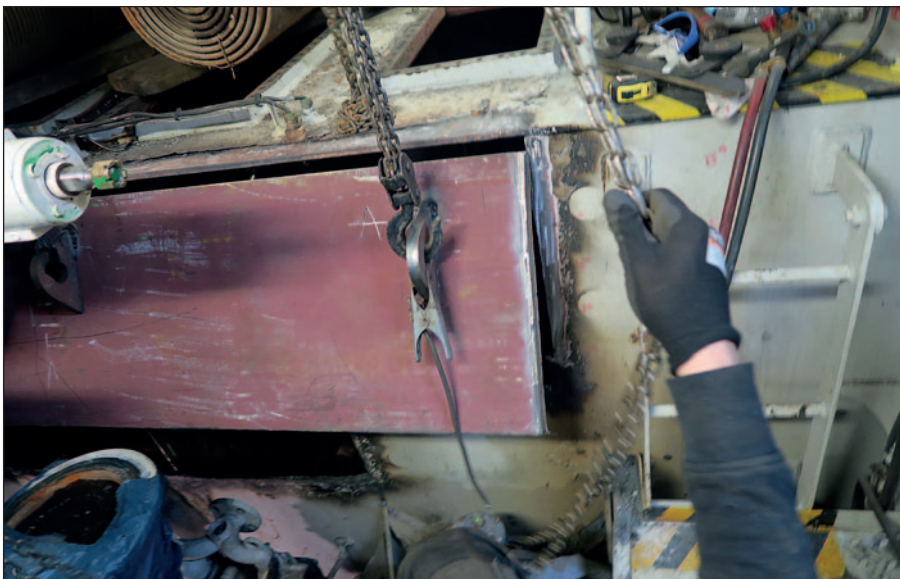
A tanker suffered leakage in the star-board side sea chest of its engine room. We were asked by the owner to provide an on-site solution and sent a team to the ship's location in Rotterdam to carry out an insert repair.

On request of the class surveyor, an NDT specialist was arranged to take thickness measurements of the star-board sea chest from inside the engine room. These measurements showed that the damage inside the sea chest was more widespread than had been presumed.

Positioning one of the new sea chest inserts.

diver/welders worked in shifts to fit and weld the two insert plates. This was done with class approved full-penetration welds.

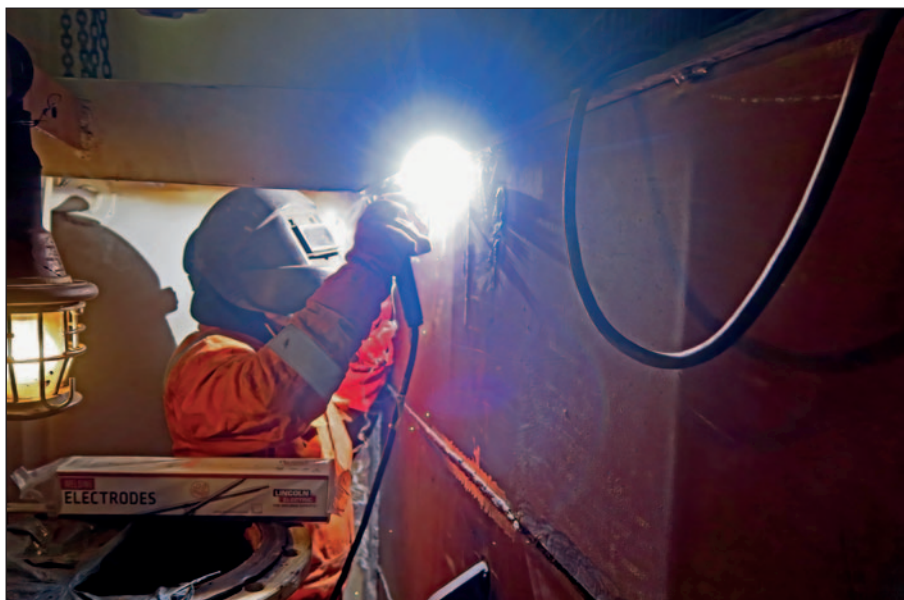
Securing the new inserts in Rotterdam with full penetration weld.

When the installation was complete, a successful NDT test was carried out by an independent surveyor. As a result, the class representative gave his approval of the repair.

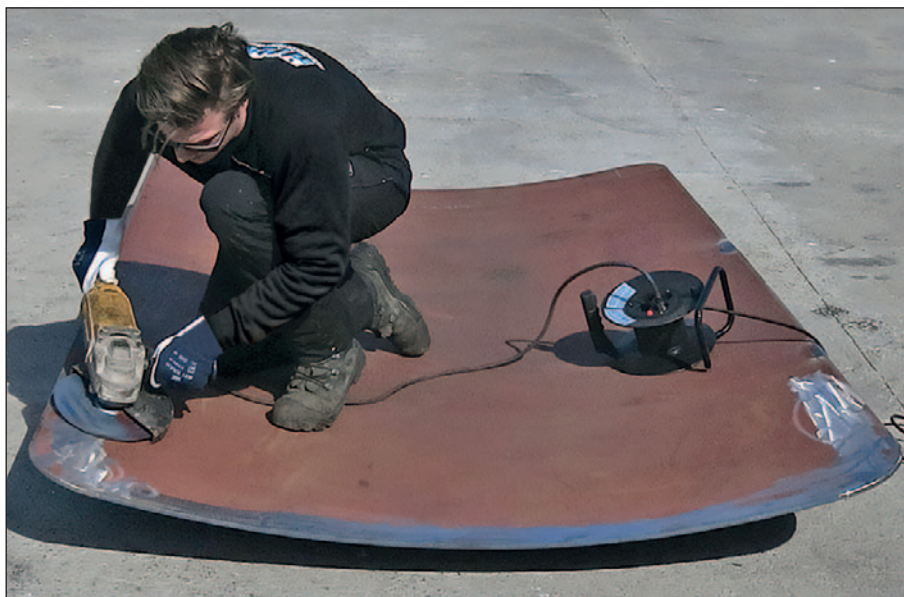
A fully loaded 180-meter bulk carrier suffered grounding damage in Las Palmas, Spain. An underwater repair was needed so that the vessel could sail to her unloading destination safely. Unfortunately, a first repair attempt proved unsuccessful. After the ship had been delayed for almost two weeks we were contacted to take over the operation and get the bulker sailing again as soon as possible.

Preparing one of the doubler plates for installation in Las Palmas.

The first step of the repair consisted of removing the cofferdam that had been installed during the previous effort to repair the damage. Once this was done our diver/technicians installed two doubler plates over the affected areas of the flat bottom.

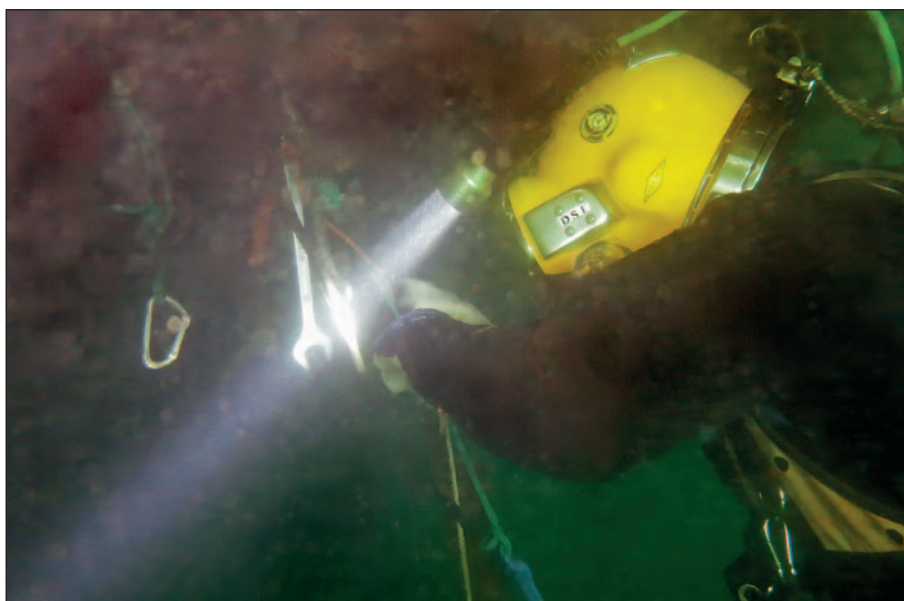
Hydrex diver/technician preparing the hull for installation of doubler plate.

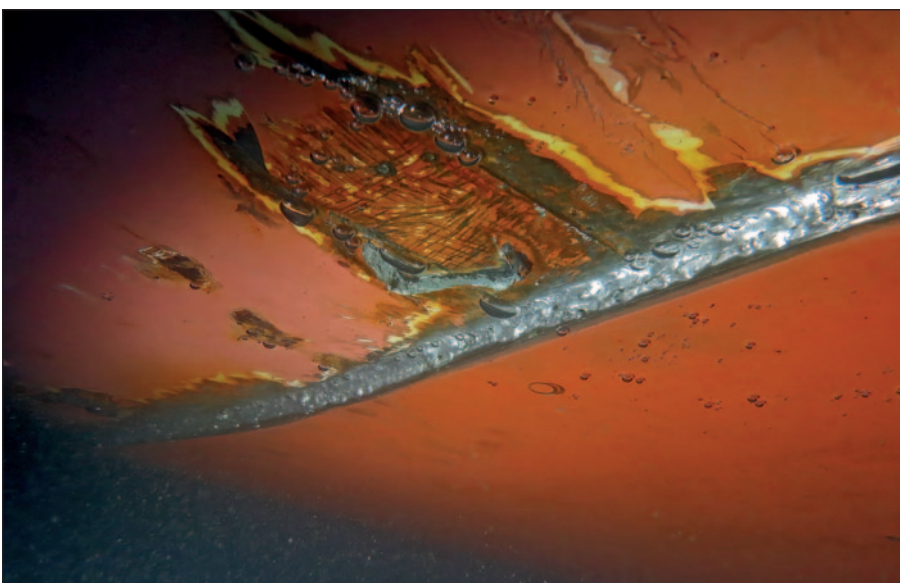
The doubler plate repair in Las Palmas allowed the owner to continue the ship's voyage and unload its cargo.

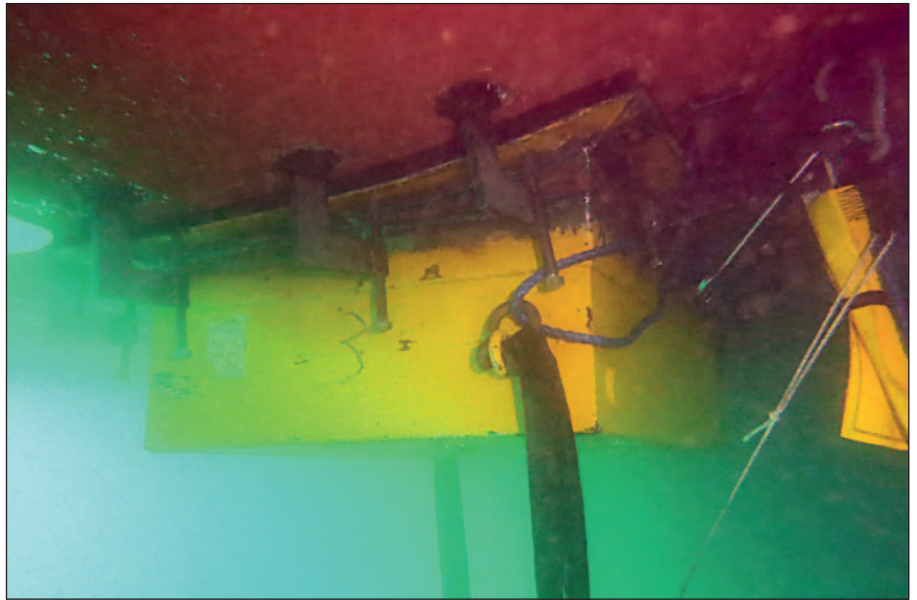
A 115-meter LPG tanker needed to have a new insert installed on a damaged section of its flat bottom.

A team of our diver/technicians traveled to Santander. First they performed a preliminary underwater inspection of the damage. This revealed that the required insert would be 400 x 300mm. Next they used a special frame to take the measurements needed to design the

Tailor-made mobdock secured over flat bottom of LPG tanker.

stalled by our team. The shipyard could then perform the insert repair in the best possible conditions. Once the repair was finalized and approved by the representative of the classification society, our team removed the mobdock.

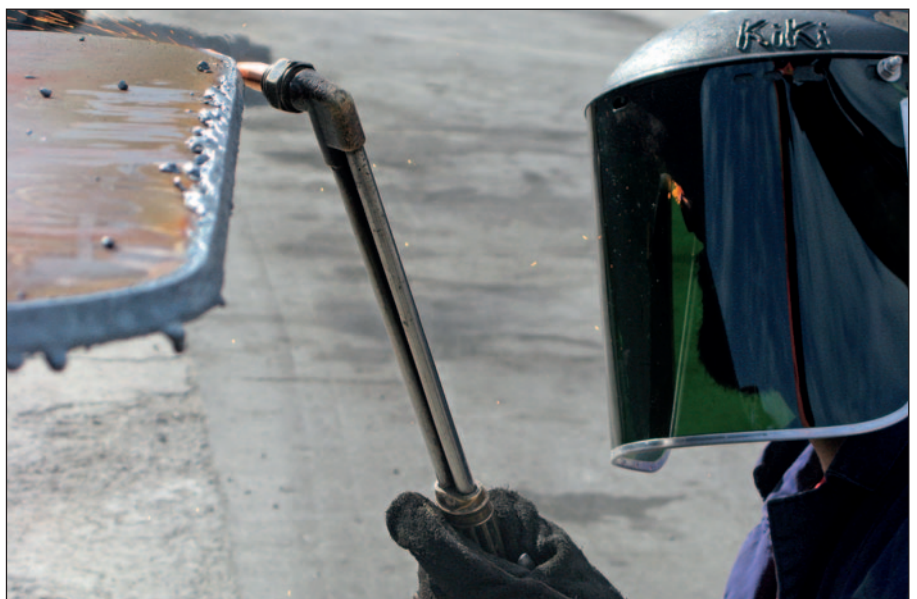
The ship had suffered corrosion damage to the aft starboard side shell plating. Because the damage was situated in the turn of bilge it was again essential that the mobdock was modified to fit perfectly over the rounded shape of the hull.

Hydrex welder preparing the insert plate in Palm Beach.

After the mobdock was installed, the frame covering the damage was removed. This allowed the team to cut away the damage and the surrounding area. A new insert plate was then positioned and welded following our class-approved procedure.

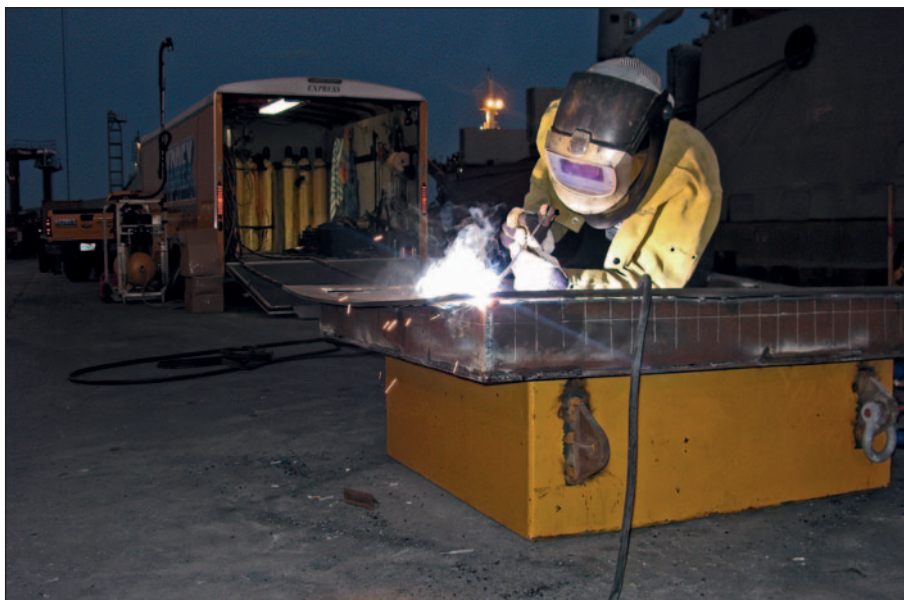
Preparing the cofferdam for installation on ro-ro vessel.

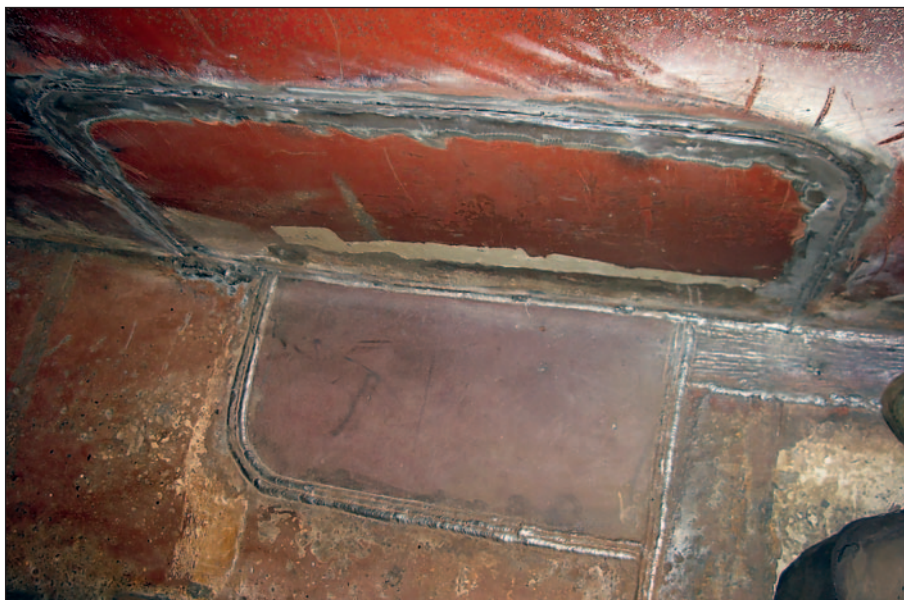
Finished insert with reinstalled frame.

An independent inspector carried out ultrasonic tests and the repair was approved by the classification surveyor who was present during the operation.

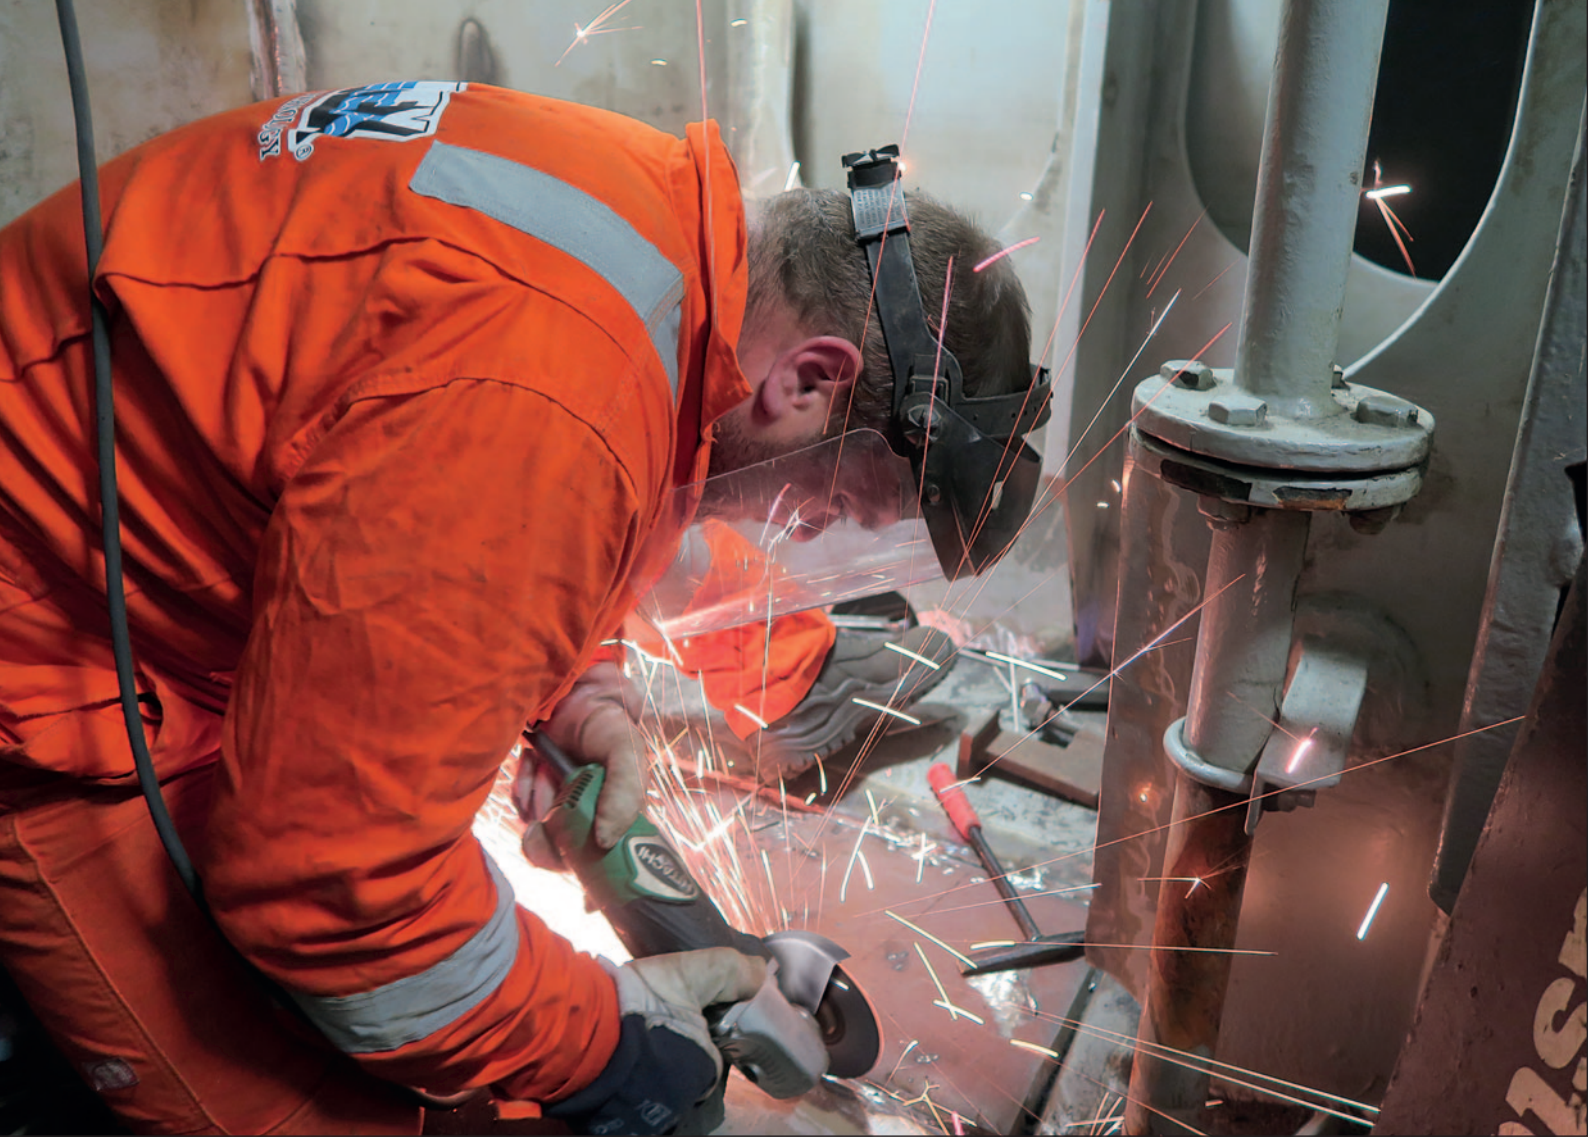
An emergency call came in on a late Friday afternoon to carry out a permanent insert repair on board a 145-meter chemical tanker that had suffered a crack in its port side grey water tank. The job was carried out during the vessel's stop in Amsterdam.

Hydrex technician working on new insert in Amsterdam.

In close communication with the superintendent of the vessel and the attending class surveyor, it was decided that a 700 x 300 mm insert would need to be installed. The new insert plate and a steel mobdock were fabricated at our headquarters in Antwerp.

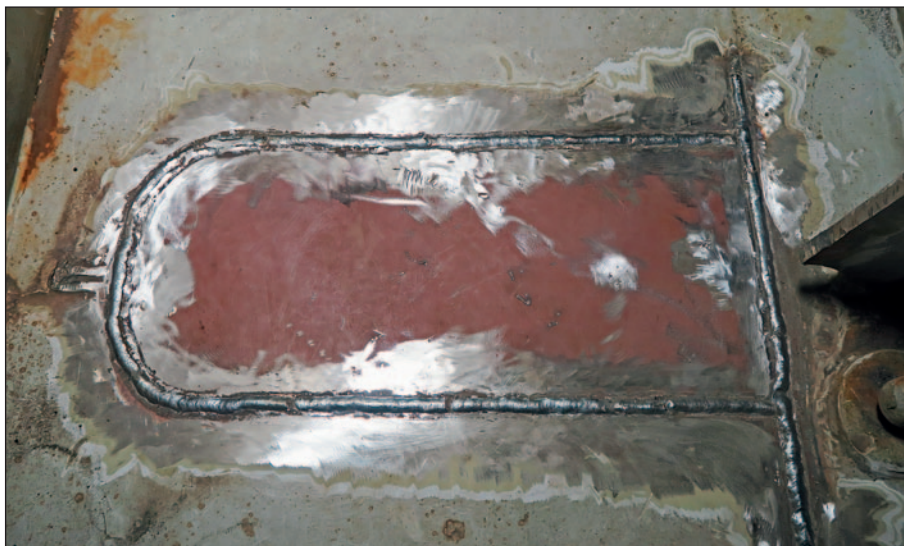
Insert on chemical tanker after full penetration weld.

By installing the new insert to repair the large crack, this area of the ship did not require further repairs during her next drydocking. The vessel could sail on time as the repair was carried out well within the stipulated time frame.

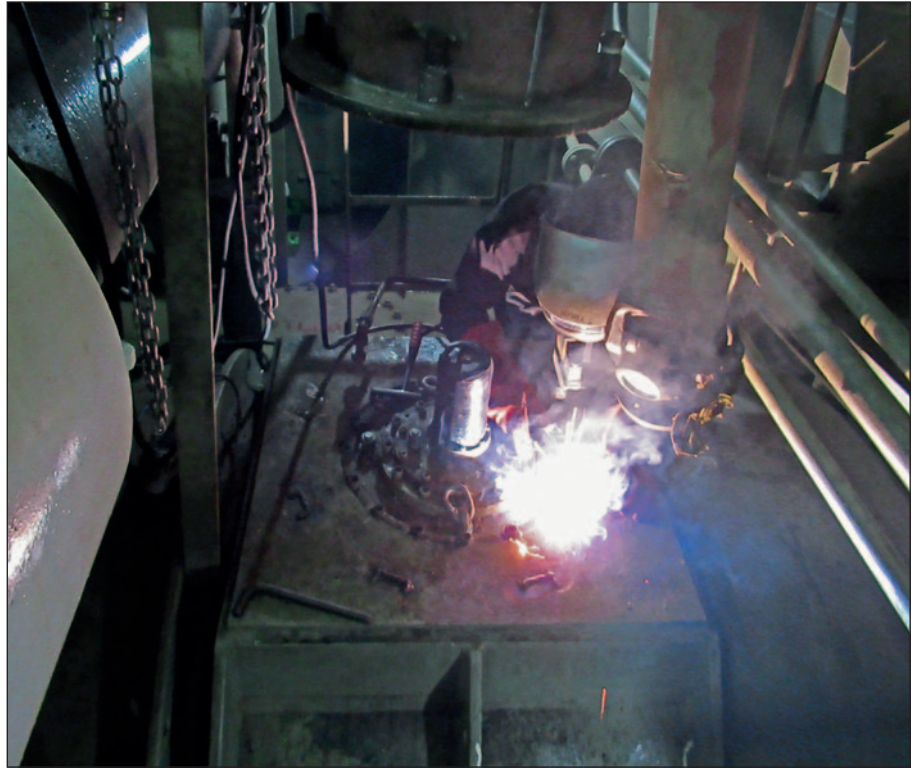
Hydrex technician preparing the engine room for removal of the thruster unit.

After the team set up a monitoring station next to the vessel, the divers started the operation with a detailed inspection of the bow thruster and tunnel. In the meantime, initial preparations were made in the bow thruster engine room for the removal of the unit so that there would be no ingress of water once it was taken out.

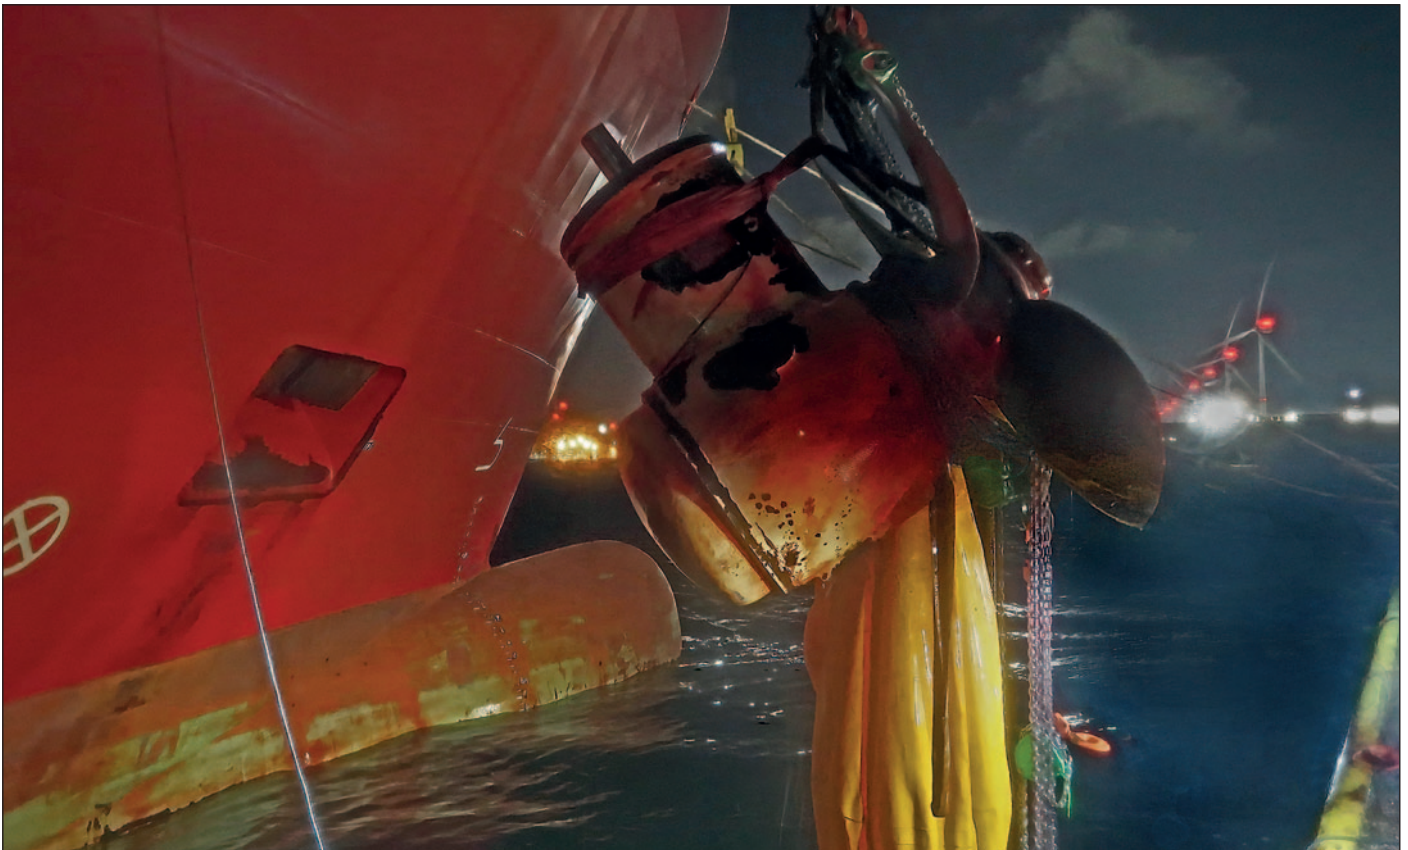
Bow thruster unit brought to the surface.

from the engine room and removed it from the thruster tunnel. It was then brought to the surface. Our team then transported the unit to Rotterdam to be overhauled.

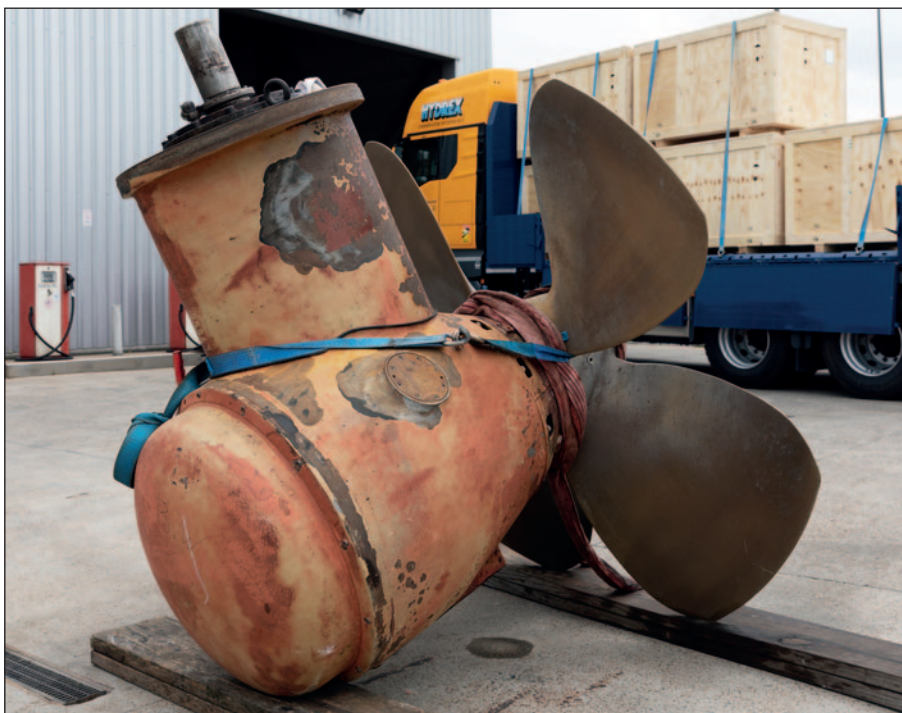
The unit at our warehouse in Antwerp, ready for transport to Rotterdam to be overhauled.

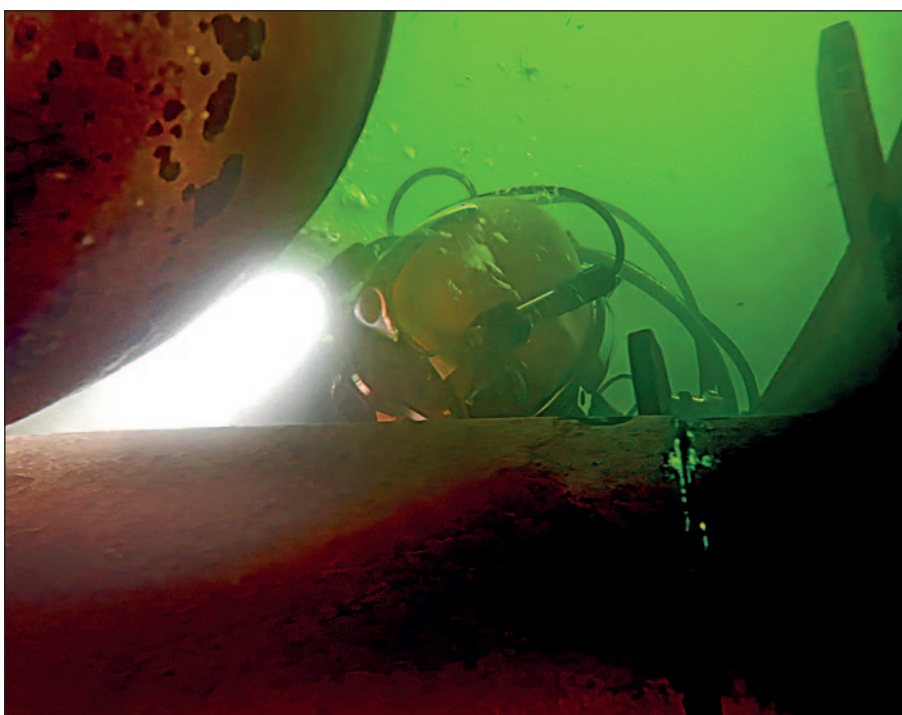
Hydrex diver during reinstallation of the bow thruster.

Because the thruster was fully assembled and prepared, it could be installed in its entirety without the need to create a dry environment in the tunnel as is required when the blades are installed separately. Our diver/technicians lowered it into the water and brought it into the thruster tunnel. The team secured the unit and connected it to the engine room.

The operation ended with the removal of the padeyes and the reinstallation of the thruster tunnel grids.
