UNDERWATER TECHNOLOGY

Magazine

Number 331

Double stern tube seal repair on roro vessel in Tasmania

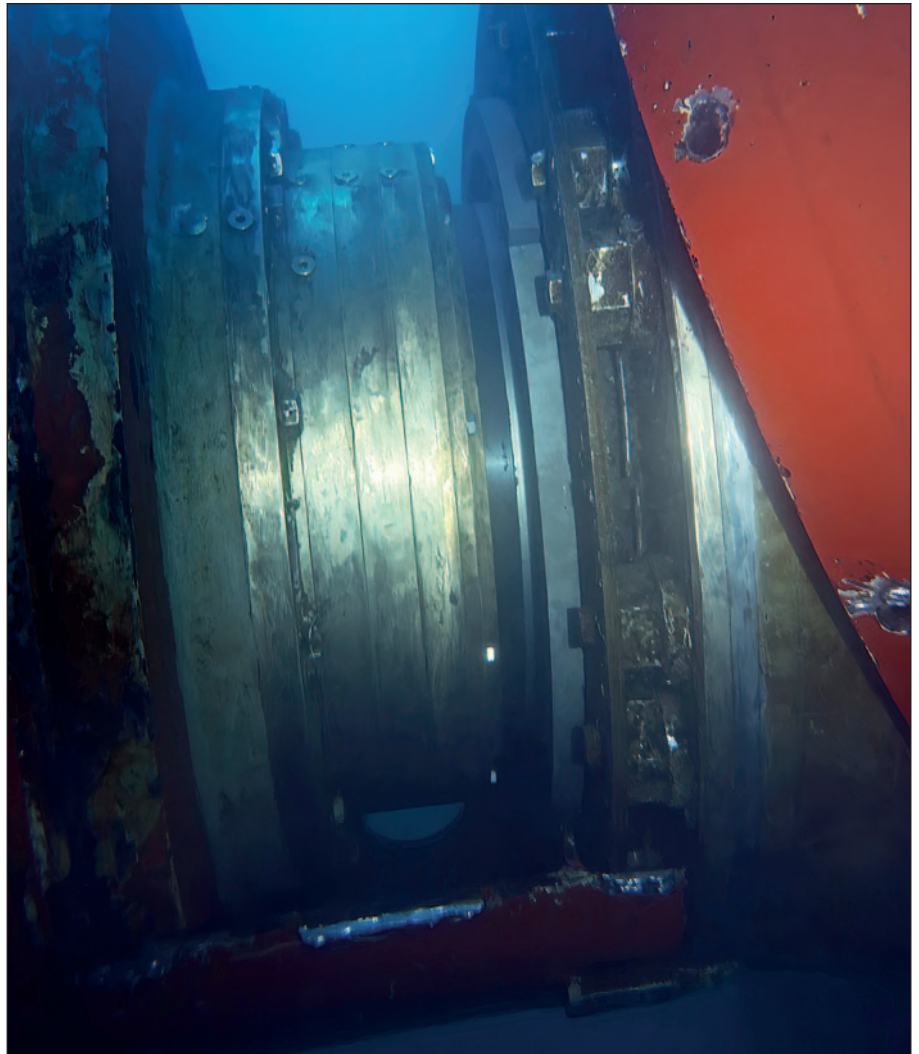
One of the seal assemblies after removal of the rope guard, prior to the repair.

The exact same procedure was followed on both stern tube seal assemblies. The split ring was first disconnected and brought to the surface to be cleaned. After cleaning the entire assembly, the divers removed the first seal and replaced it with a new one which was then bonded. This was done in cooperation with the supervising OEM technician. The procedure was repeated with the other three seals.

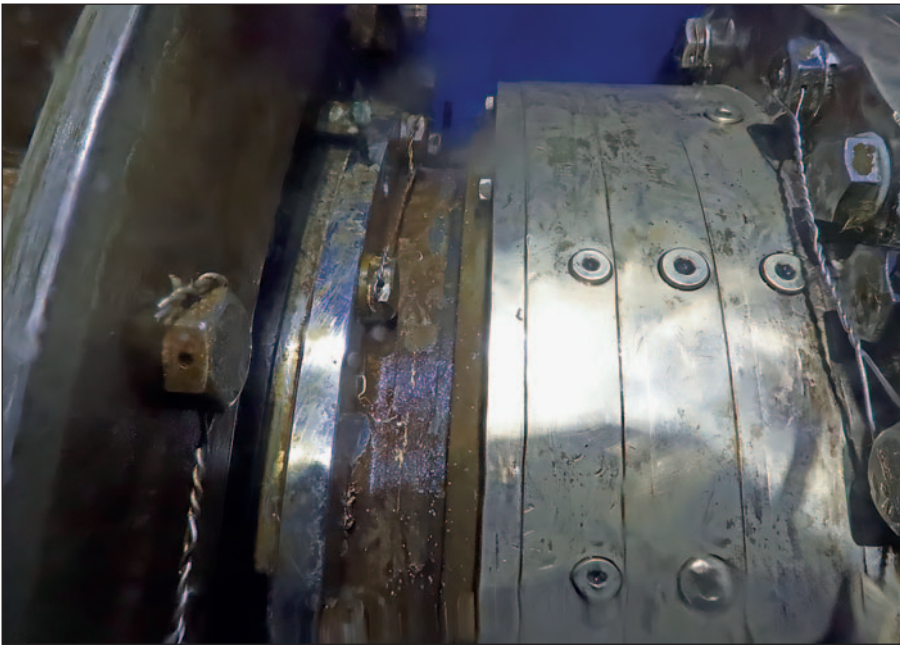
Damaged running area of the seals.

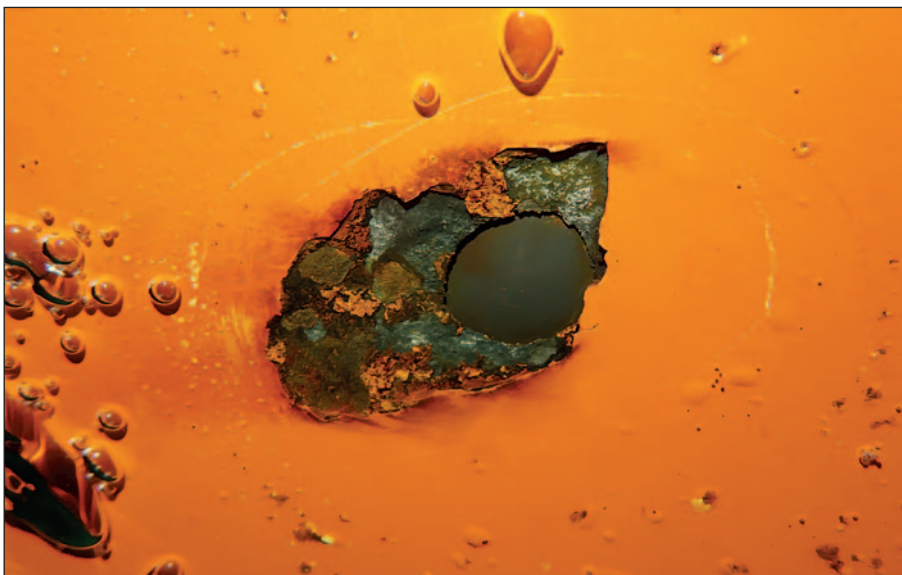
Damage seen from the water side.

The damaged plating was underneath the sounding pipe in one of the ballast tanks. A temporary repair had been performed, but a permanent repair was needed to avoid going to drydock.

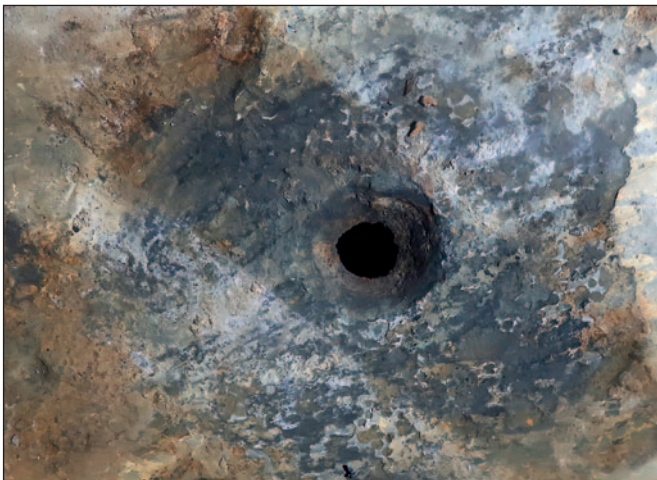
A 164-meter chemical tanker needed to have an insert installed on a damaged section of its bottom plate.

Hole in bottom plating of tanker in Trinidad.

A round section of the damaged plating with a diameter of 200 mm was then removed. The size of this area was decided in communication with the classification society and the owner. Next our team prepared the edges of the hole for the insert, and positioned the new plate. The insert was then welded following the Hydrex procedure for insert plates, using a full penetration weld.

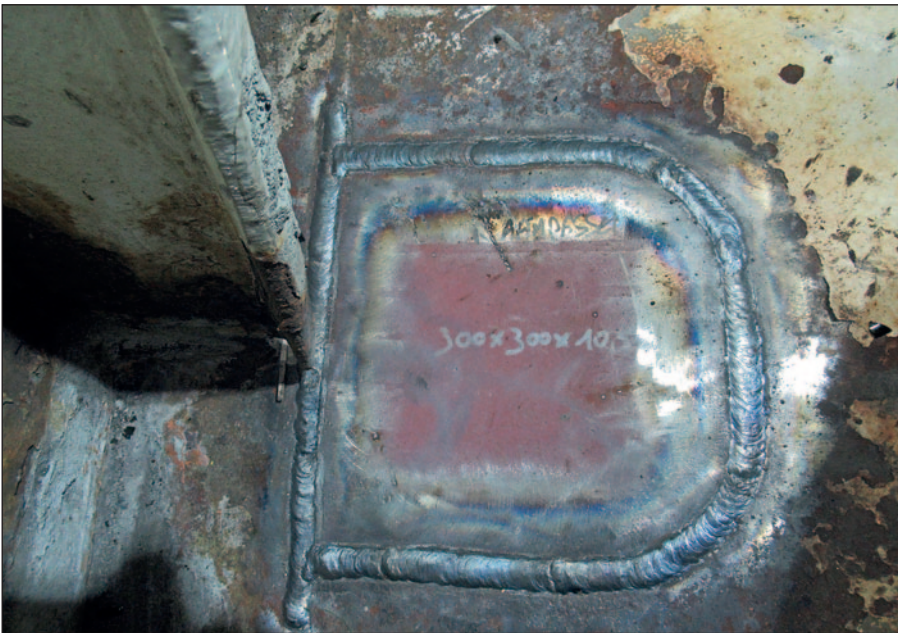
A similar operation was performed close to home on a 144-meter oil tanker during its stop in Amsterdam. In this case the damage was situated in the ship's engine room and an insert measuring 300 by 300 mm was installed.

New insert installed on tanker in the Netherlands.

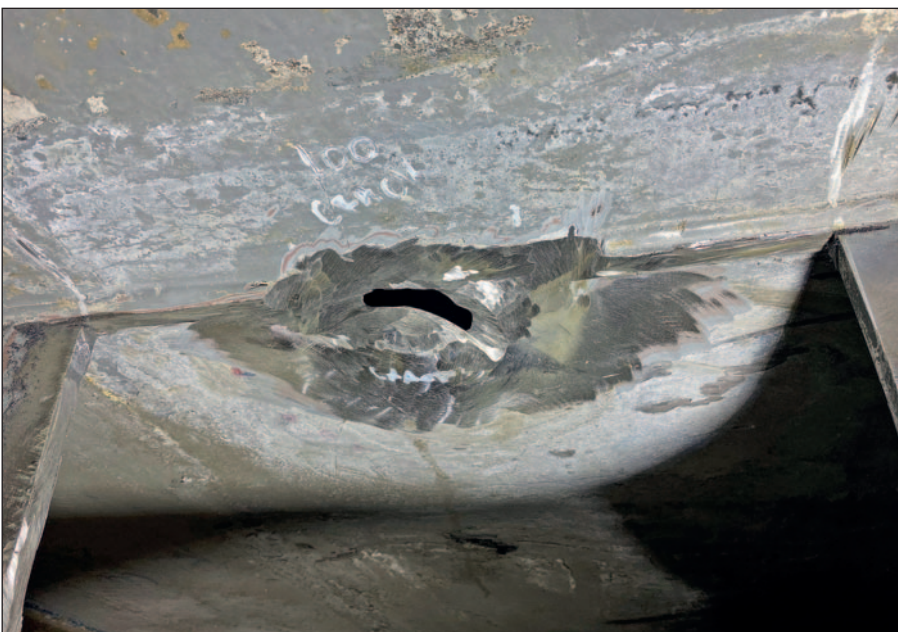
Crack on car carrier after being ground out.

For smaller damage such as crack repairs, it is not always necessary to install a new insert. This was the case for a 229-meter car carrier in Zeebrugge, Belgium that had a leak in its forepeak ballast tank. As our fast response centers have a large stock of state-of-the-art equipment ready, mobilization for smaller operations like this can be almost immediate.

the crack and take the exact measurements. The crack was ground out over its entire length and filled with our class approved full penetration welding.

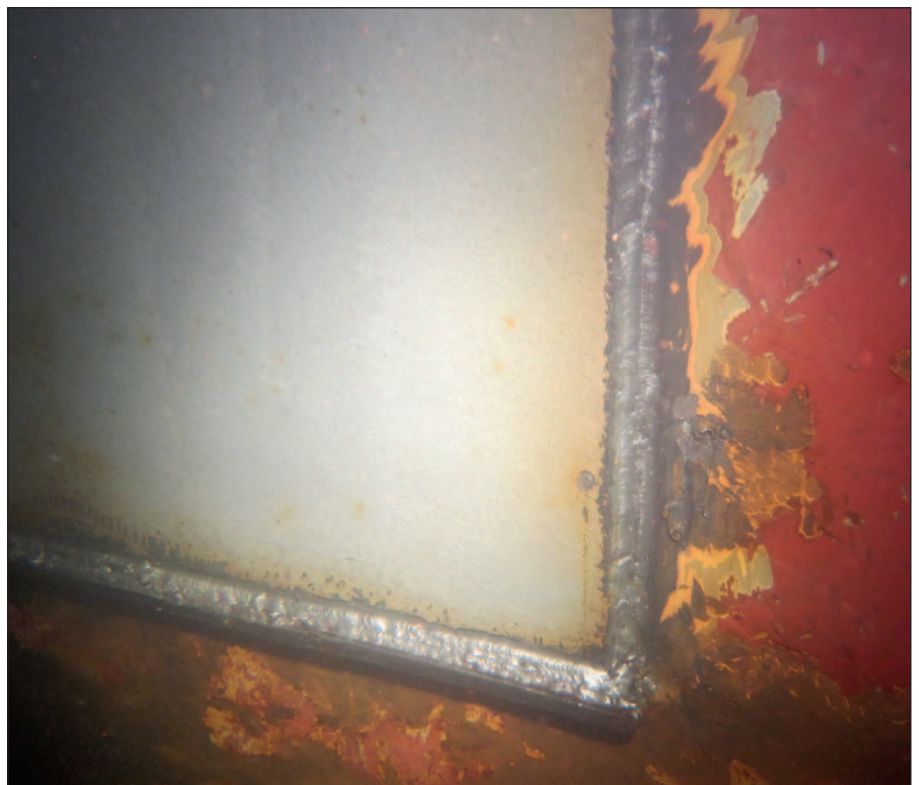
Weld seams of doubler plate installed over damaged hull area.
