HYDREX[®]

Magazine

Number 333

Complex steel repairs carried out afloat

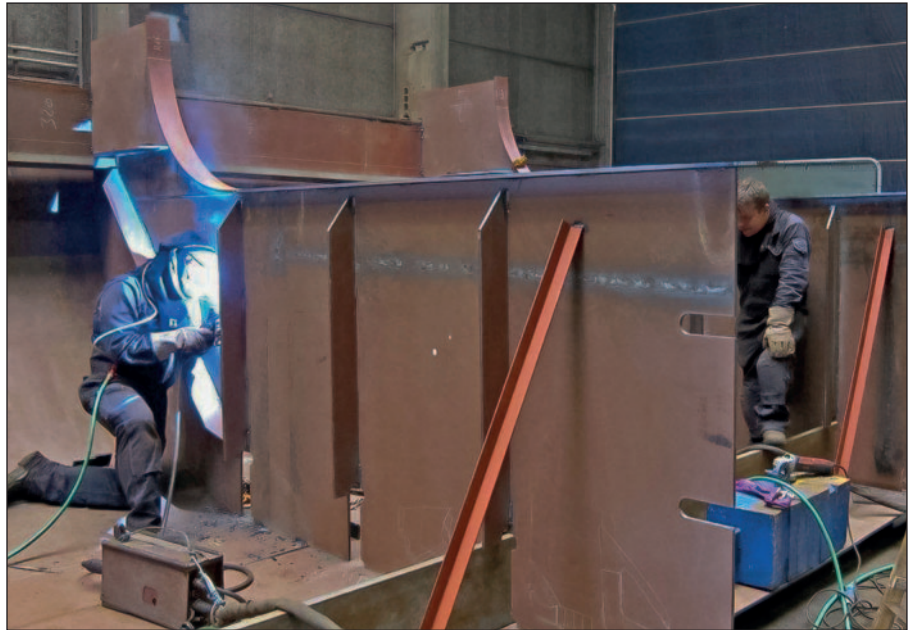
Fabrication of the section used to repair the 5 x 5-meter hole in the aft section of the hull of the bulk carrier Navios Sagittarius.

Using these measurements and the original drawings of the ship, the naval architects were then able to produce final drawings from which a section and a doubler plate could be fabricated and installed. As soon as fabrication of the section and the doubler plate was completed, preparation for installation began. In the case of the section, it was necessary to cut through the hull plates where the hull was distorted and broken. Divers proceeded to cut a hole in the hull about 5 x 5 meters in size. The prefabricated insert was lowered into the water and rigged into place with chain blocks. While work was going ahead with the section, another Hydrex team worked on the fabrication and installation of the 8 x 1.8 m doubler plate in the area of DBBT No. 1. A frame was fabricated and used for measurement and then the plate itself was cut, pre-shaped and attached.

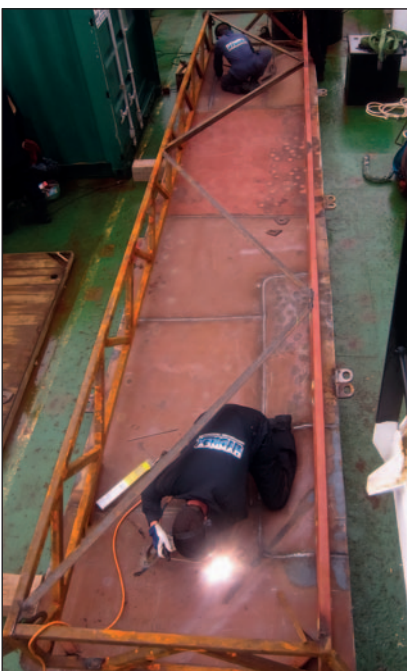
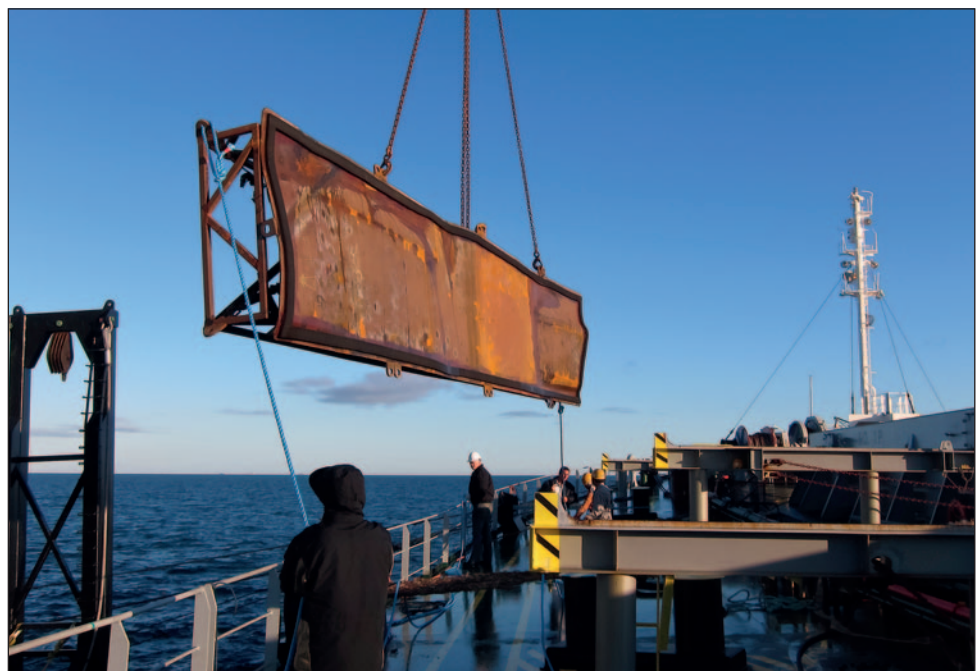
Preparing and lowering the doubler plate into the water so that it could be welded in place to repair the 8 x 1.8 m rip in the hull near the forepeak of the Navios Sagittarius.

Without accurate measurements and data, the naval architects could not produce drawings and plans which would make this repair possible. So, the first step for the Hydrex divers was to perform a detailed inspection of the two major areas of damage on a hull that was badly deformed, pierced, torn and indented.

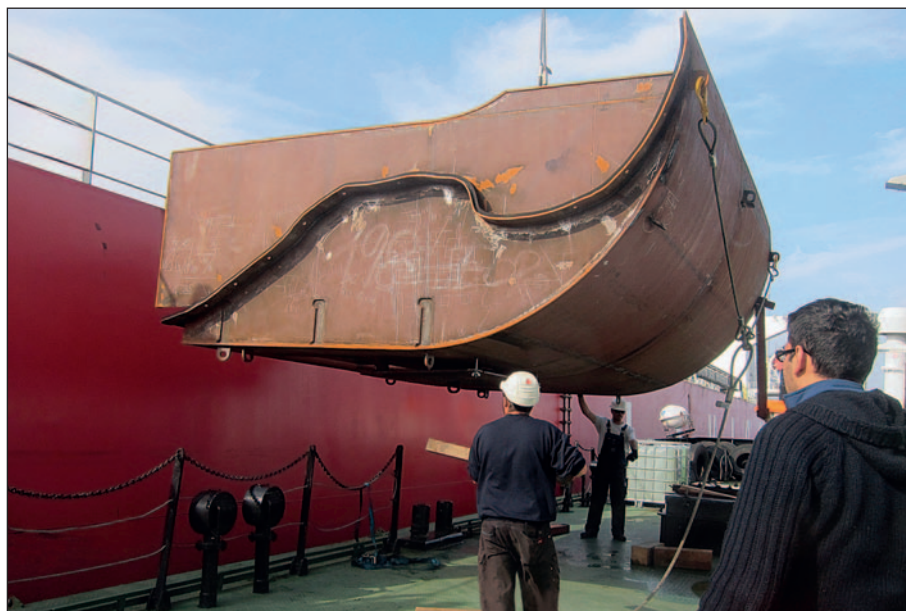
The finished section being lowered into the water in Denmark.

Speed was of the essence for this operation as the ship was on a long-term charter and each day it was out of service was costing tens of thousands of dollars. It was the first time ever that an entire hull section had been prefabricated and inserted into a ship's hull, cutting away the existing damaged plates, with the ship still afloat.

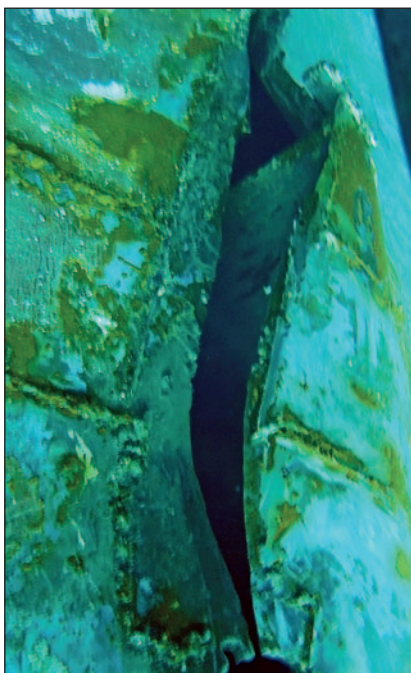
Almost back-to-back with the operation described above, we sent a nine-man diver/technician team to a 300-meter bulker's location, 21 miles off the coast of Fujairah, United Arab Emirates. The ship's shell plating was indented over a length of 150 meters after a grounding in the Suez Canal, and a large crack 1.5 meters long appeared, making it impossible for the vessel to sail any further. We were asked to close off the crack to allow the vessel to continue its route.

A crack of 1.5 meter appeared after the grounding of a 300-meter bulker, making it impossible for the vessel to continue its voyage.

To get a perfect assessment of the way the shell plating had been compressed, a special frame was made and secured over the damaged area. This allowed the diver/technician team to take exact measurements of the distorted plating. These measurements were then used to create a special cofferdam that would cover the crack and prevent it from growing further.

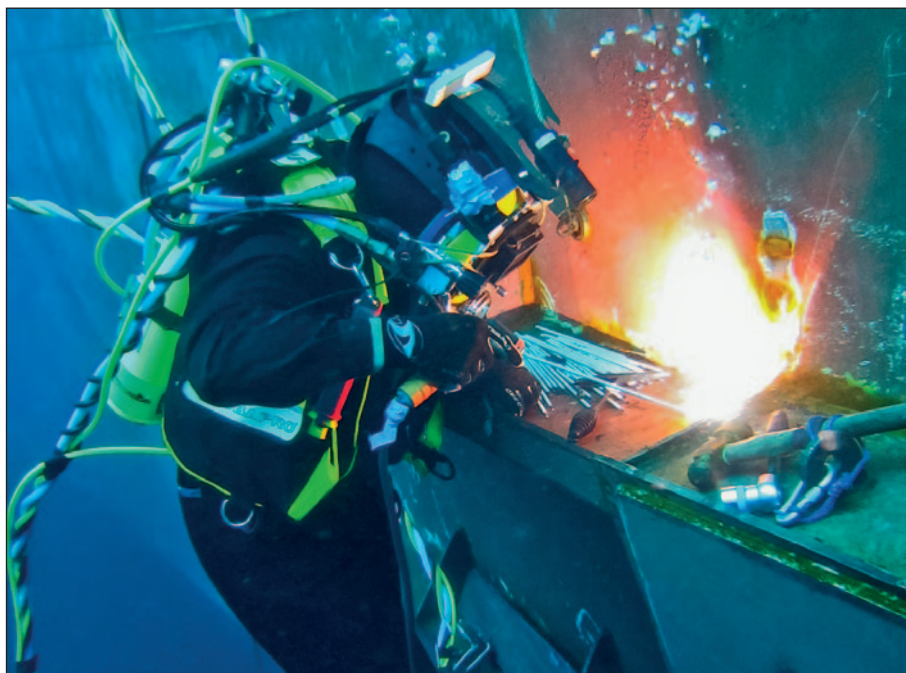
to 22 meters. Because such a water depth means shorter diving intervals, a large diving team was immediately mobilized to the vessel to allow the team to work continuously for the 12 hours that were available each day.

A rotating diver/technician team was mobilized to Fujairah to make sure that the operation could continue for 12 hours each day, despite the working depth of 22 meters.

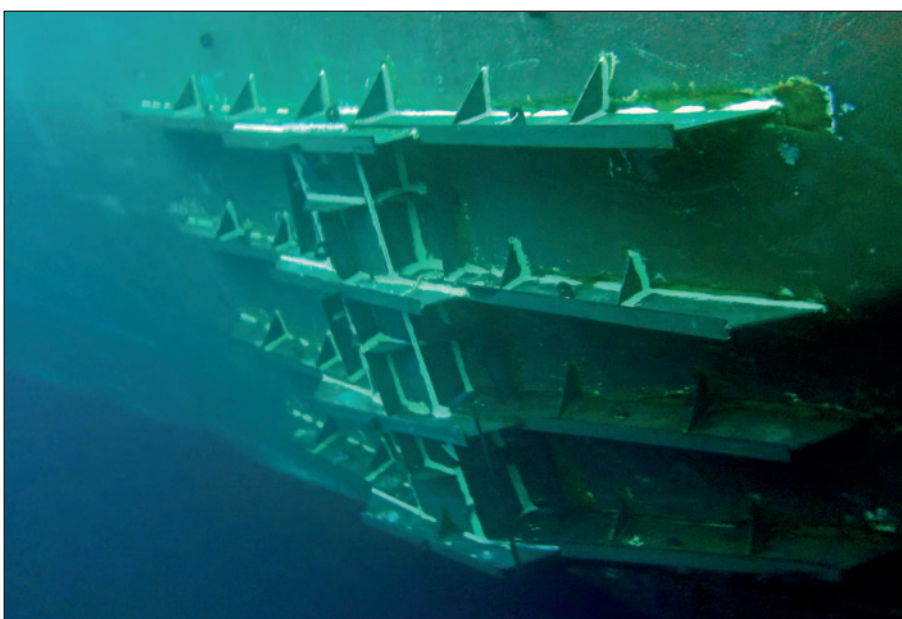
The cofferdam made it possible for the bulker to sail to China for unloading.

After the cofferdam had been positioned and secured, it was reinforced with longitudinal stiffeners and additional fortifications until it was strong enough to hold the water pressure. The tank behind the crack was then emptied, bringing the vessel back to its previous draft of 18 meters. In total the reinforcements covered an area of 18m² and the combined length of all the welds was over 500 m.

When the operation was finished, only a few reinforcements had to be added to the inside of the hull to prepare the ship for its journey to China.

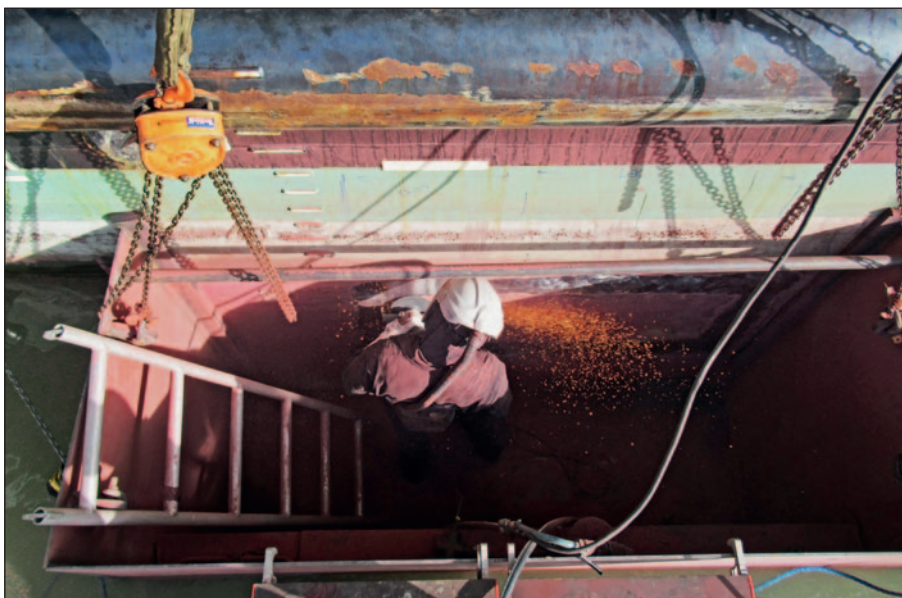
When the vertical side of the ferry *Texelstroom* was damaged during storm *Eunice* in 2022, a leak in the ballast water tank prevented the ship

Hydrex welder cutting away the old plating from inside the open-top cofferdam on the ferry Texelstroom.

The team then installed the open-top cofferdam over the damage and created a dry environment in which to work. They cut away the old plating and installed the new insert. Our men secured the insert with a certified weld both from inside the vessel and inside the cofferdam.

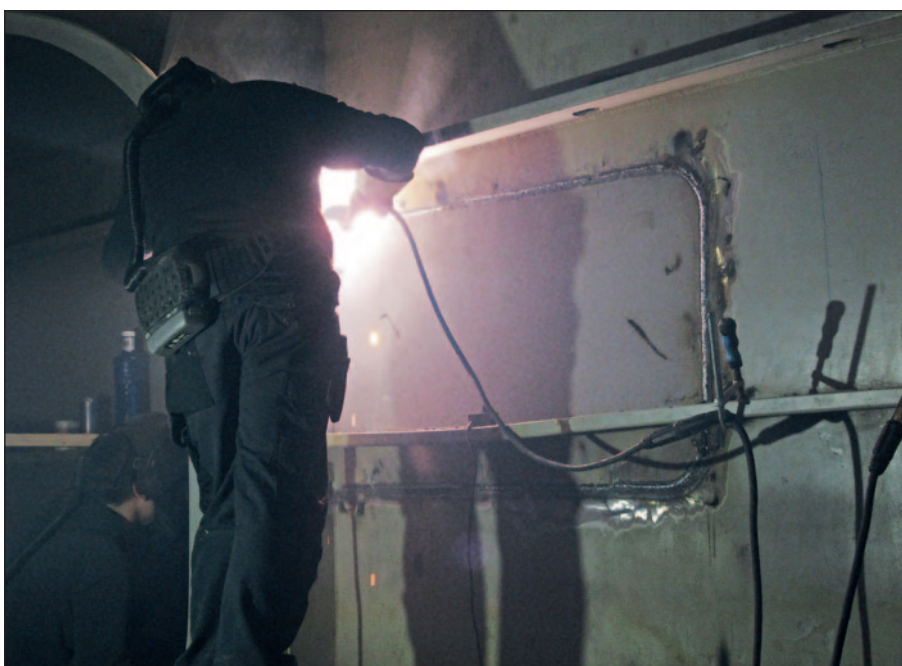
The insert on the ferry was welded by our certified welders.

agreed to install an insert repair measuring 1500mm x 700mm.

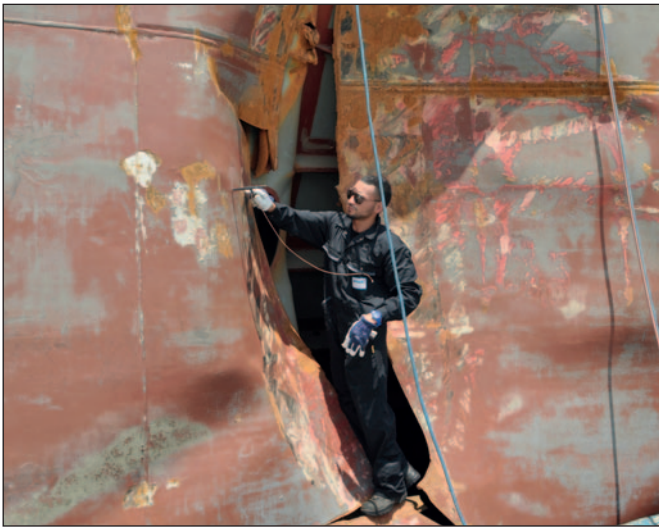
In 2013, a 190-meter bulker suffered severe collision damage in Lagos, Nigeria. A large hole in the hull plating prevented the ship from sailing at full speed. The classification society also demanded that the vessel go to drydock immediately unless an on-site solution was found. Hydrex therefore sent a diver/technician team to the vessel's location to carry out an emergency doubler plate repair at anchorage. This would give the owner the opportunity to take his ship to drydock when he wanted and where he wanted.

A full inspection of the damage on the bulker in Abidjan

At this new location the team cut away part of the deformed plating. This created an even surface to position the doubler plate. Next the team made crack arrests to make sure that the cracks would not spread any further.

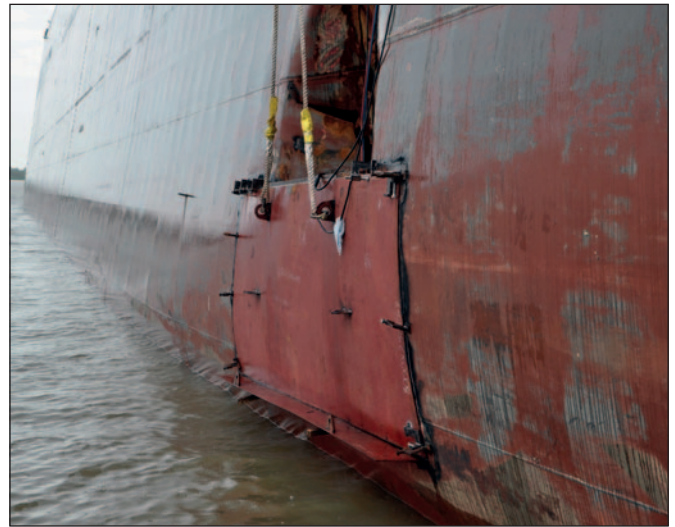
The doubler plate was fitted to the slightly rounded shape of the hull.

The bottom part of the doubler plate was then lowered from the deck and positioned over the lower half of the opening. This part of the plate was 4.5 meters wide and 2 meters high. The diver/technicians then welded the plate onto the hull. Horizontal stiffeners were then installed on

the plate to give it extra strength. This could not be done in advance because it would have prevented the team from adjusting the plate to the exact shape of the damaged hull.

The same procedure was repeated for the top part of the doubler plate. This part of the plate was trapezium-shaped with a width of 4.5 meters and a height of 2.5 meters. Both parts of the plate were then welded together to finalize the repair.

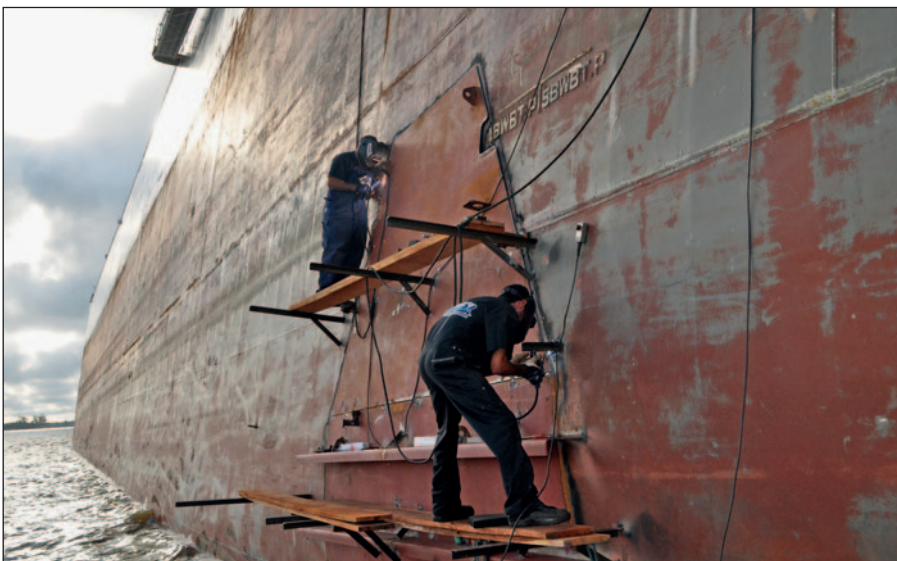
Hydrex certified welders securing doubler plate on bulker in Abidjan.

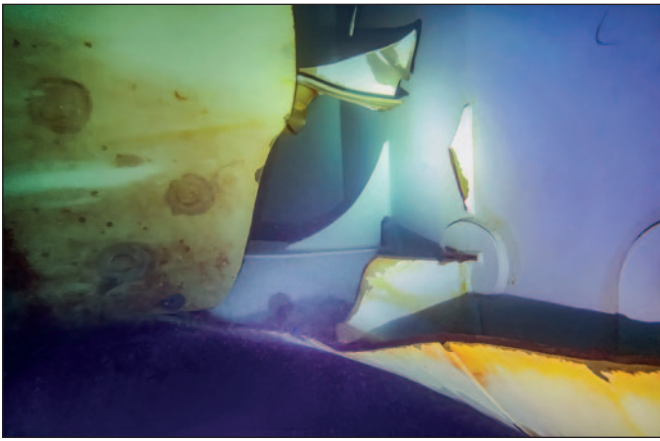
The pressure of the water was, however, too much for the structurally weak hull which started to cave in when the ballast tank began to be pumped out. It became clear that the ship had suffered too much internal damage to permit the water ballast tanks to be fully pumped out. This was not something that could have been predicted or remedied with the ship afloat.

Severe damage to the hull of a bulk carrier from the grounding in Suez.

Based on the initial inspection and rough measurements, a plan was proposed to carry out precise measurements of the hull where the large damage occurred so that a cofferdam could be designed which would then be installed to make the hull watertight so that the water ballast tanks could be pumped out.

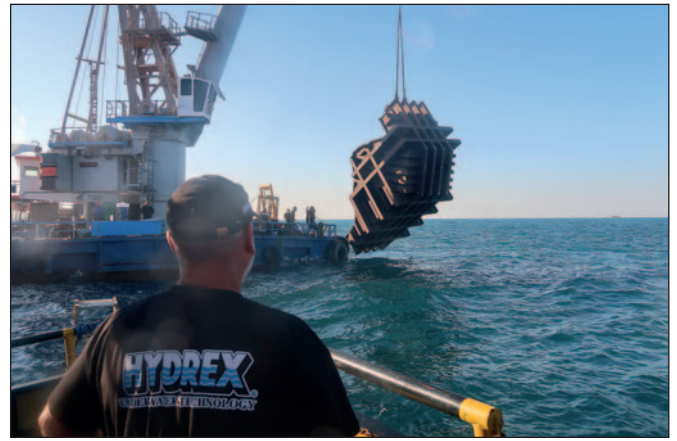
Crane barge moving the 45-ton cofferdam into position.

As soon as the fabrication was completed by a local workshop, we flew back to Suez. After some needed modification, the massive, 45-ton cofferdam was lowered into position by crane and secured against the hull.

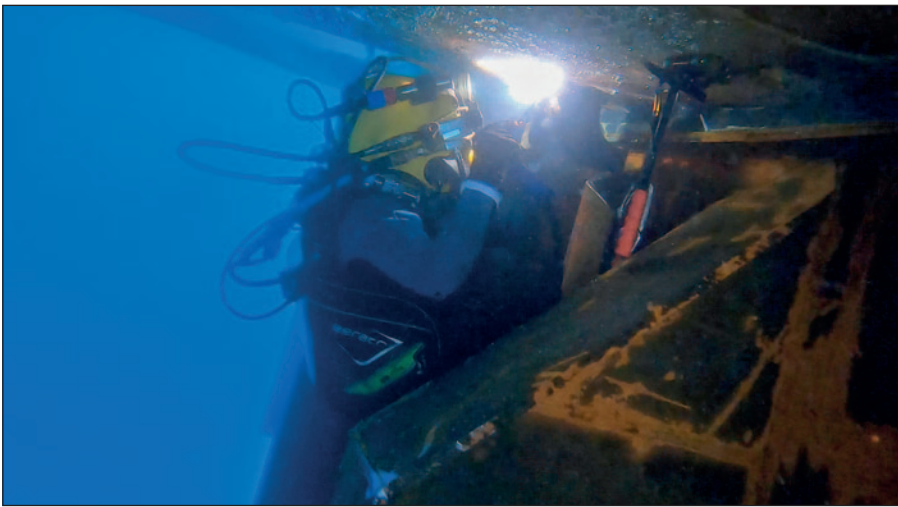
Welding the cofferdam in place.

In order to reinforce the bulkhead between the water ballast tanks, a new plan was proposed to build cement boxes and pour concrete to provide enough strength for these

bulkheads. But WBT 2 port could not be emptied. Part of the plan, therefore, was to lighten the ship as necessary until the class-required draft could be achieved.

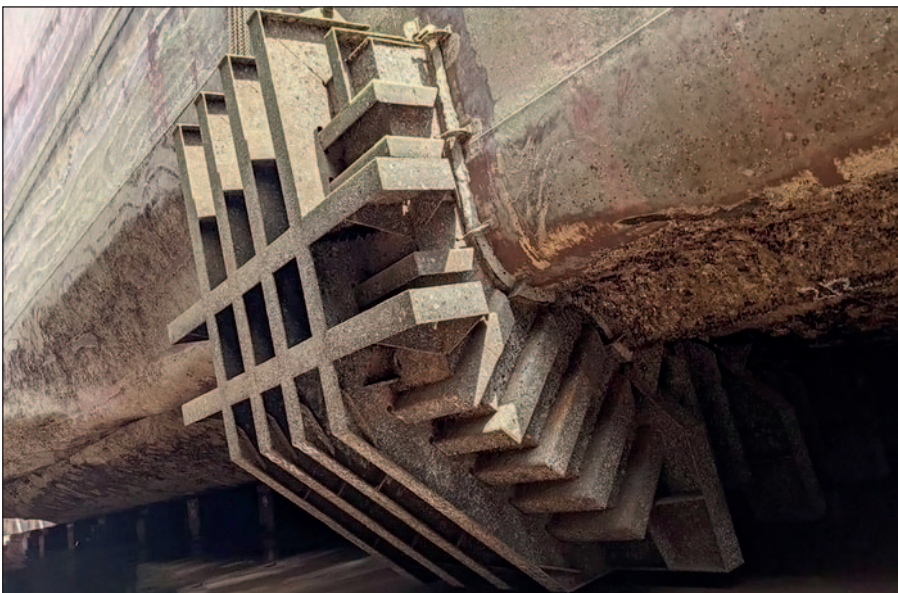
When the ship arrived in drydock, the sheer size of the cofferdam could be appreciated.

With the cement boxes in place, the cofferdam was fully secured, and successful sea trials were conducted. The cofferdam remained firmly in place until it could be removed when the ship was in drydock and permanent hull repairs could be carried out.

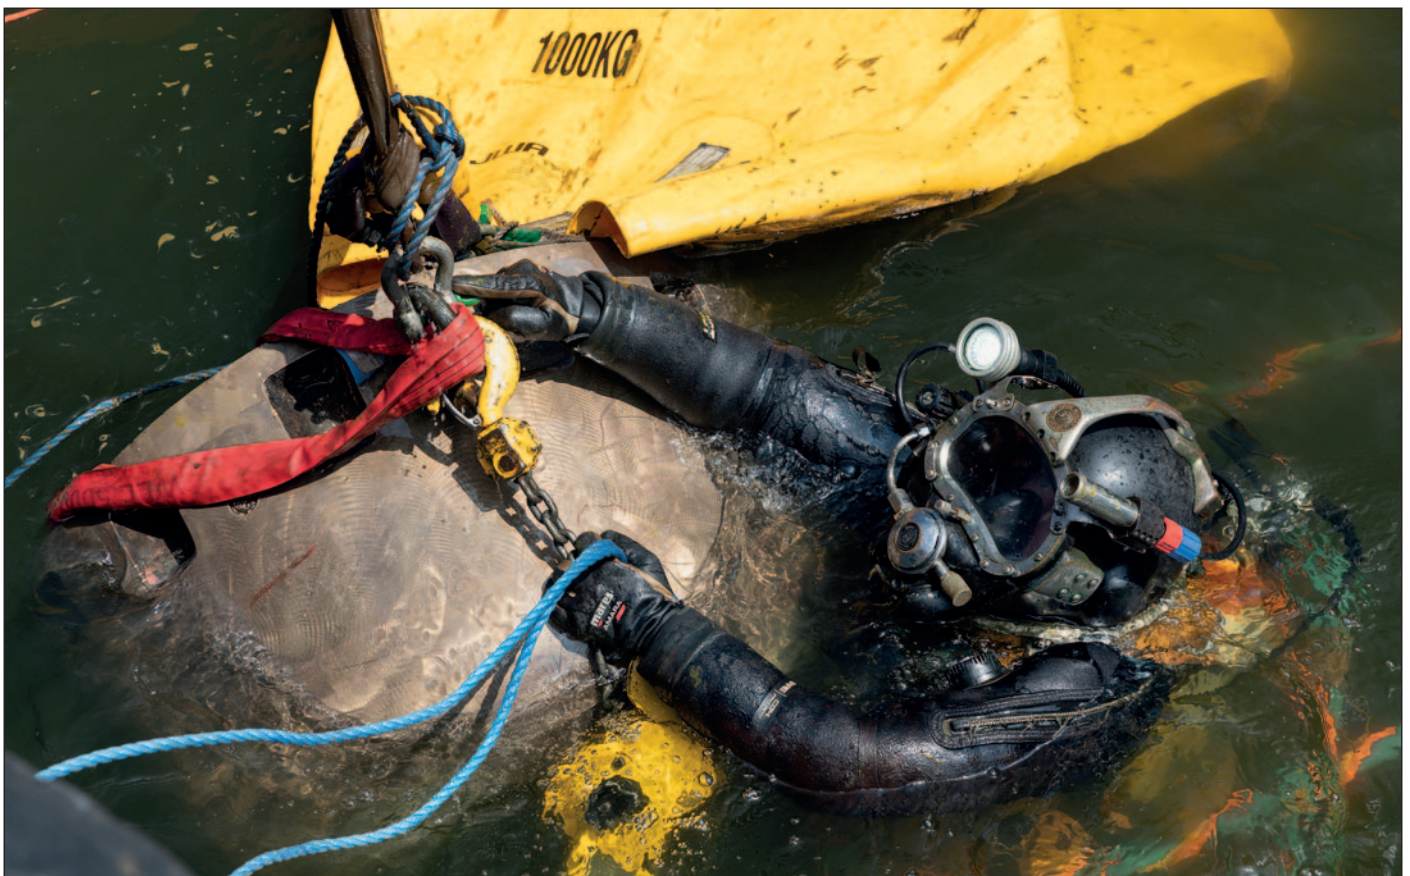
Hydrex diver during removal of the old propeller cap.

After a preliminary inspection, the divers remove the existing propeller cap and clean the flange where the device is to be installed. They then lower the new propeller cone into the water and position it on the propeller. The bolts are inserted with the correct torque and secured. Hydrex teams can work in shifts around the clock to finish the operation as quickly as possible.

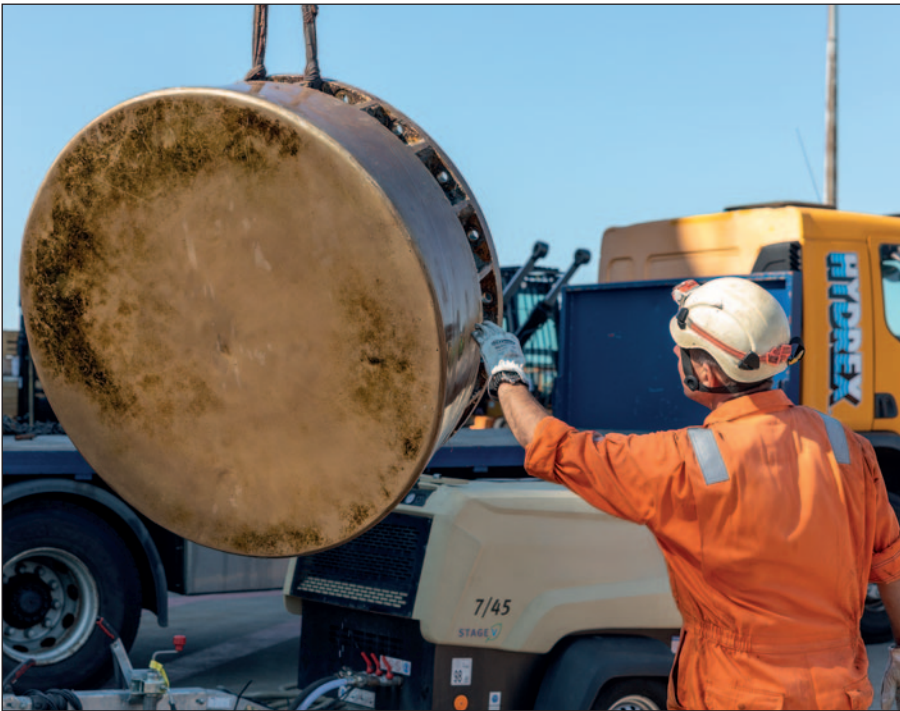
Old propeller cap lifted onto the quay side.
