| Permanent on-site pipe repairs around the world..... | 3 |
| Three out of drydock underwater propeller repairs across Europe..... | 8 |

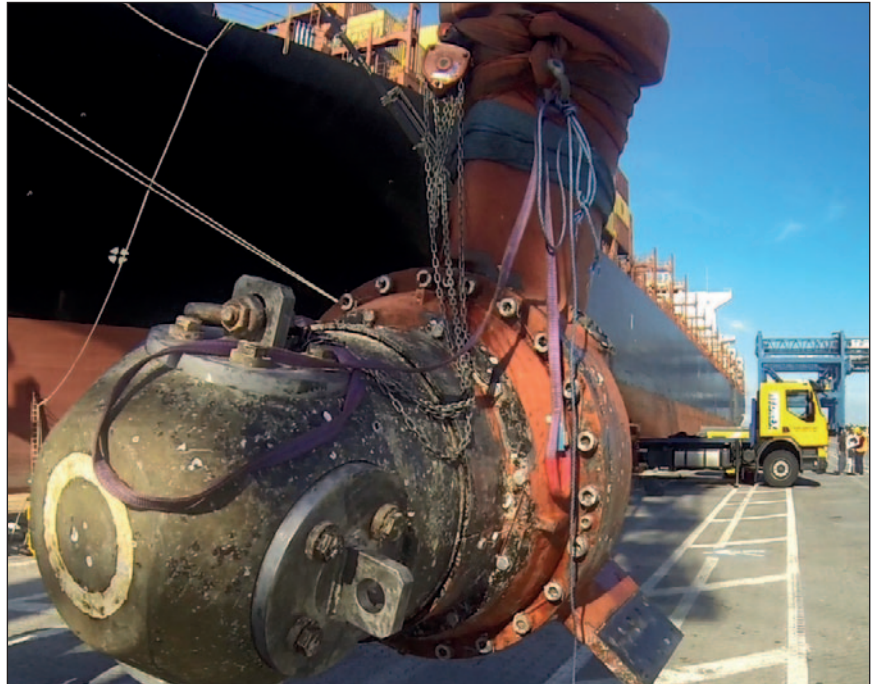
**O**ur lightweight flexible mobdocks are designed to be easily transported around the world and are used to close off the thruster tunnel on both sides, allowing divers to perform repairs and other operations in a dry environment around the bow thruster unit.

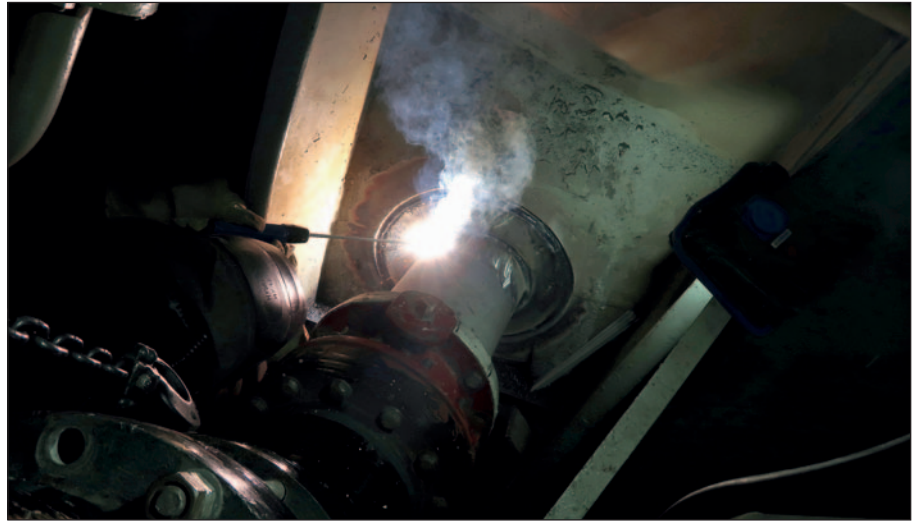
*Welding work on overboard pipe in Dunkirk.*

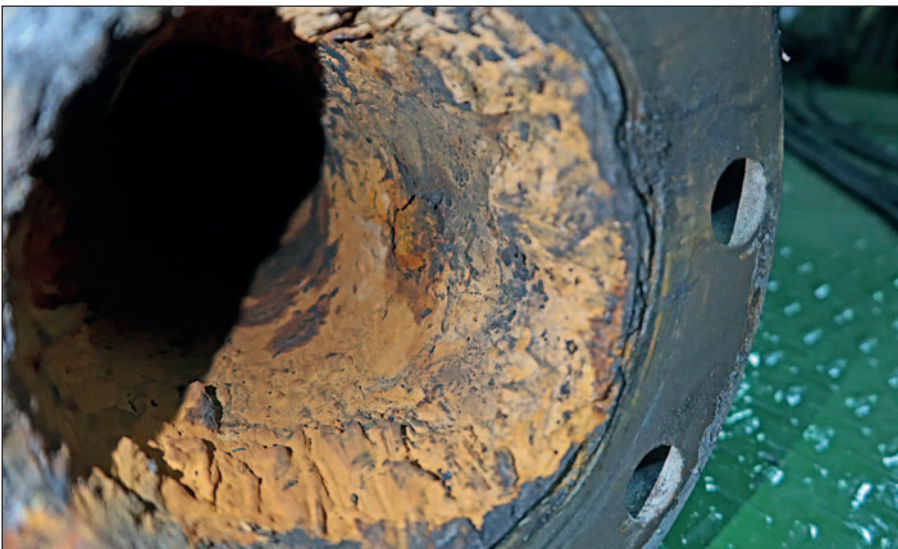
*Severely corroded discharge pipe on crude oil tanker in Rotterdam.*

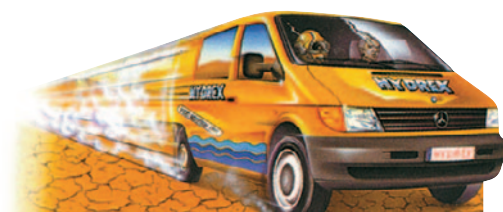
## Permanent in-water rudder repairs now possible without drydocking

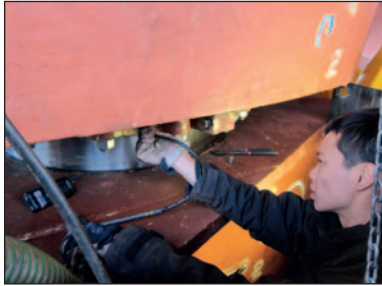
**H**ydrex has developed an entirely new method enabling permanent repairs of rudders without drydocking the ship. Permanent repairs were hitherto not possible and ships had to drydock in case a major defect was found. The newly designed equipment is light-weight and can be mobilized very rapidly in our special flight containers.

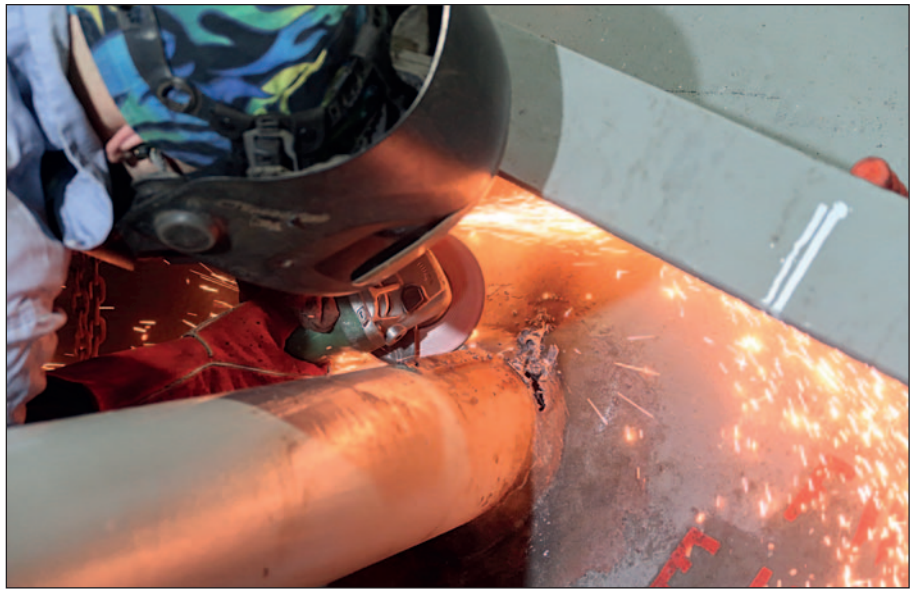
*Removing the damaged pipe.*

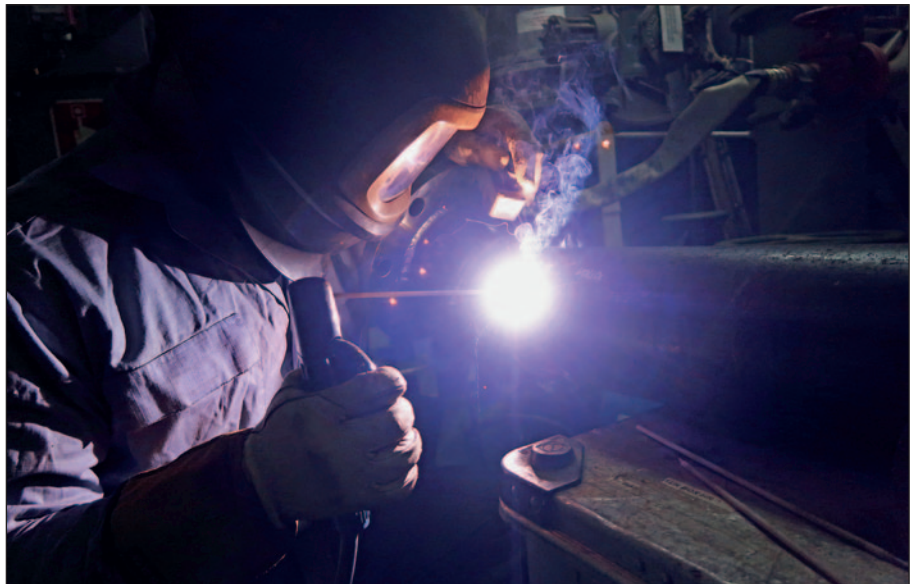
*Hydrex certified welder preparing the new discharge pipe for installation.*

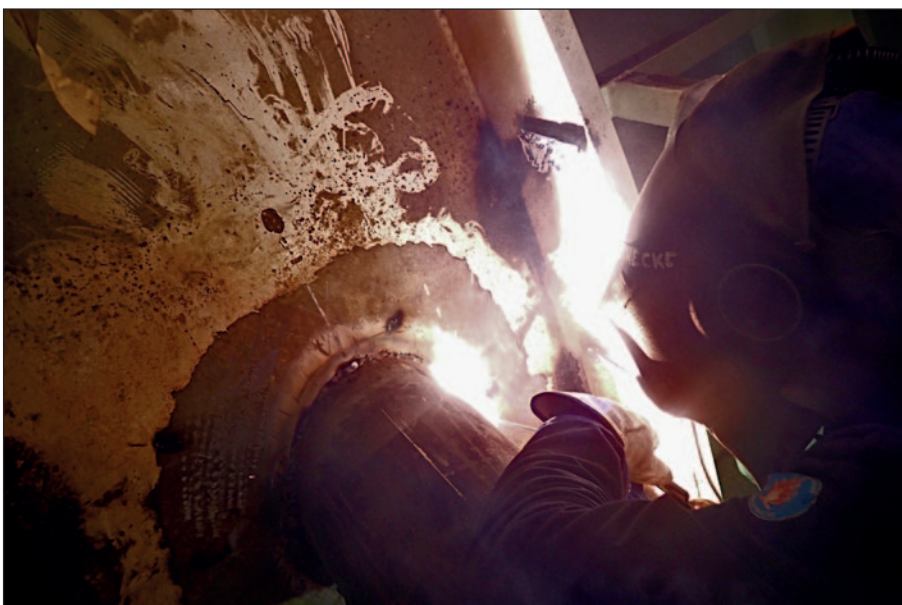
*Welding work on new scrubber overboard pipe in Jebel Ali.*

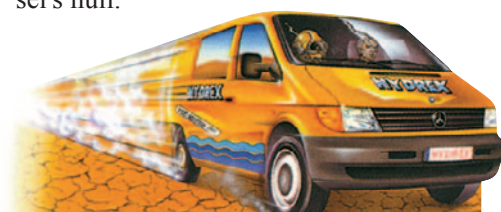
Following an onboard inspection, our team prepared a new pipe and flange assembly. The existing damaged components were removed, and the replacement was accurately positioned and welded into the vessel's hull.

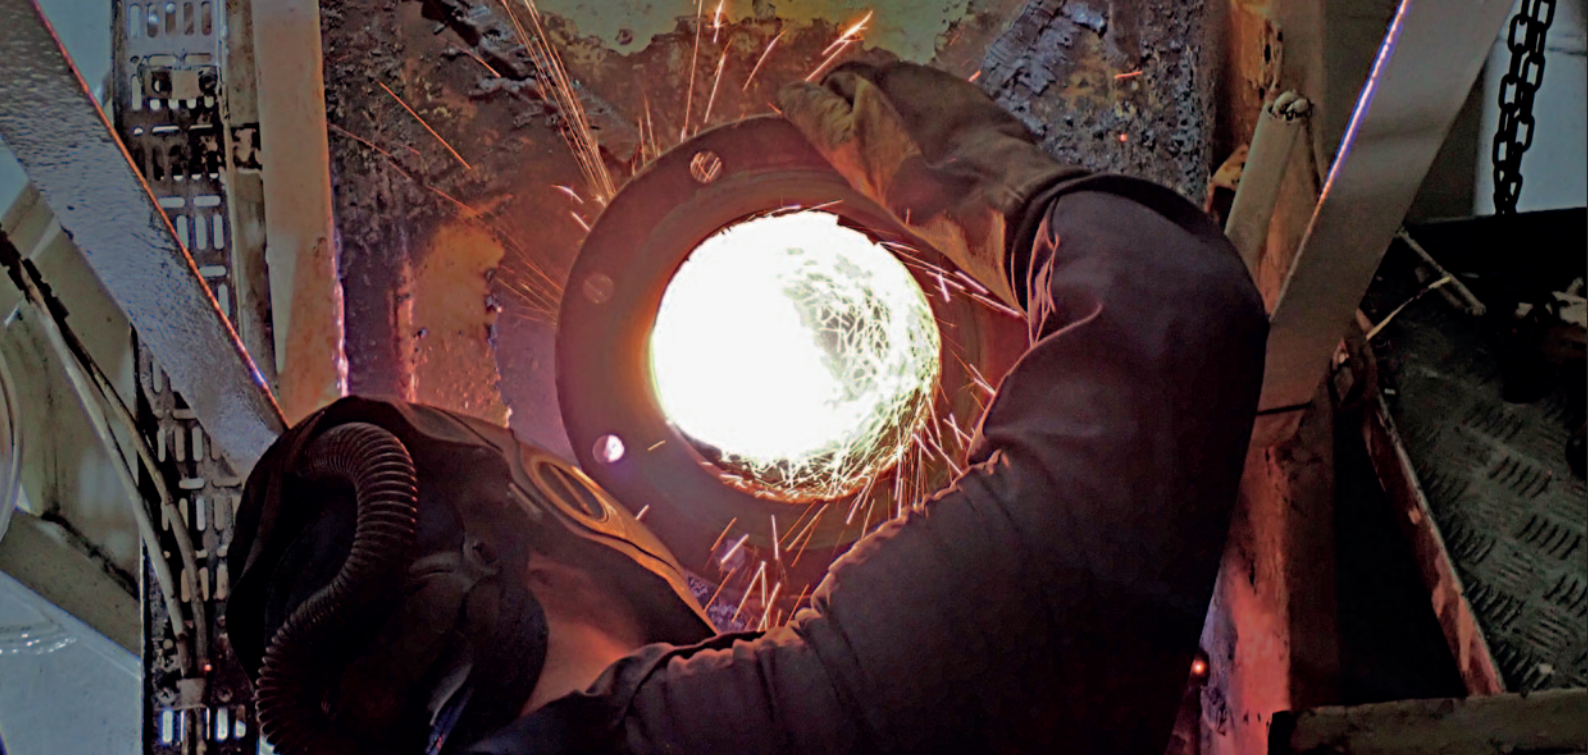
*Cutting away the old overboard pipe.*

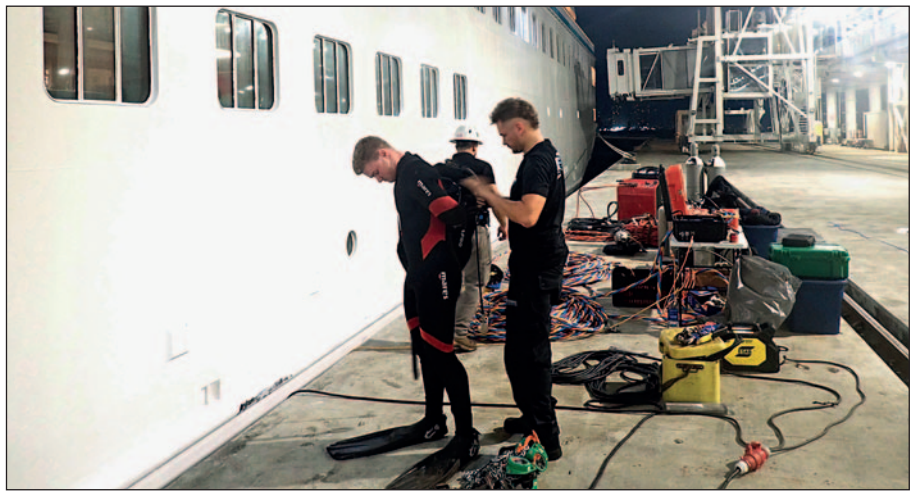
*Hydrex diver getting ready to dive in Panama.*

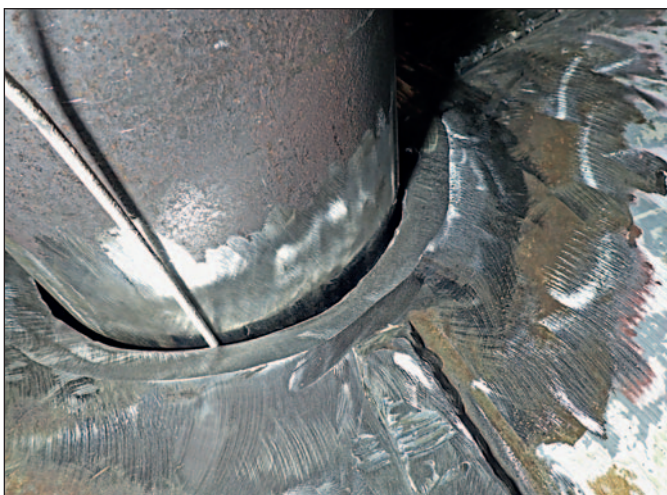
*The new pipe positioned and ready to be welded.*

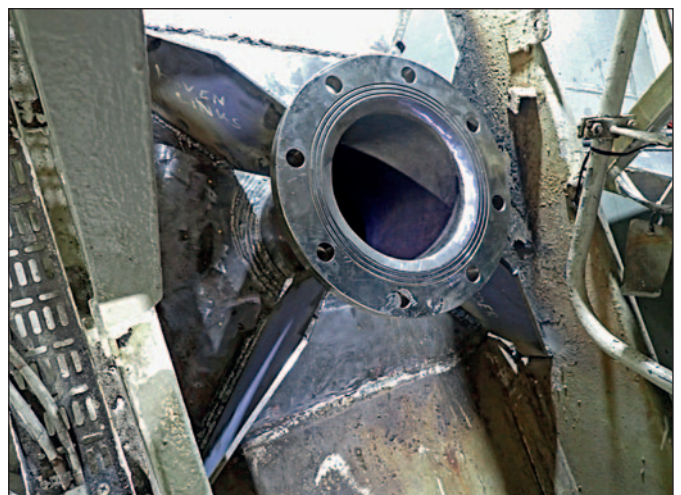
*New overboard pipe after reinstallation of the brackets.*

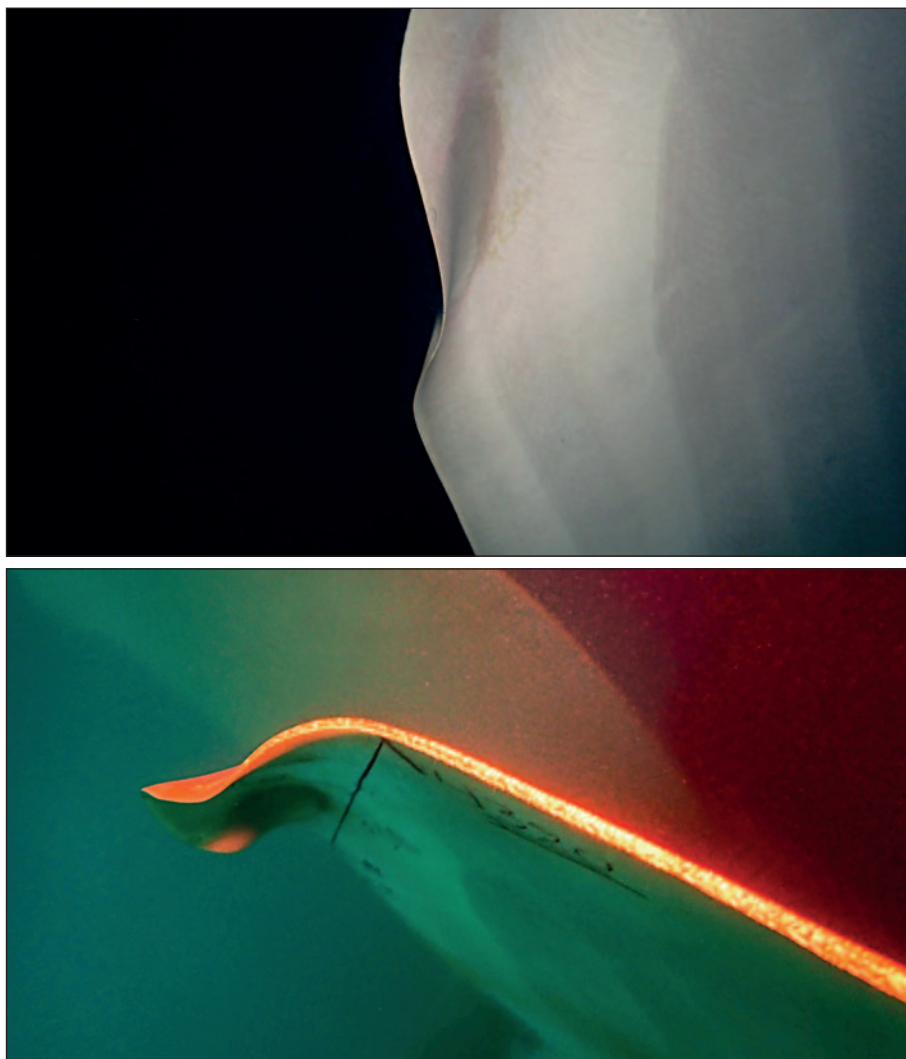
*Bent propeller blades on bulk carrier in Spain.*

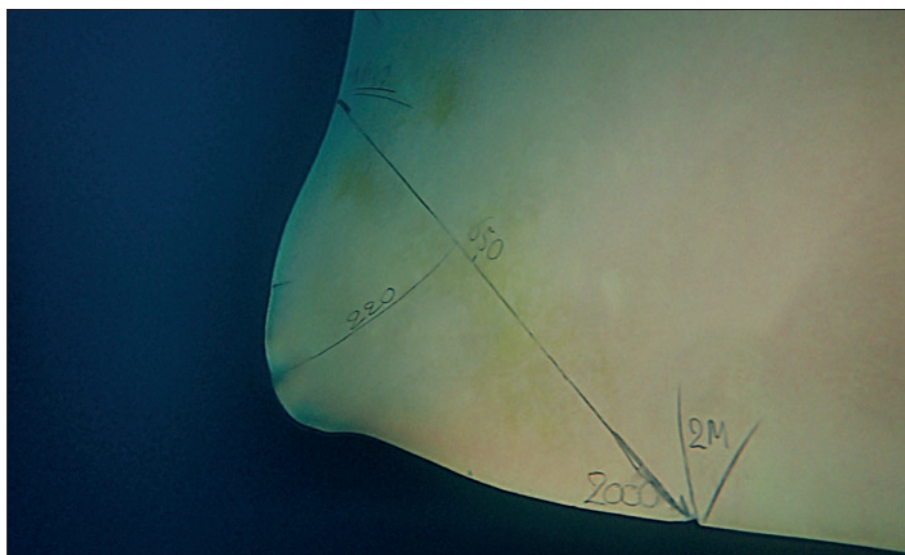
*Markings on propeller blade to indicate the exact location where the straightening needed to happen.*

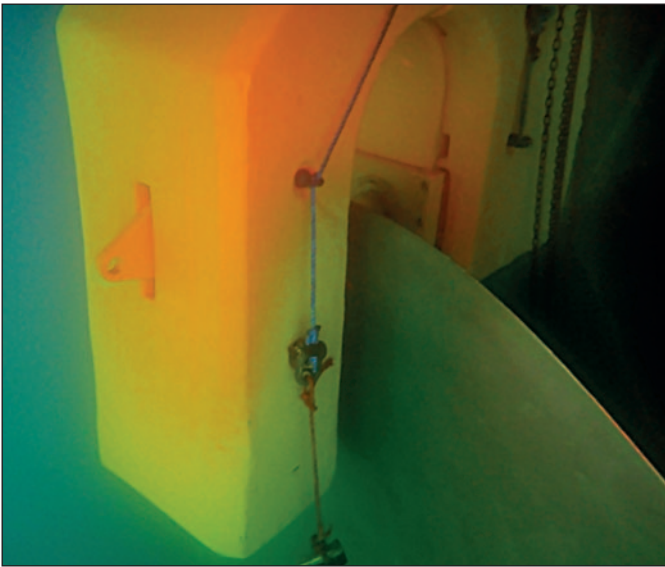
*Propeller cold straightening machine positioned over one of the bent blades.*

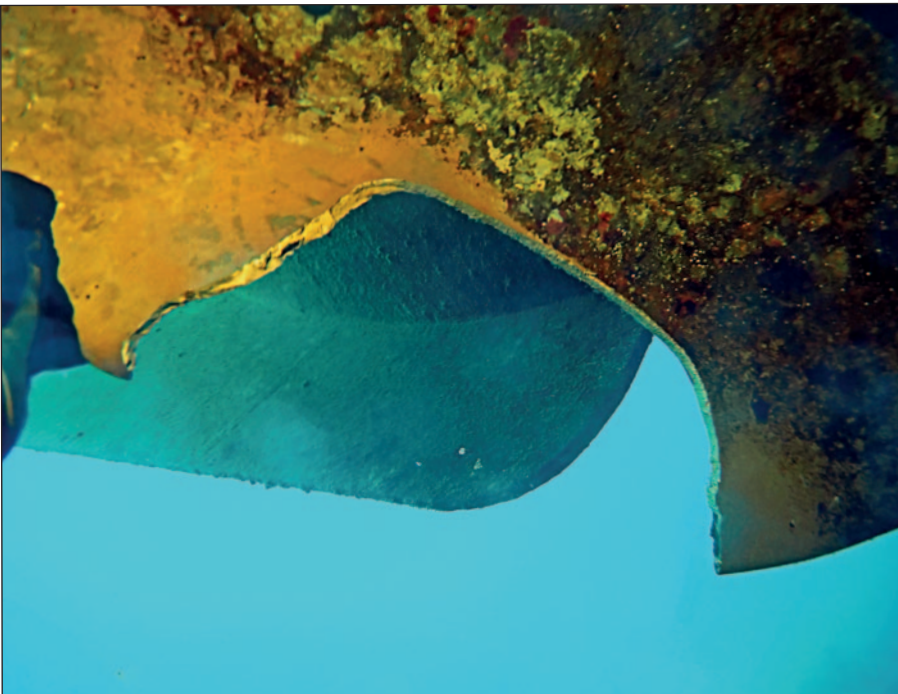
*One of the propeller blades of the cargo vessel in Portugal had lost a large chunk of its tip.*

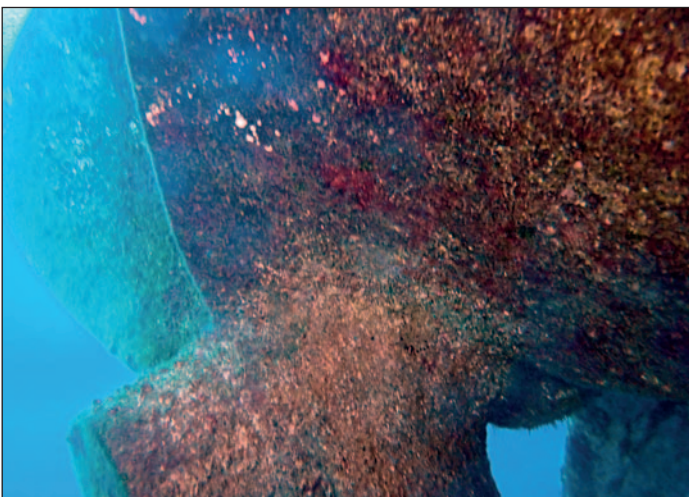
*Propeller of cargo vessel before*

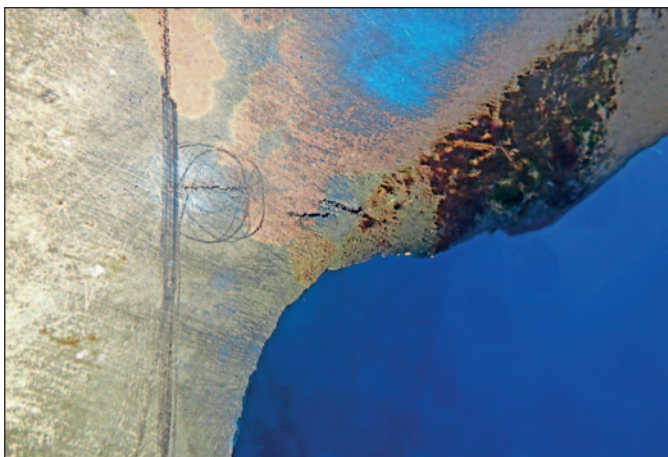
*Cracks next to the missing blade tip.*

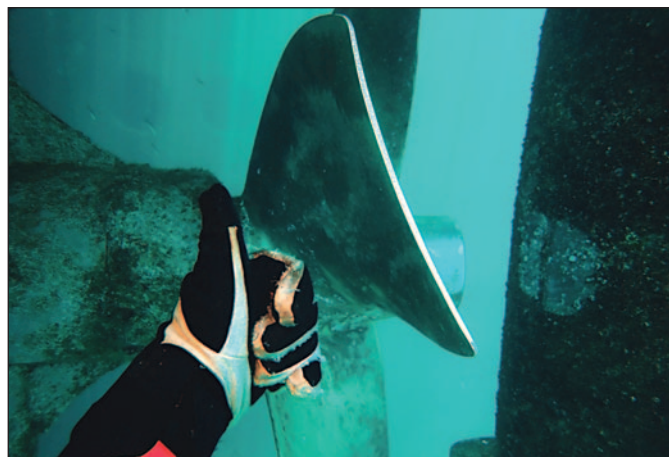
*Damaged blade after cropping.*

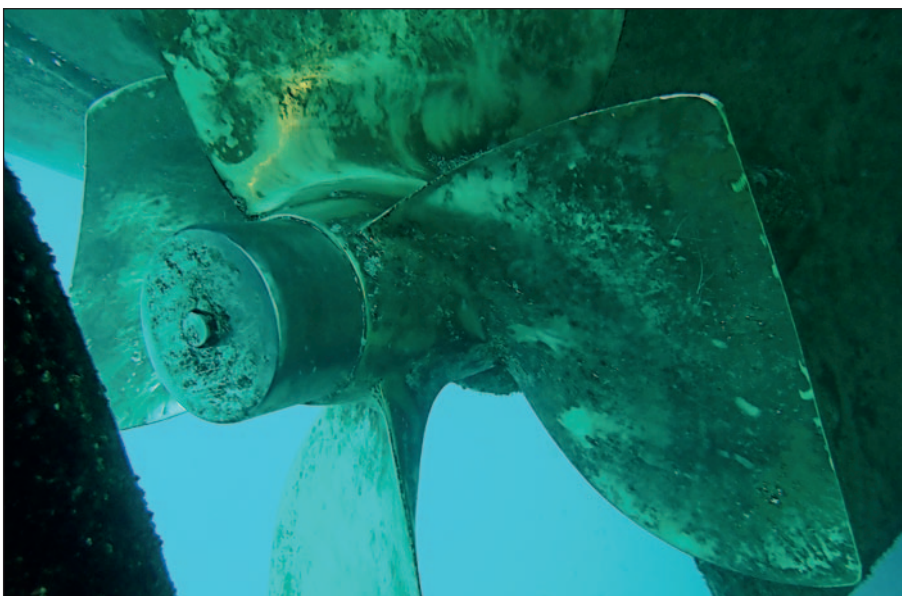
*The opposite blade was also cropped to keep the propeller's balance.*

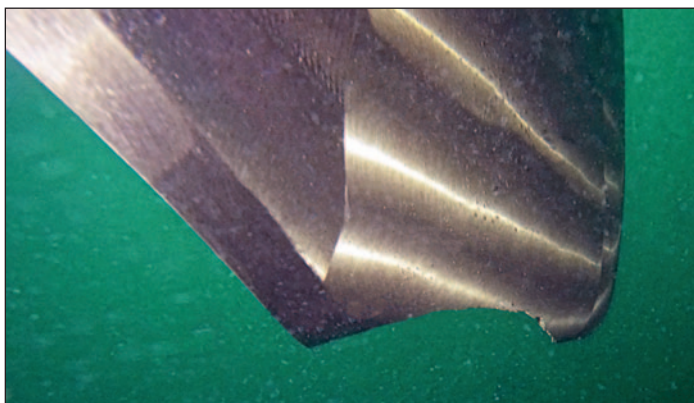
*Damaged propeller blade tip*

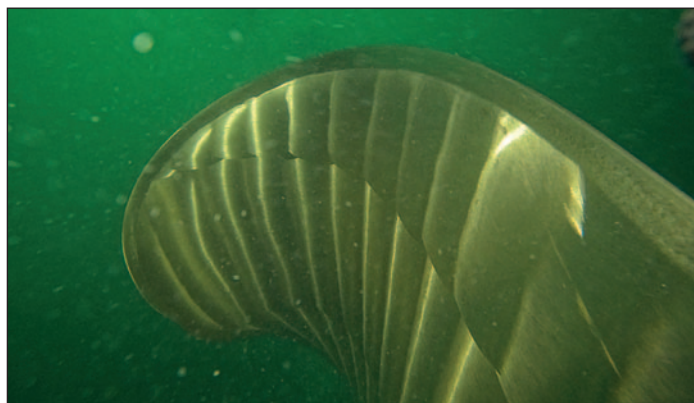
*...and bent blade on oil tanker in Denmark.*

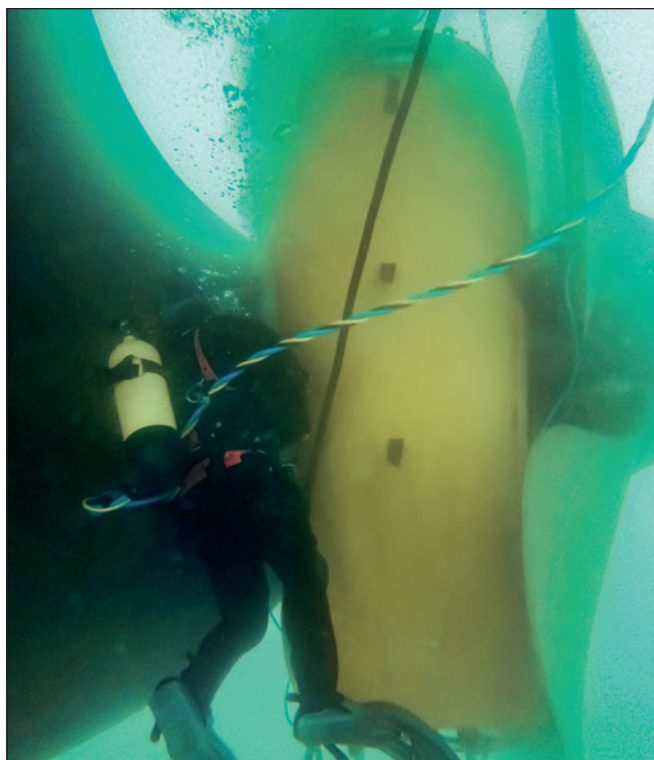
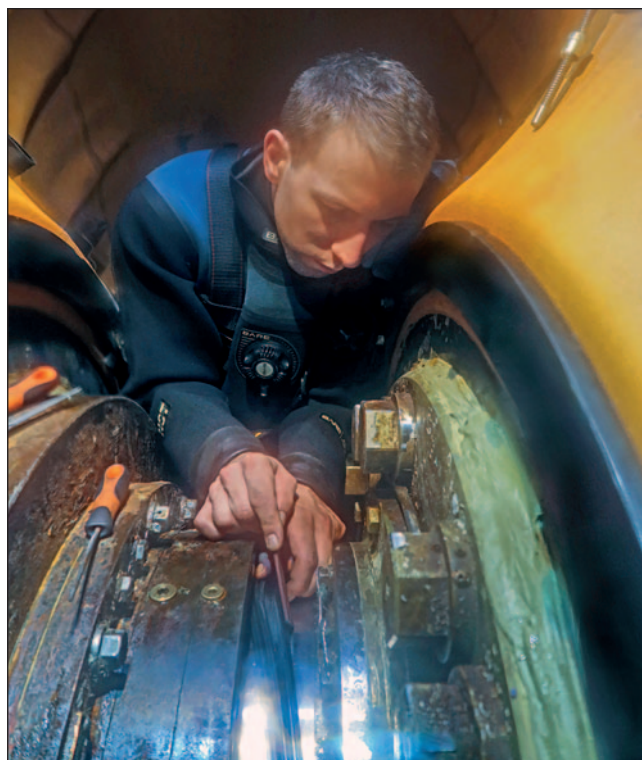
- Immediate response to minimize vessel downtime
- Accurate estimates with final invoices that match
- Typical stern tube seal repair/replacement by Hydrex:  
Two (2) days start to finish
- All major brands repaired/replaced
