SHIP AND OFFSHORE REPAIR JOURNAL

Underwater repair activities of Hydrex

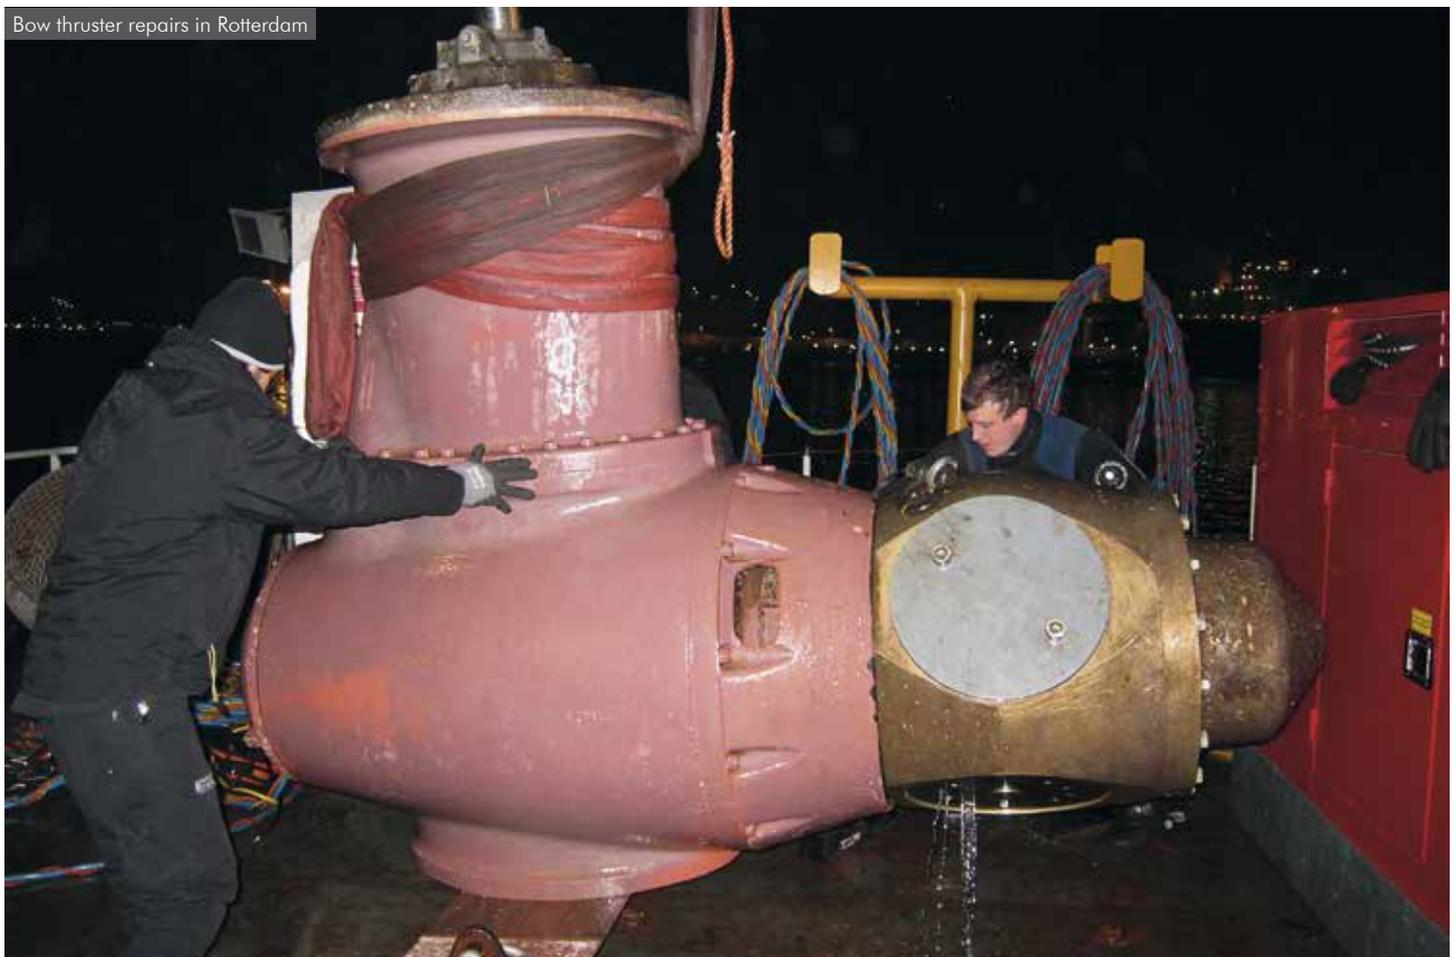
The stainless steel belt is installed around the perimeter of a thruster tunnel at the location of the thruster blades. There the impact of the cavitation caused by the movement of the blades is the most severe. Extra protection against cavitation damage is therefore essential. When the stainless steel belt in the thruster tunnel of the research vessel suffered cracks, the underlying steel was exposed to cavitation. The belt needed to be replaced as soon as possible to prevent the thruster tunnel from getting damaged too severely. The owner of the vessel would have had to take his vessel to drydock if

After a short trip the ship arrived in Port Gentil with the Hydrex team and all the equipment on board. A diving station was set up and the diver/technicians started the installation of the cofferdams. Next they emptied all water from the thruster tunnel. They then descended into the tunnel and carried out the repair. The old, damaged, belt was removed and replaced with a new stainless steel belt.

A tailor-made open-top cofferdam was designed by the Hydrex technical department. It was constructed in a local workshop in Pointe-Noire under the supervision of Hydrex diver/technicians. At the same time a regular shaped second cofferdam was also built. Cofferdams like these are used to close off the thruster tunnel on both sides. Water can then be drained from the tunnel, creating a dry working place. This allows the team members to descend into the tunnel through the open top. They can then carry out any necessary welding work in drydock-like conditions.

The actual operation was finished in only five days. The team removed the cofferdams and the ship was ready to continue its schedule with its thruster tunnel fully protected against cavitation once more.
