# ON SITE STERN SEAL REPAIRS

Around the world the Belgian specialist Hydrex has carried out repairs and replacements on all types of seals in-situ, and in most cases underwater, for a number of years

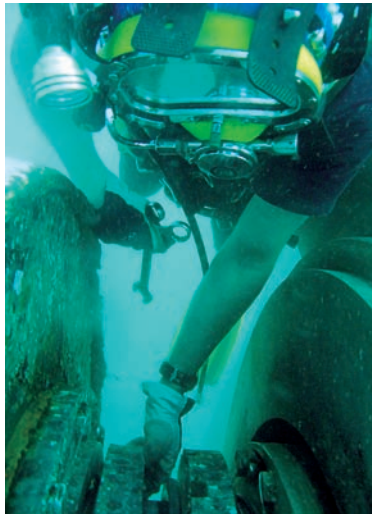
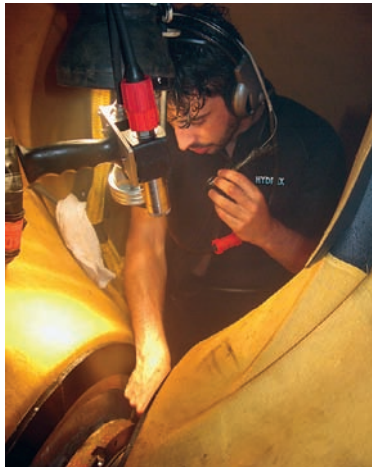
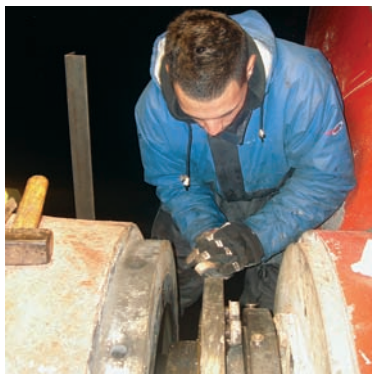
revealed that a fishing net had been caught in the assembly and was tangled up around the entirety of the seals. The flexible mobdock was then installed. This created a dry working environ-

ment for the divers at a depth of 12m in which they could replace the damaged seals.
