ON SITE STERN SEAL REPAIRS

Around the world the Belgian specialist Hydrex has carried out repairs and replacements on all types of seals in-situ, and in most cases underwater, for a number of years

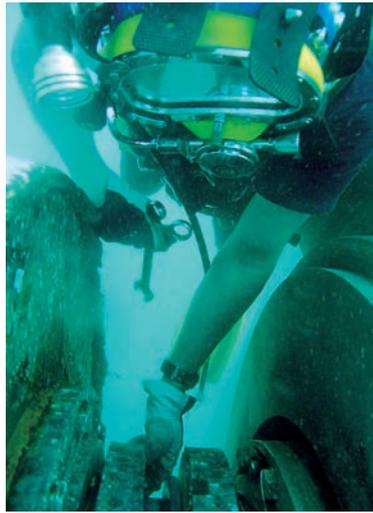
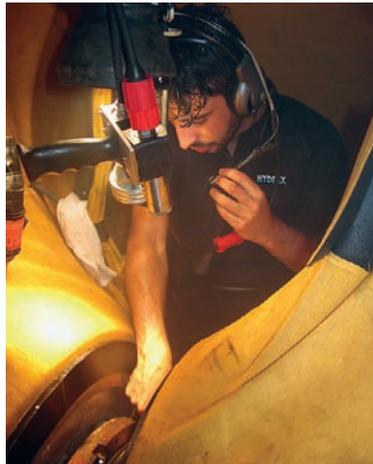
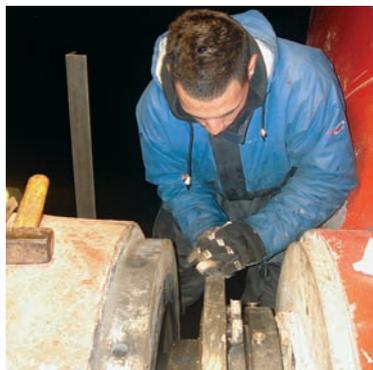
Still under severe sea conditions, the rope guard was removed and an inspection

revealed that a fishing net had been caught in the assembly and was tangled up around the entirety of the seals. The flexible mobdock was then installed. This created a dry working environment for the divers at a depth of 12m in which they could replace the damaged seals.
