DRYDOCK

Underwater tanker repairs

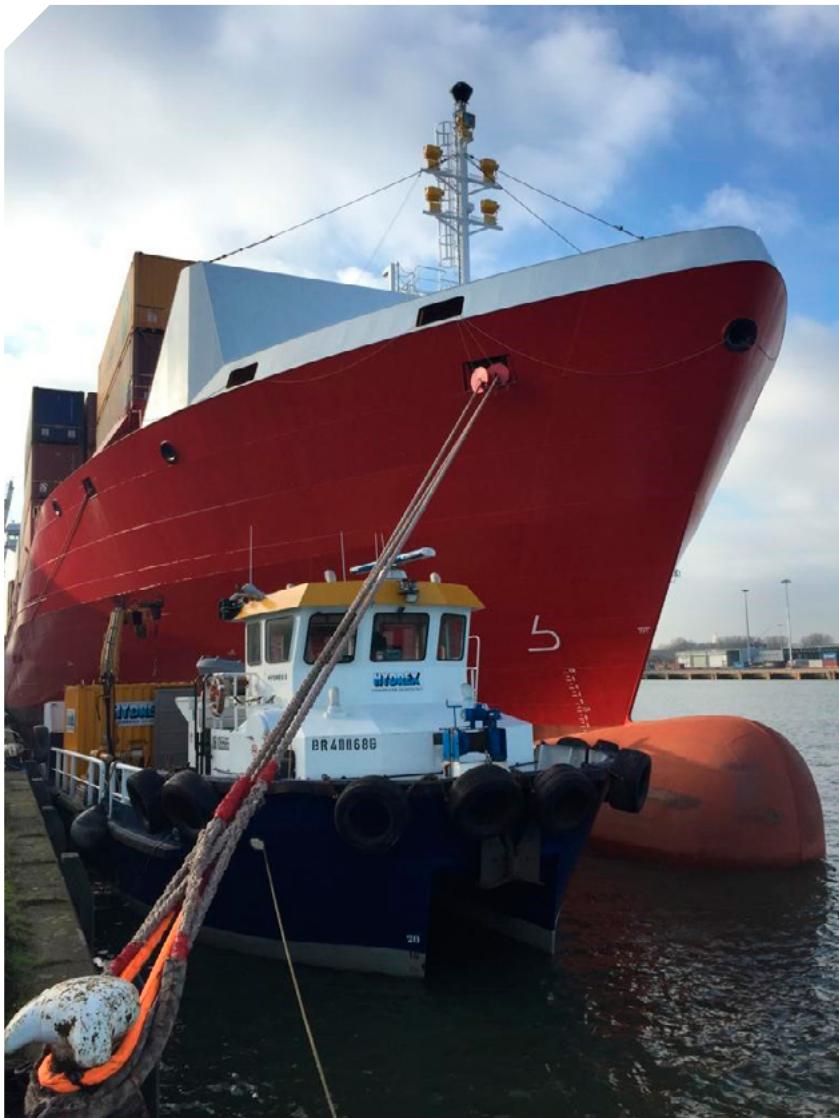
Above: Hydrex recently removed a bow thruster from a 170m containership during a stop in Rotterdam

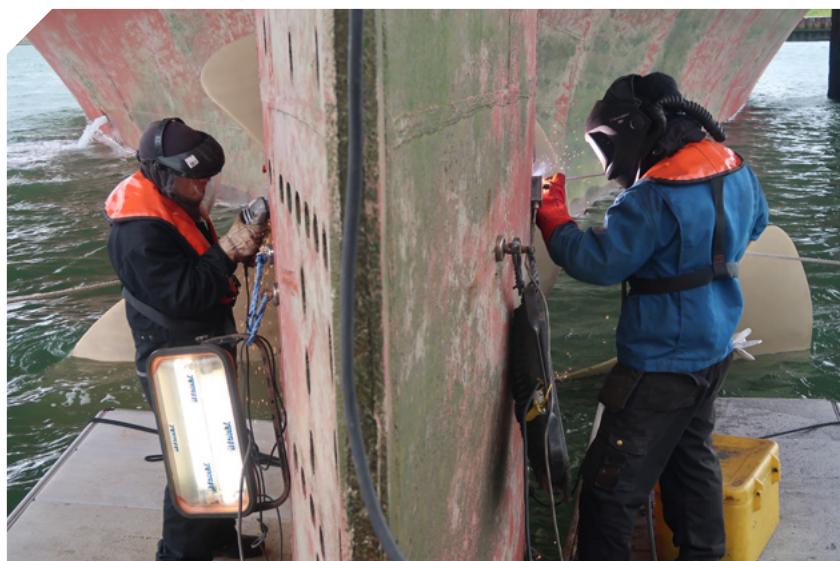
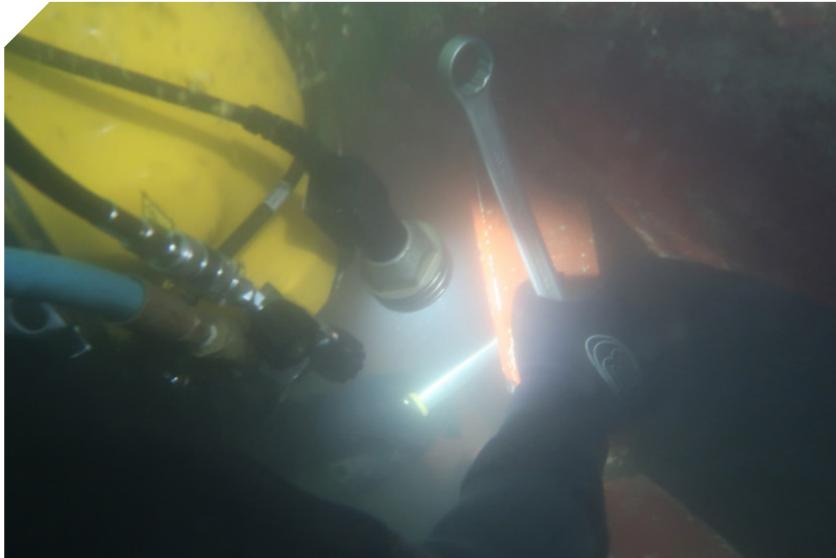
Right: Hydrex carried out several repairs on a 165m tanker, including work on the rudder, bilge keels and bow thruster grids

Rudder cracks and thruster grid bolts

Upon arrival the men split up into two teams. One team performed an underwater inspection of the bow thrusters, while the other technicians started working on the rudder. A previous inspection had revealed cracks in the rudder's lower pintle area. The vessel was able to be trimmed enough to bring the damaged area of the rudder above water. This allowed Hydrex to access the cracks using a pontoon.

Two thruster grid bolts were found to be missing during the inspection of the thruster tunnel and 10 other bolts were found to have come loose. Hydrex diver/

After reinstalling the bolts, this team started the last part of the operation. The bilge keels on both port and starboard sides of the ship had suffered several cracks. A total of nine sections needed to be cropped or removed underwater by diver/technicians.

The team worked on both sides of the rudder at the same time, following the same procedure. First they used a dye penetrant test to discover the crack ends. Crack arrests were then drilled to prevent further spreading. Diver/technicians then ground out the cracks over their entire length and then the cracks were filled with the company's class-approved full penetration welding.

To finalise the repair, the corners of the lower pintle were re-shaped with a larger radius, as was advised by the attending class representative.

technicians reinstalled the missing bolts and secured the others.

On the starboard side, three sections were cropped over a length of 2,600mm, while one section was removed completely. On the port side, four sections needed to be cropped over a length between 2,100mm and 2,600mm. One section was removed completely.
