Afloat rudder repairs	3
Rudder cover crack repair in Rotterdam	6
The solution to scrubber corrosion	8

# **Contents**

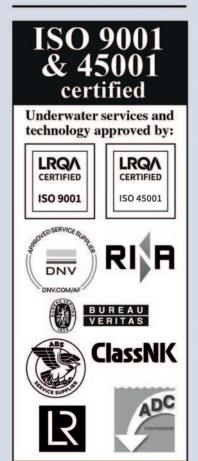
# Start saving fuel with your propeller cone fin now

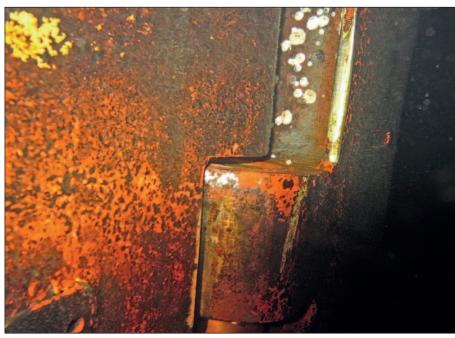
The top hinge of the rudder flap had come loose.

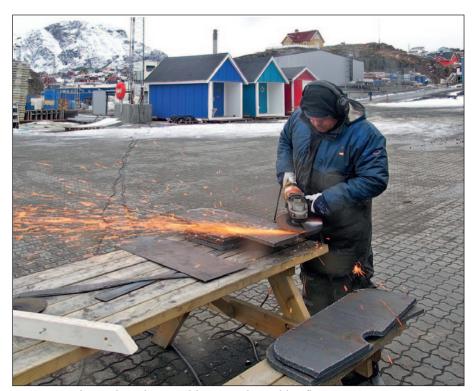
Preparing the girders that would secure the rudder flap.

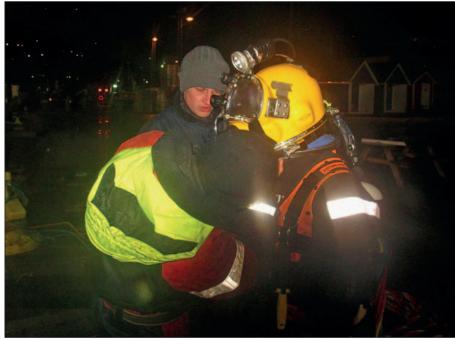
Hydrex diver getting ready for underwater repair.

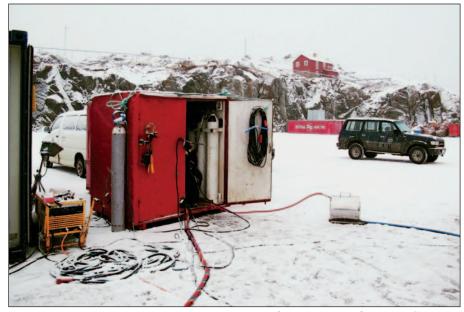
Monitoring station in polar winter conditions in Sisimiut.

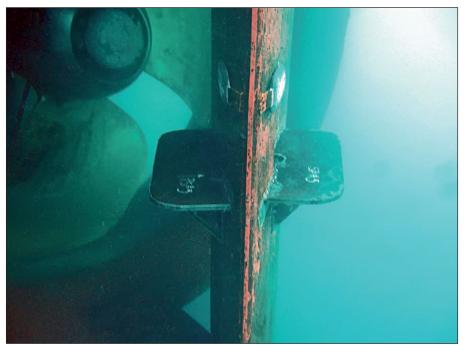
Three stiffeners were installed on each side of the rudder.

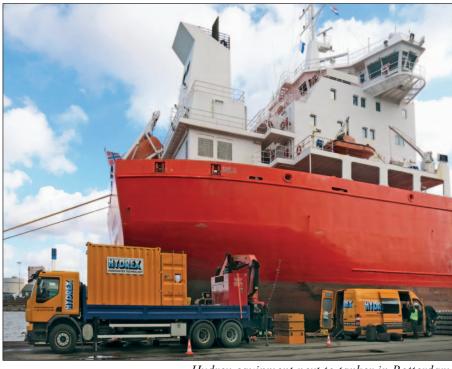
Hydrex equipment next to tanker in Rotterdam.

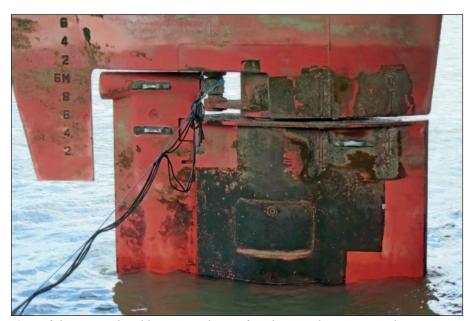
One of the original rudder cover plates after the vessel was trimmed.

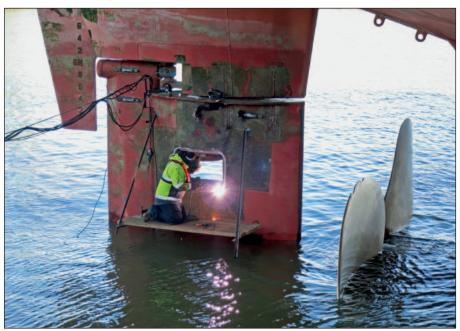
Preparing the rudder for installation of the new cover plates.

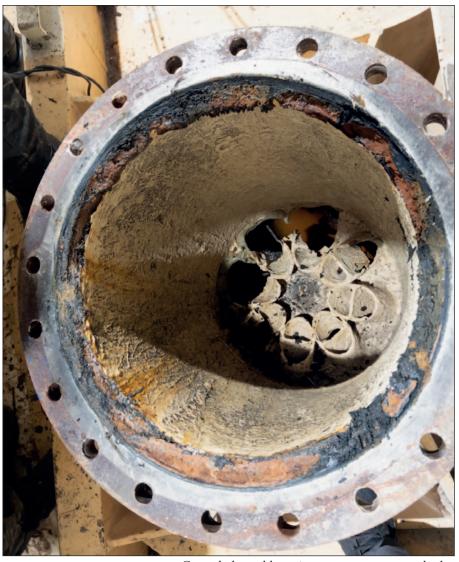
Corroded scrubber pipes can cause severe leaks.

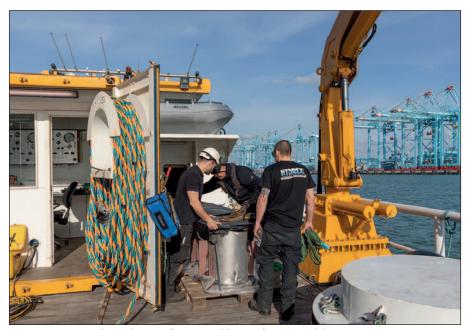
Preparation on board one of our workboats for a scrubber pipe operation.

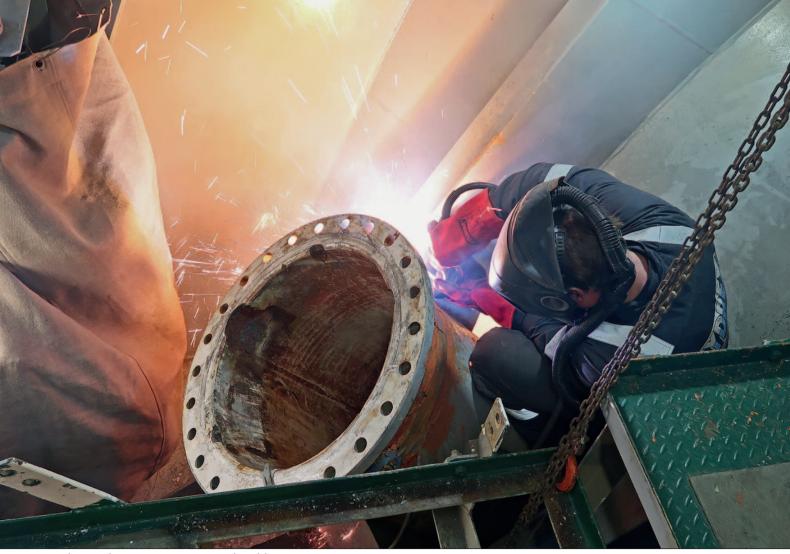
Hydrex technician cutting away the old pipe.

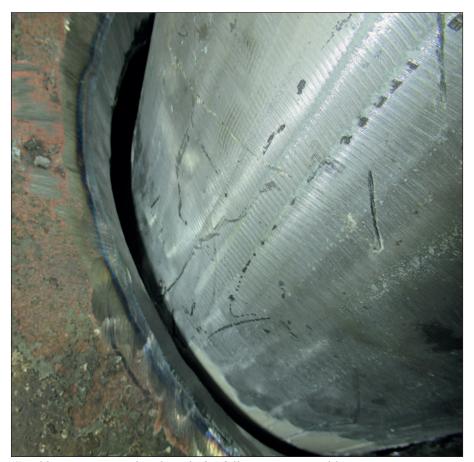
Scrubber pipe secured and ready for full penetration weld.

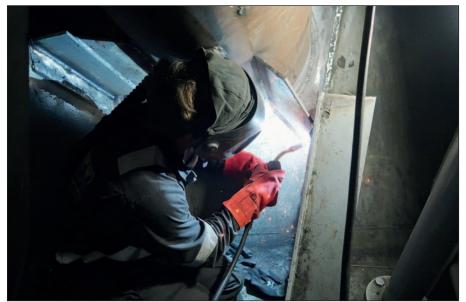
The frame and brackets are cut through to make way for the new pipe.

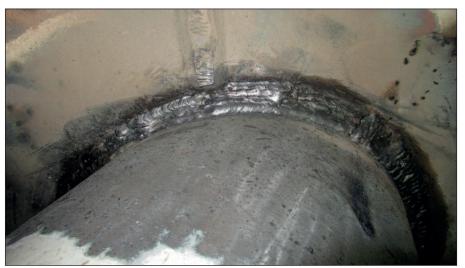
New scrubber pipe after welding.

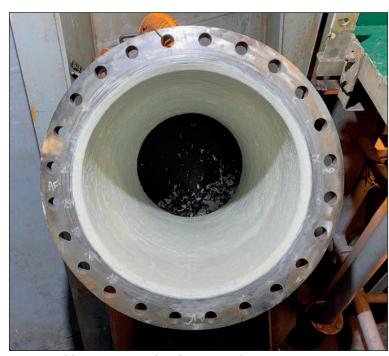
New scrubber pipe coated with Ecospeed.

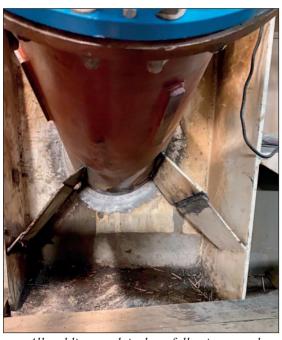
All welding work is done following our class approved procedures.

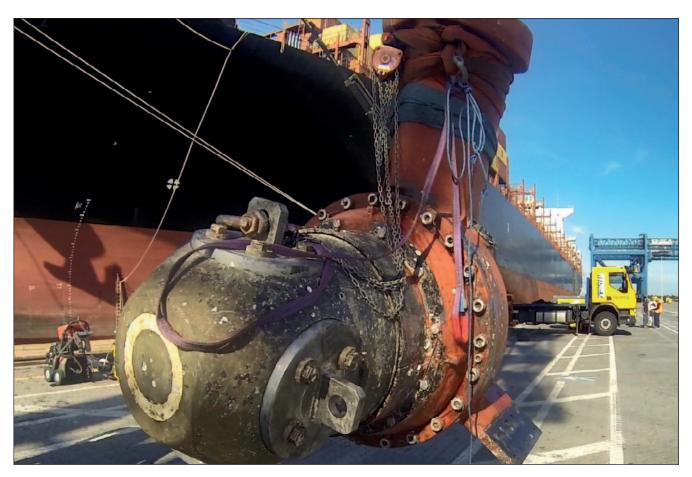
Our lightweight flexible mobdocks are designed to be easily transported around the world and are used to close off the thruster tunnel on both sides, allowing divers to perform repairs and other operations in a dry environment around the bow thruster unit.
