# Shipping World & Shipbuilder

# Fixing seals on-the-go

**ON SITE REPAIRS OF SEALS MEAN OWNERS CAN AVOID THE INCONVENIENCE AND COSTS OF VISITING A DRYDOCK**

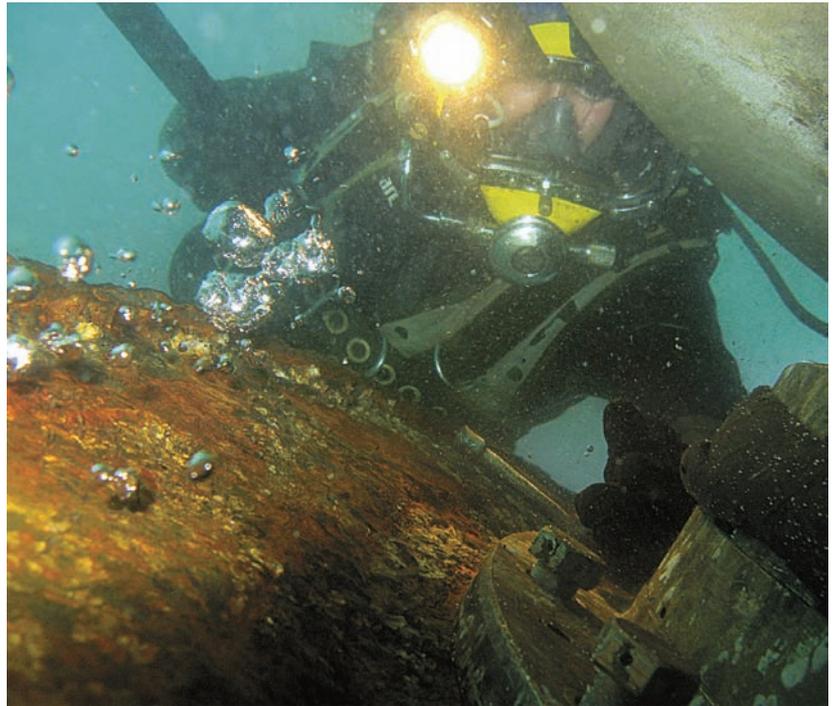
**Diver working on a seal assembly**

In one recent case, the mobdock technique was used to reposition the aft stern tube seal assembly of a 210m container ship in Le Havre. A Hydrex diver/technician team performed the operation to stop an oil blockage that occurred just after the vessel came out of drydock.

After the rope guard was removed the diver/technicians discovered that the oil flow through the stern tube seal assembly was blocked because part of the assembly had been positioned 180 degrees the wrong way. After the flexible mobdock was

installed, the assembly was opened and all parts were closely examined and cleaned. This inspection revealed that all seals were in good condition but that the bonding was faulty. The seals were rebonded and the seal assembly refitted correctly. The job was completed after four days, including full re-welding of the rope guard and shifting of the vessel to another berth.

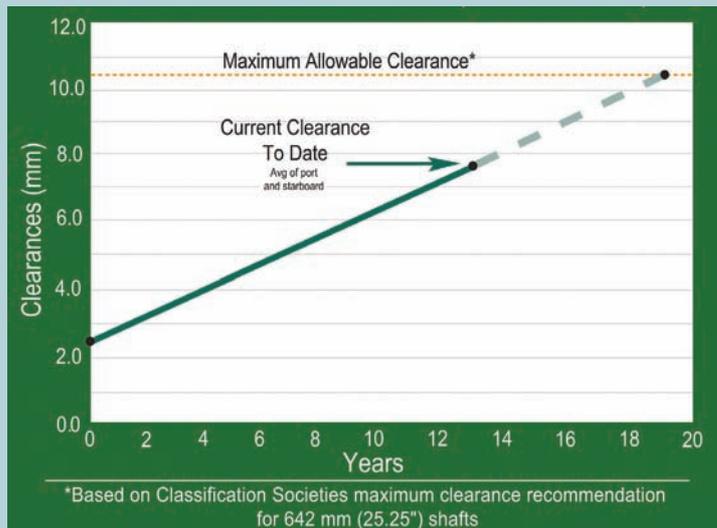
**Thordon compac seawater lubricated propeller shaft bearing clearances (for *Grand Princess*)**

Bearing clearances in the original Thordon COMPAC strut and stern tube bearings were checked and indicated that the bearing wear was well within acceptable limits. The two propeller shafts have never been withdrawn

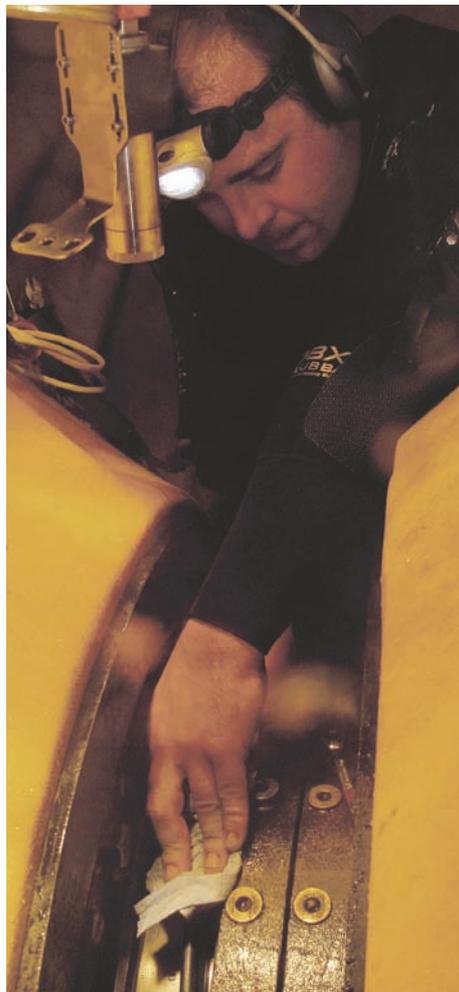
### Dry underwater stern tube seal repair inside flexible modock

A team immediately left from the company's office in Clearwater, Florida, together with the needed equipment, and set up a diving station at the berthing location of the ship. After the flexible modock was installed around the stern tube seal assembly and a dry underwater environment was created, the damaged seals could be replaced.

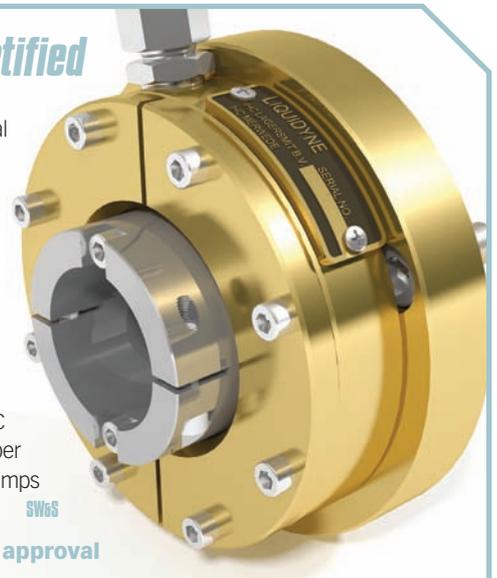
The Liquidyne shaft-seal has ATEX approval

The Liquidyne pump shaft seal – types LDS, L2T and L3T – is cleared for use in zones one and two (potentially explosive gas atmospheres) and zones 21 and 22 (potentially explosive dust atmospheres). IHC Lagersmit now anticipates an increased number of applications of the seal for cooling water pumps in these types of environments.
