Revolutionizing underwater welding repairs since 1974	3
Underwater rudder inspection and follow up repair steers owner clear of trouble	8

Revolutionizing underwater welding repairs since 1974

Underwater rudder inspection and follow up repair steers owner clear of trouble.

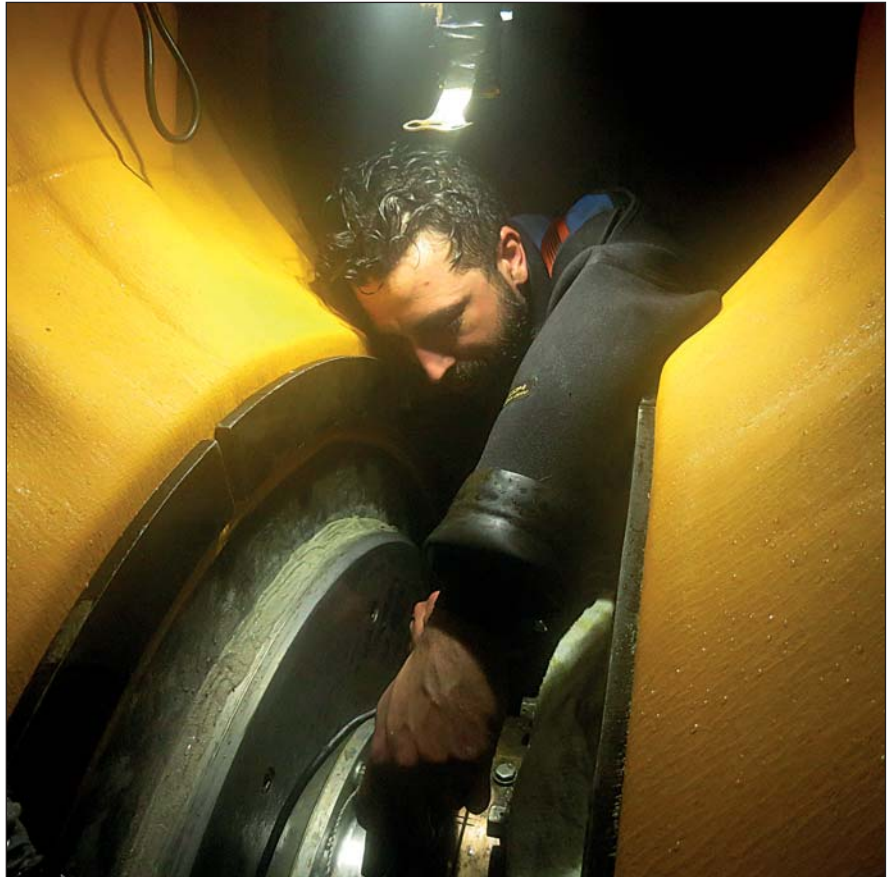
Stern tube seal repairs

Using our flexible mobdock method to create a dry underwater environment, we have carried out stern tube seal repairs and replacements underwater for some years now in cooperation with OEMs.

This technology brings drydock conditions to the ship rather than having to take the ship to drydock, saving a considerable amount of time and money in doing so.

This class accepted method is performed by our diving teams under our warranty. It can be used while the ship is carrying out its usual cargo or other commercial operations in port.

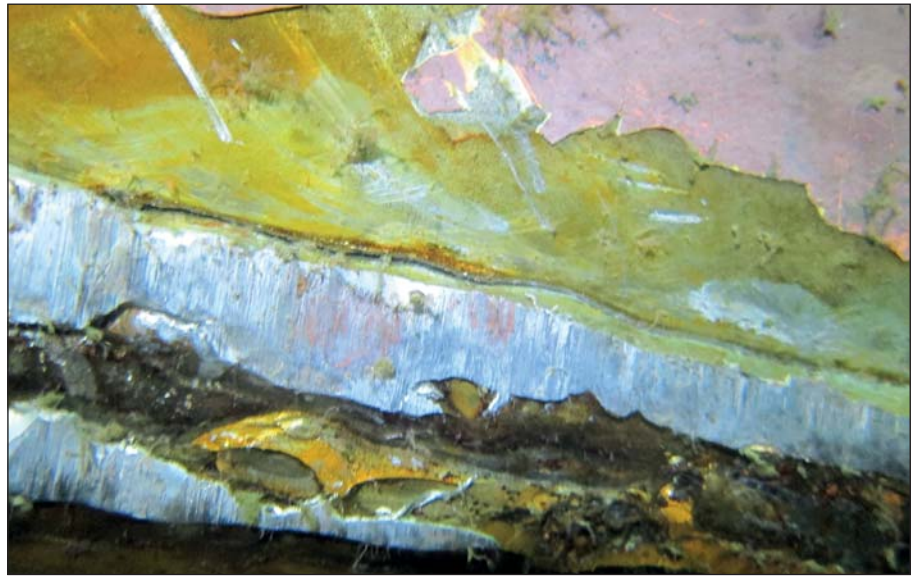
Damaged aft bulkhead area of drill ship.

The transit flap of a 225-meter drill ship came loose and started swinging dangerously. This caused damage in the aft bulkhead and a leak in the ballast tank situated behind

the moonpool hull. The vessel was located in Dakar. A fast solution was needed to prevent further damage.

We mobilized a team of diver/technicians. After an inspection of the damage, they disconnected the transit flap. It was then brought to shore, cut in three pieces and taken away. The divers also took all the measurements needed to design a repair plan for the second phase. Because of the instable condition of the flap, it was essential to keep to the highest safety standards, especially during this first part of the operation.

The second part of the operation consisted of the installation of six doubler plates over the damaged areas in the aft bulkhead. Constructed with the exact measurements taken during a detailed inspection, they were positioned and secured underwater by our certified diver/welders. All water was then emptied from the damaged ballast tank. The crew performed an inspection of the tank and confirmed that the compromised hull was once again fully sealed.

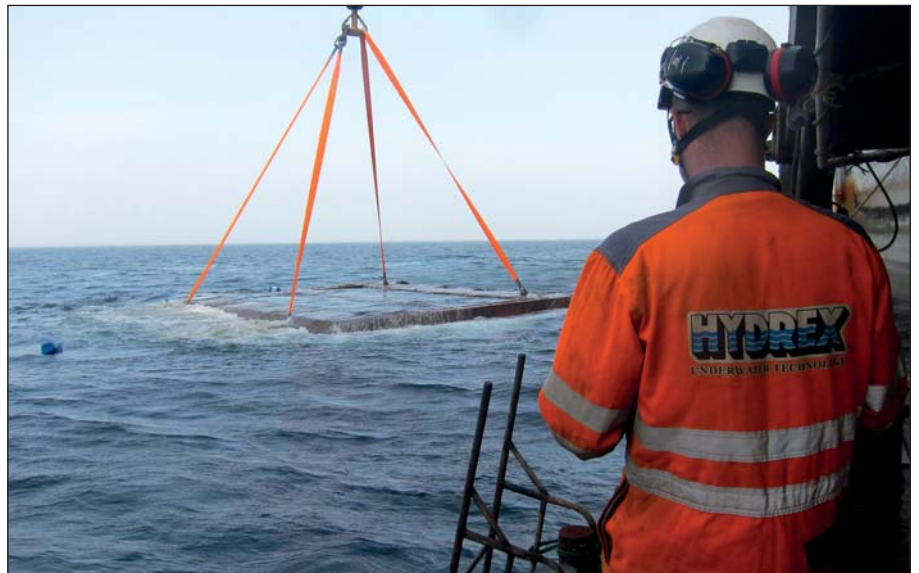
Disconnected transit flap brought to shore.

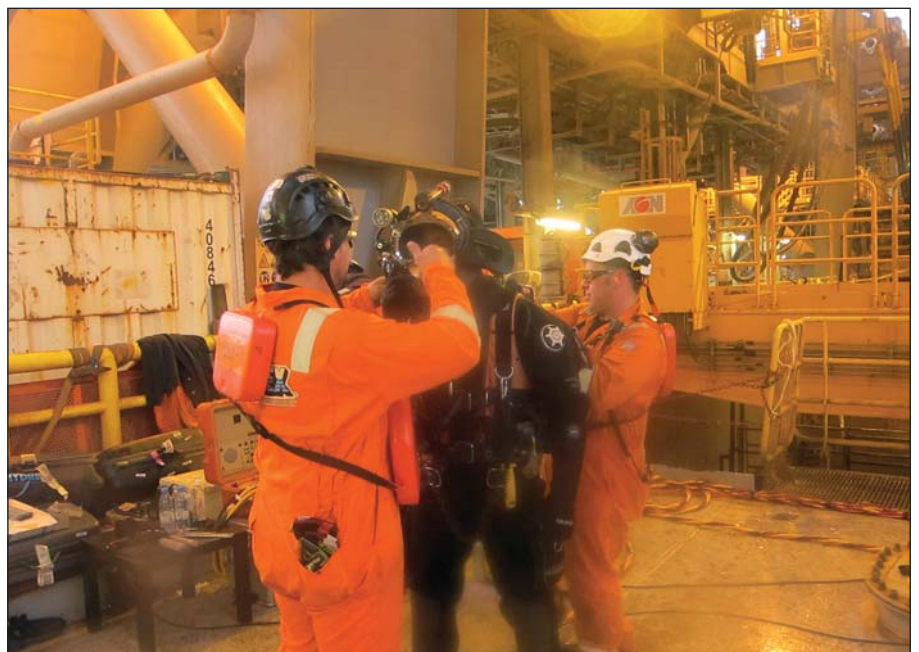
Hydrex diver/welder getting ready for repair on drill ship.

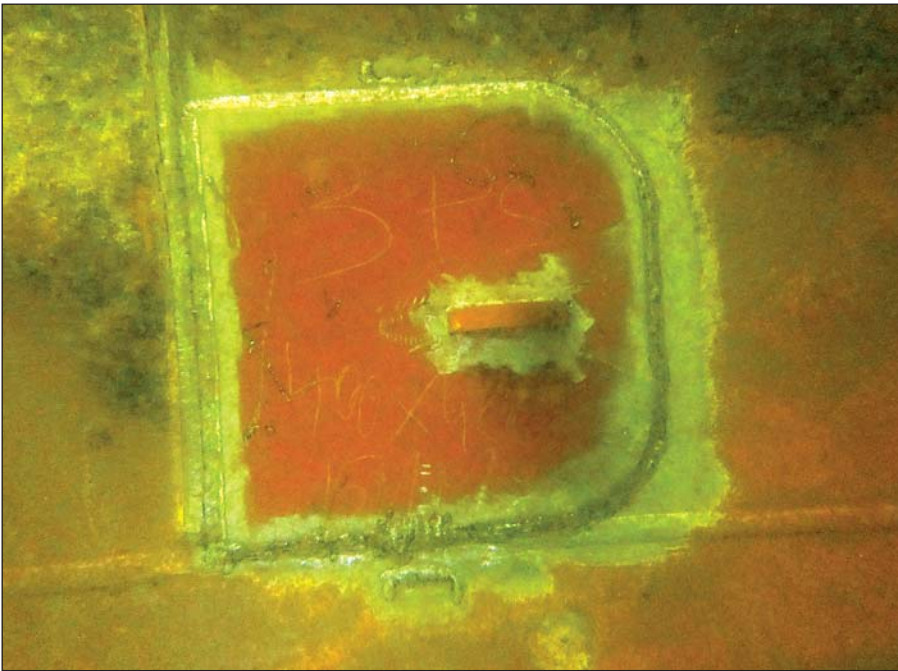
One of six doubler plates installed in Trinidad.

Thanks to the installation of the doubler plates the ship could safely start its contract. A permanent solution can now be planned at a more opportune time.

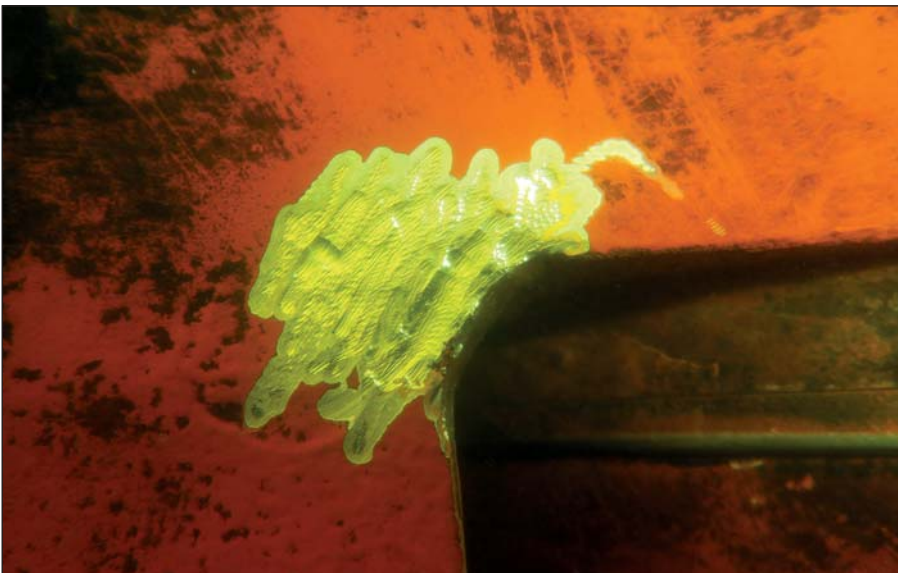
Some of the cracks on the vehicle carrier could be grinded away and filled with clad welding.

A 228-meter vehicle carrier had several cracks along the hinges connecting the rudder flap to the main rudder blade. Fortunately most of those could be repaired by grinding them away and filling the area with clad welding.

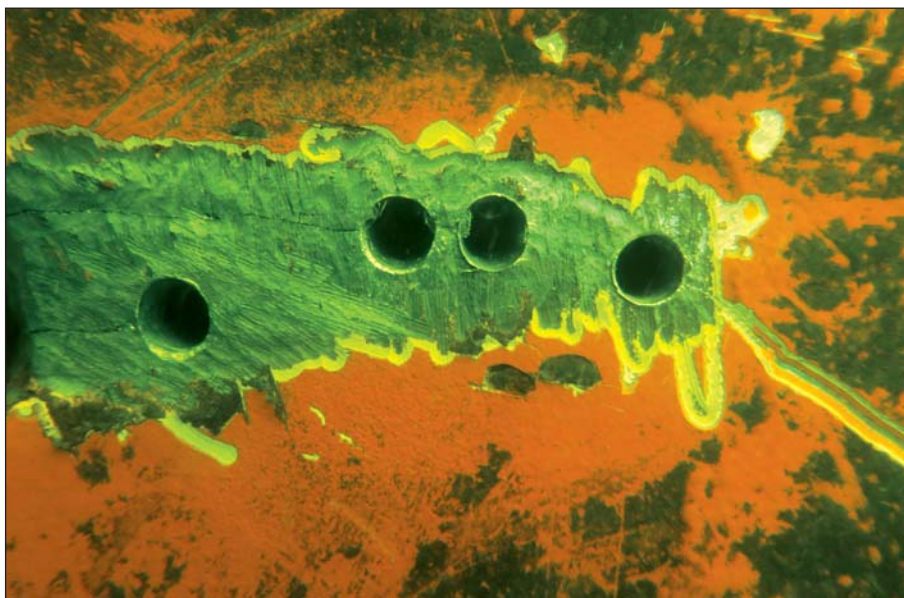
Crack arrest were made on all ends of the larger cracks in the rudder.

Three of the cracks were too big and needed a different approach. Our

diver/welders first drilled arrests on all sides of these cracks to prevent them from spreading. They then positioned a C-shaped plate over each of the cracks and secured it with wet welding.

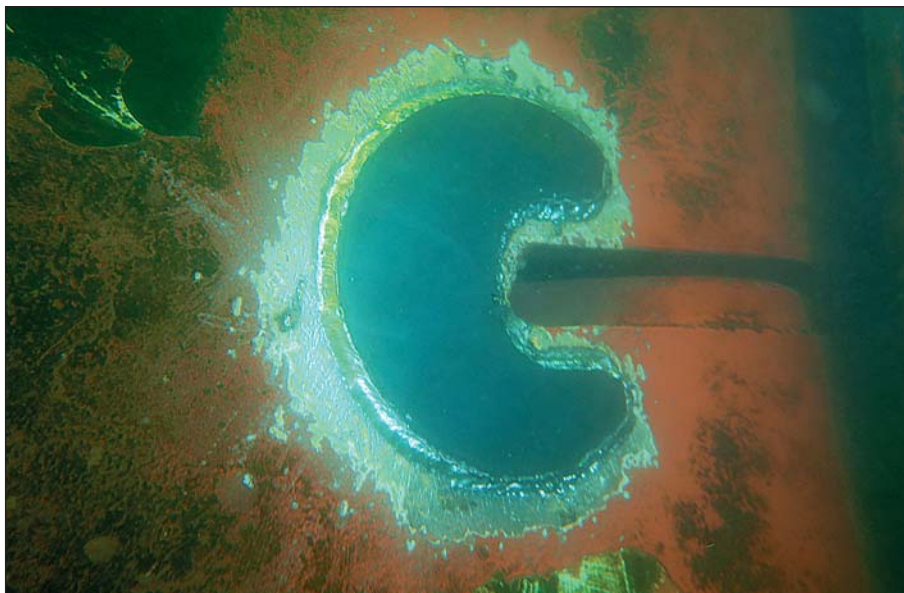
A C-shaped doubler was installed over each of the three larger cracks in the rudder.

This allowed the owner to sail the vessel without having to worry about the condition of the rudder. He can have a permanent repair carried out during the ship's next scheduled drydock visit at a more convenient time and location.

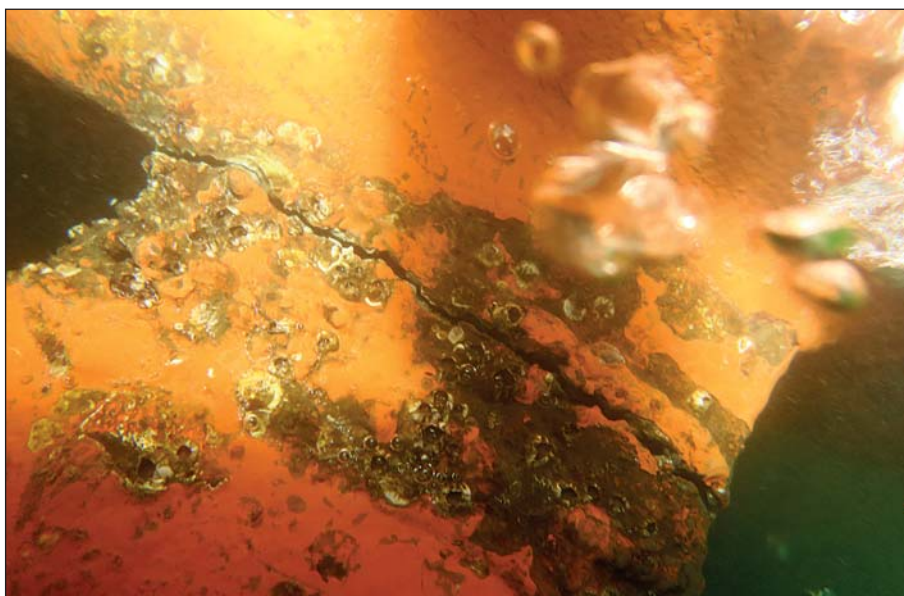
Two thruster brackets of a container ship were almost completely cracked.

This was illustrated when the damage to two of the thruster brackets of a 278-meter container ship was not discovered in an early stage. Both brackets were almost completely cracked. In communication with the class surveyor we proposed

a temporary underwater repair plan that would keep the thruster safe from further harm. The plan consisted of the installation of four steel plates: one on the top of each crack and one on the bottom.

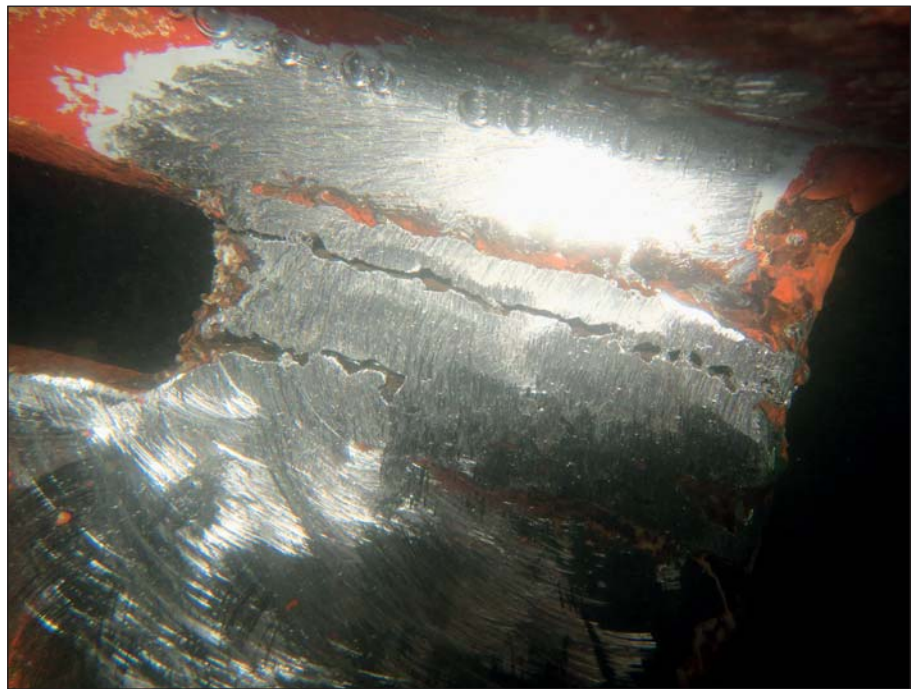
The cracked brackets were first prepared for installation of the steel plates.

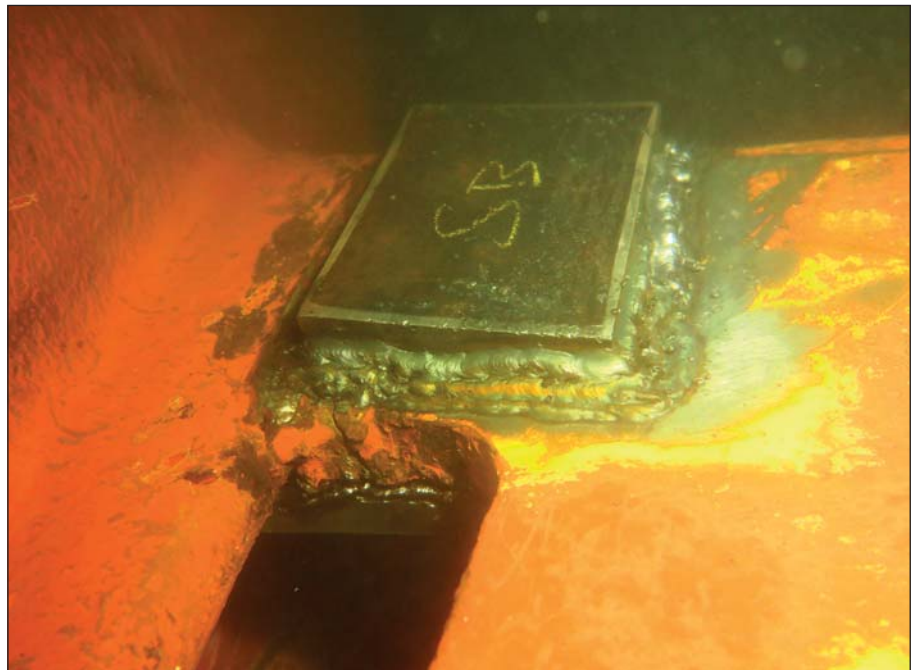
One plate was installed on the top of each crack and one on the bottom.

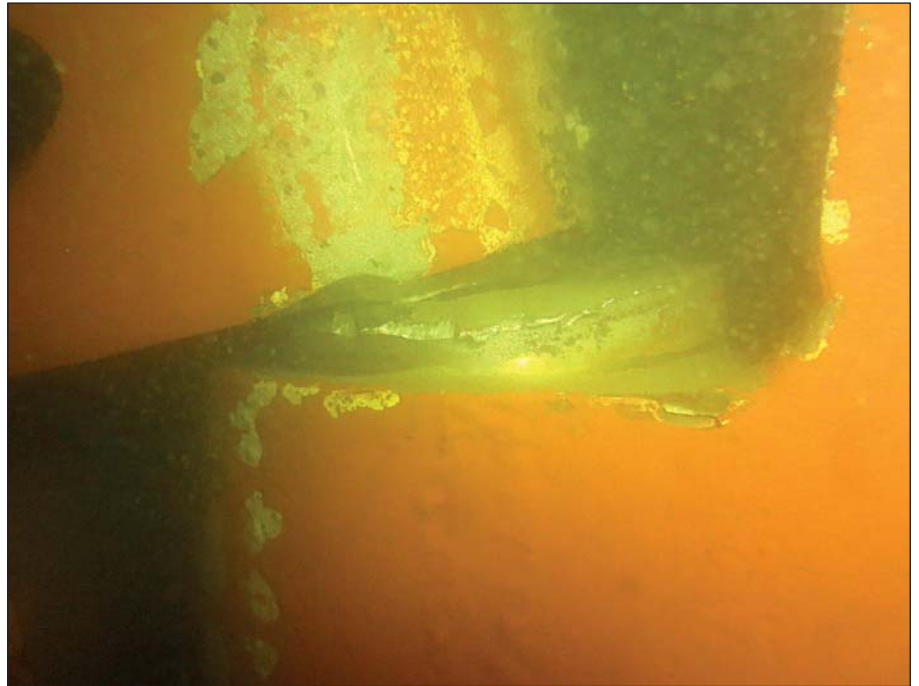
The rudder flap was almost completely detached from the rudder.

The inspection revealed that the rudder's flap was almost completely detached from the rudder. This caused serious troubles during steering. The top hinge had come loose completely. The weight of the flap had severely bent the pin that attached it to the rudder at the bottom hinge and was just barely keeping it from falling off. The edge of the rudder was also cracked and deformed next to the lower hinge.

Because of this deformation, removal of the flap was not straightforward. Many years of experience and technical expertise allowed our technical department to come up with a repair plan within a matter of hours. This solution would allow the owner to continue his vessel on its schedule without any noticeable delay, so he gladly accepted.

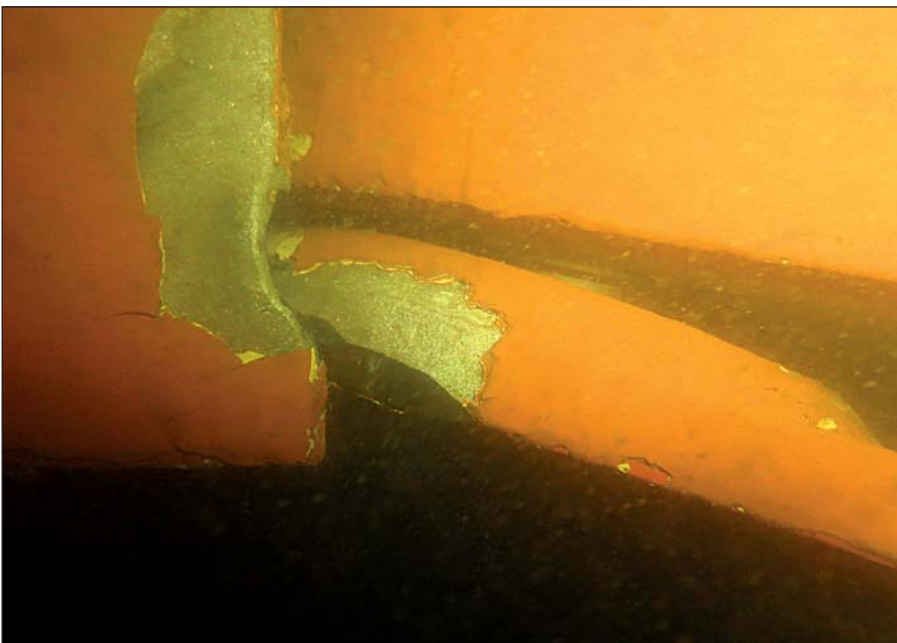
The edge of the rudder was cracked and bent.

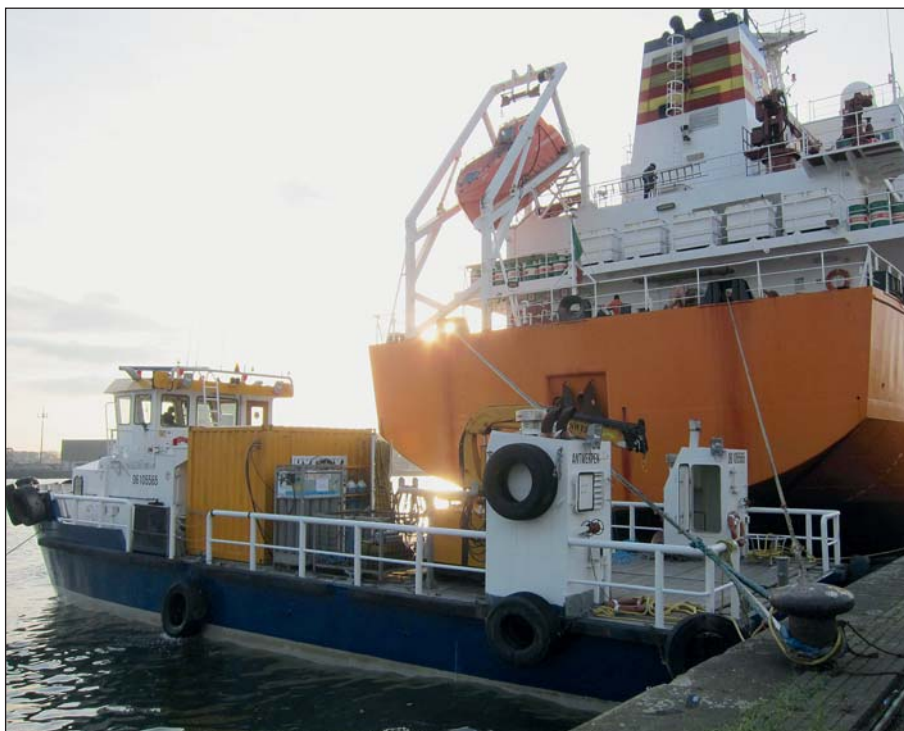
Hydrex workboat next to tanker during rudder operation.

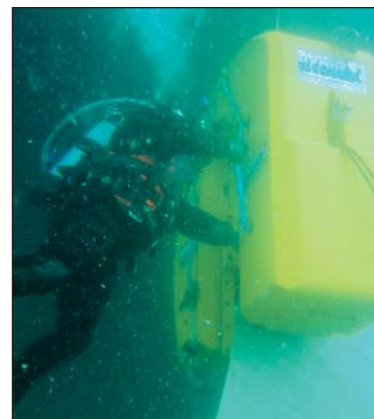
Fast underwater propeller blade straightening

In its quest to provide cost effective services to customers, Hydrex developed procedures to address different kinds of damage to propellers. This research led to the design of the Hydrex cold straightening machines first used in 2002.

By taking advantage of this technique damaged blades can be straightened underwater, allowing the ship to return to commercial operations without the need to drydock. Blades can be brought back close to their original form, restoring the propeller's optimum efficiency.

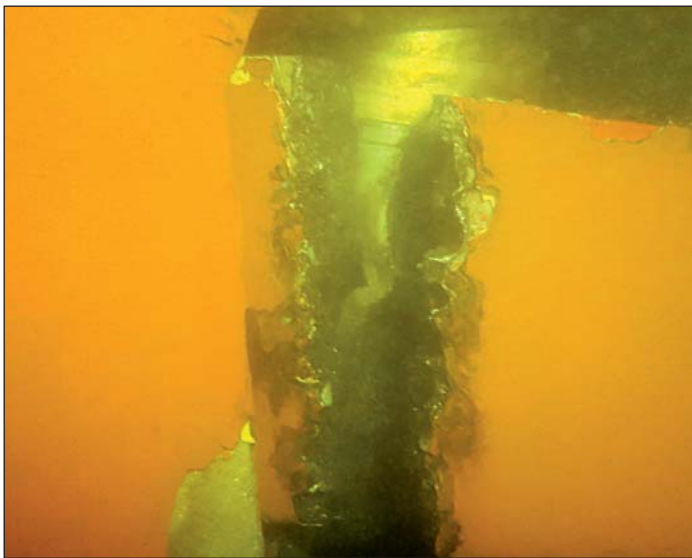
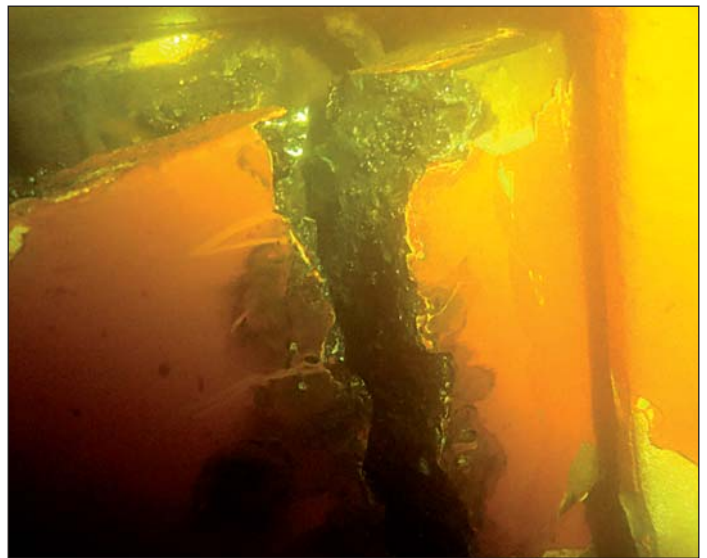
The part of the rudder flap that was still connected to the bent pin was burned off.

After arriving next to the vessel, the diver/welders started the operation by securing the rudder flap with chains. Next they burned off the area of the flap that connected it to the bent pin. Once this was done, the divers left the water and the crew of the tanker slowly moved the rudder's position until the flap disconnected from the rudder and came to rest completely on the chains.

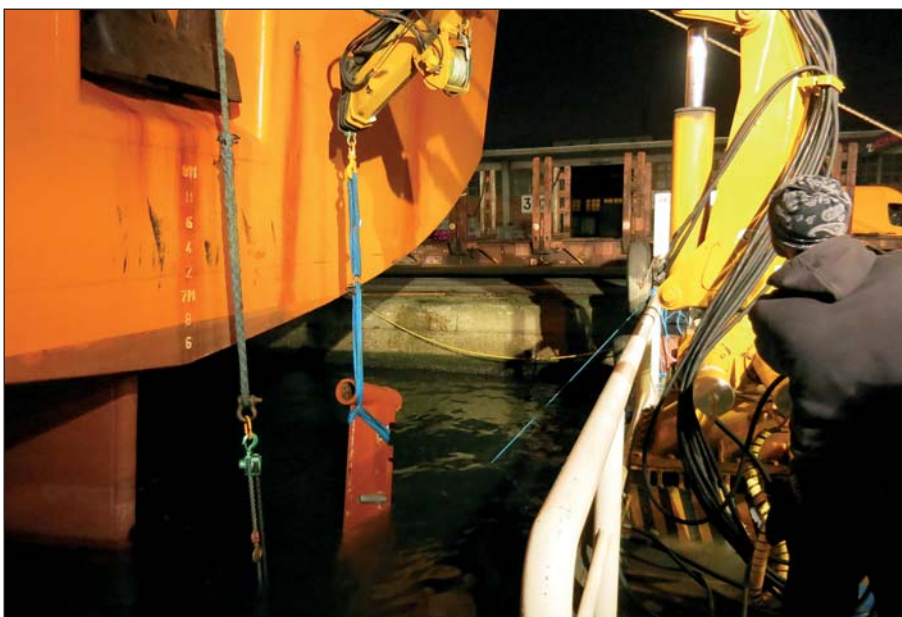
Rudder flap brought onto the workboat.

The flap was then lifted onto our workboat and brought to our workshop. By doing this the vessel could immediately sail on to her next scheduled stop. The flap was later transported to the OEM to be repaired. It will be ready to be reinstalled when the tanker will dock at a convenient time and location that fits the schedule of the owner.

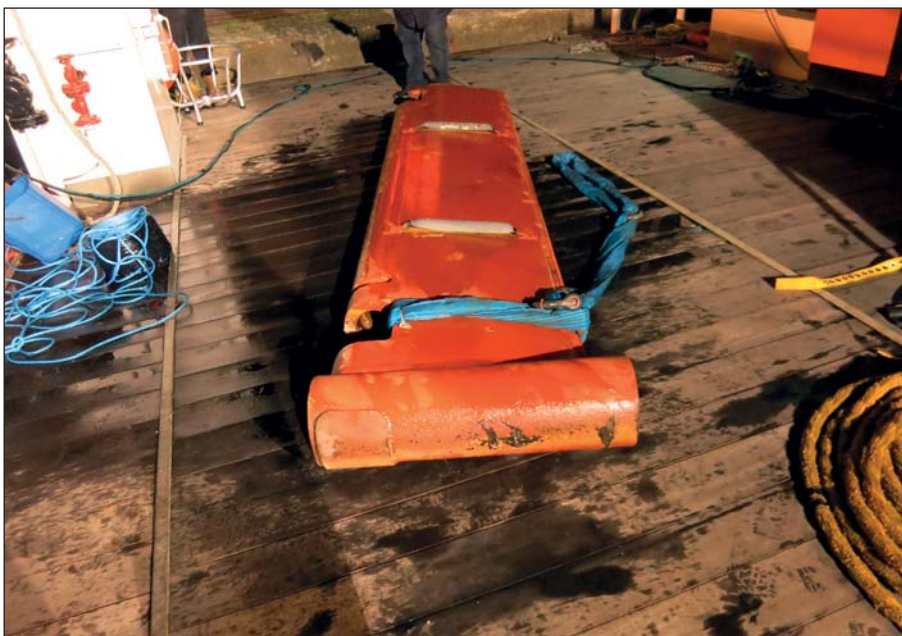
The rudder flap was brought to our workshop and later transported to the OEM.

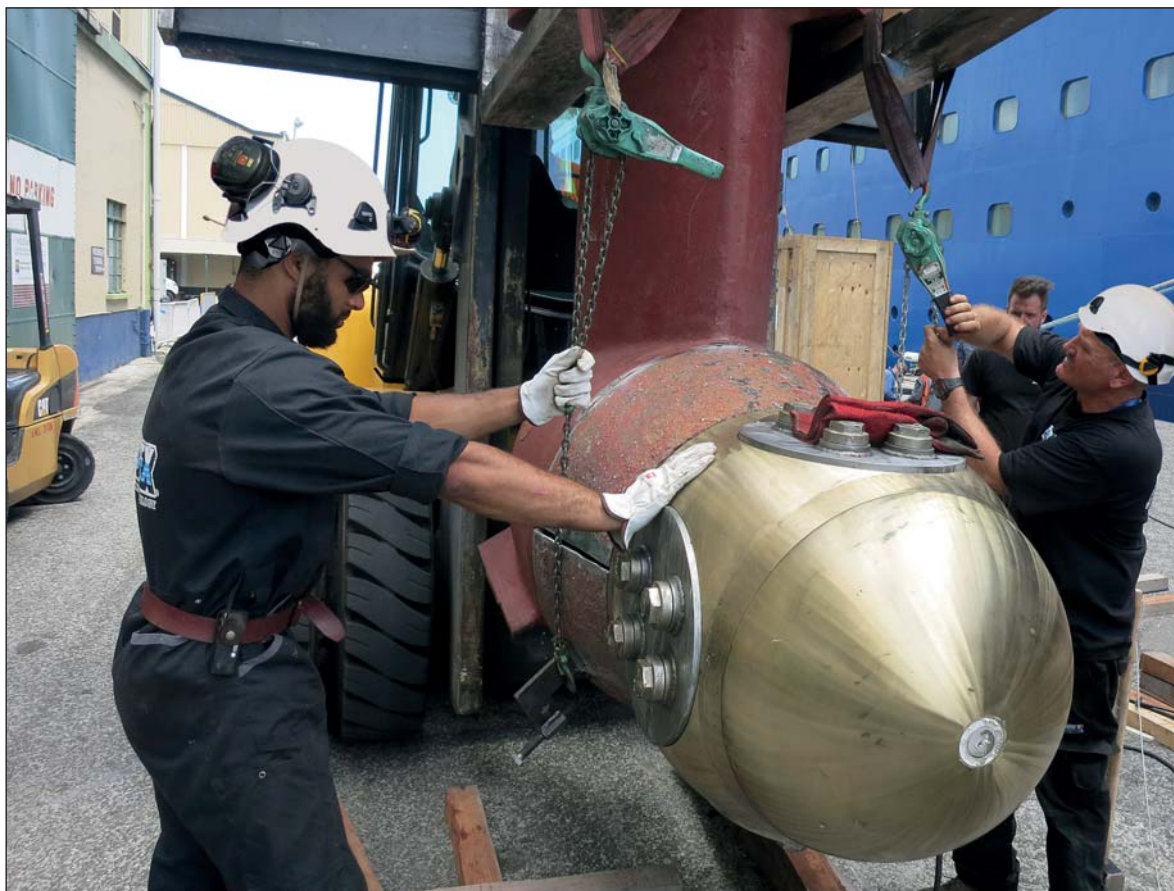
The Hydrex lightweight flexible mobdocks are designed to be easily transported around the world and are used to close off the thruster tunnel on both sides, allowing divers to perform repairs and other operations in a dry environment around the bow thruster unit.

This technique enables them to reinstall the propeller blades of an overhauled thruster inside the thruster tunnel after the unit has been secured or replace the blades or seals and perform repair work on a specific part without removing the unit.
