Hydrex repairs rudders in Zeebrugge, Dunkirk and Le Havre

RUDDER CRACKS REPAIRS ABOVE AND UNDER WATER

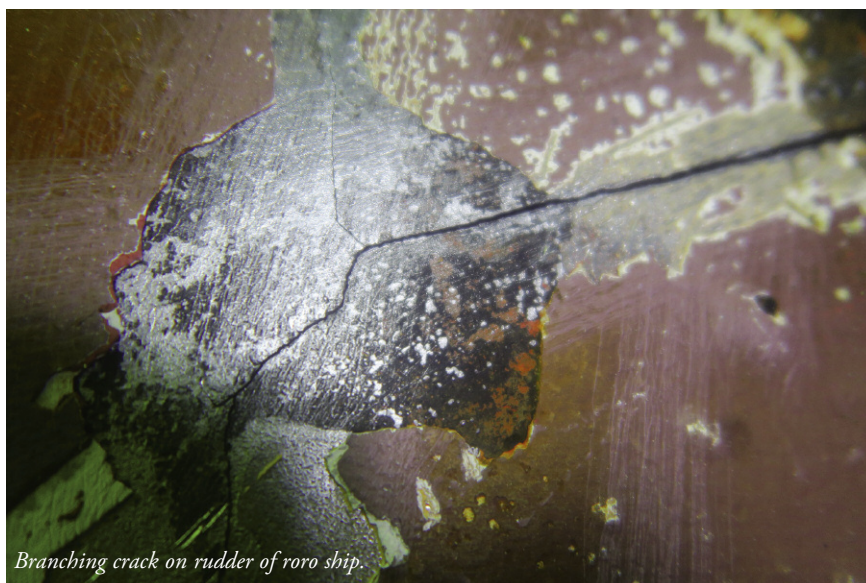
A 230-meter roro ship in Zeebrugge had suffered cracks on both sides of the rudder flap. On the starboard side a branching crack was found while a single crack was present on the port side.

Branching crack on rudder of roro ship.

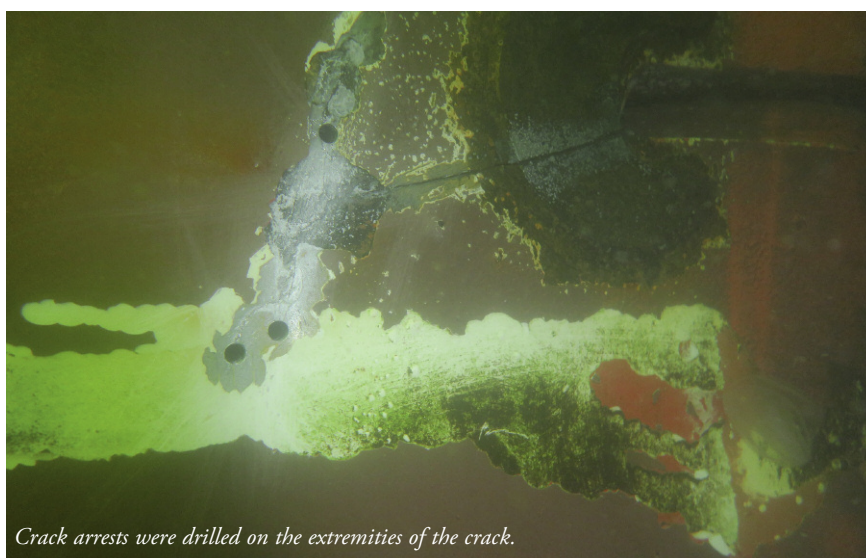
Crack arrests were drilled on the extremities of the crack.

Hydrex divers first drilled arrests on all extremities of the cracks to prevent them from spreading. They then positioned C-shaped plates over the crack arrests and secured these with wet welding.
