# Extensive damage repairs to container ship in extreme conditions in Boston in 2001

## Breaking new boundaries: finding solutions to problems

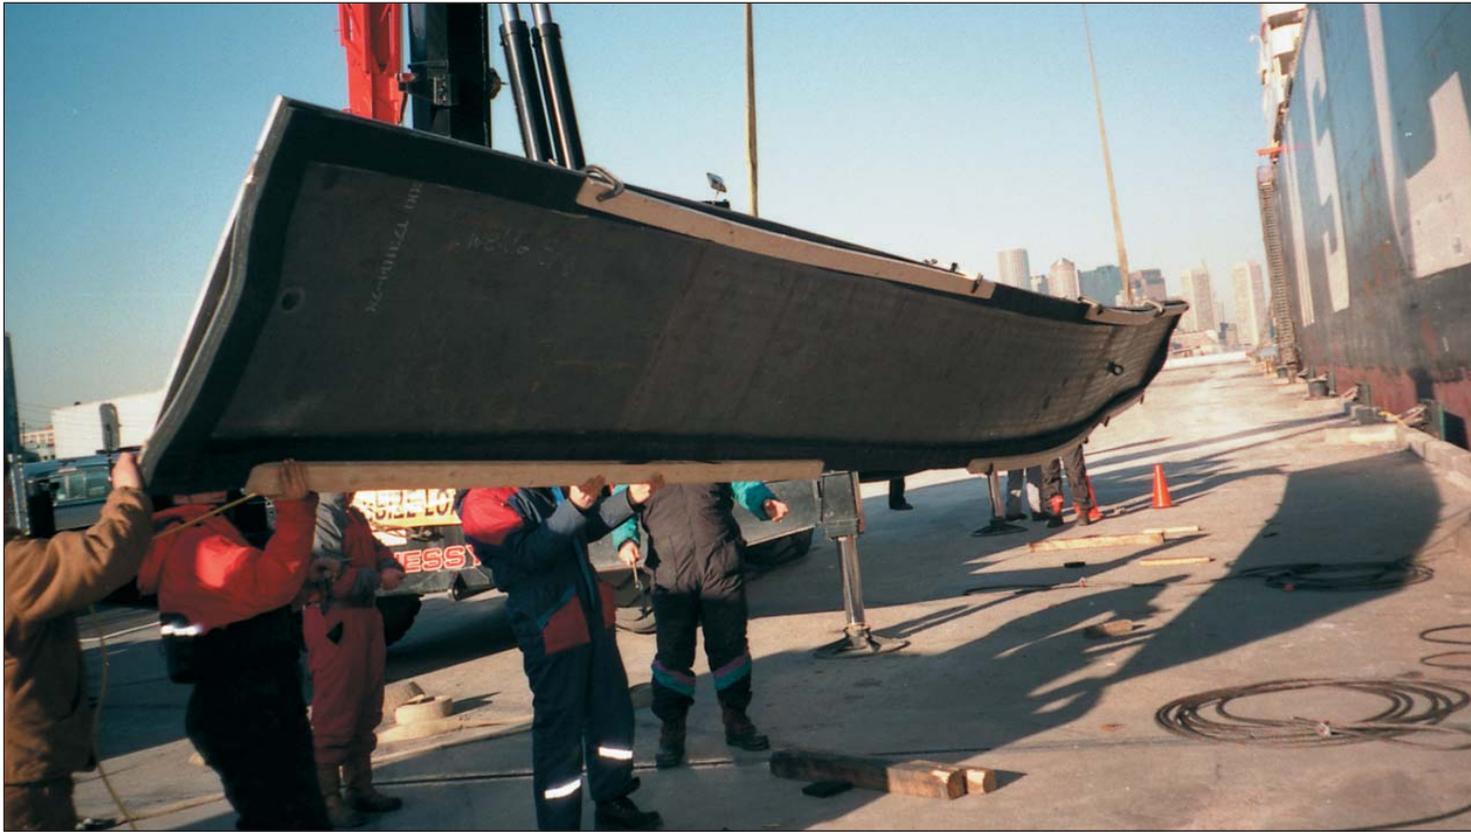
*Lifting one of the large plates.*

The work required 5 different patches to be welded to the flat bottom. The biggest one was 14.5 meters long by 1.3 meters wide and weighed around 2 tons. To get this one into position heavy-duty rigging equipment was necessary and an expert procedure needed to be worked out so that the

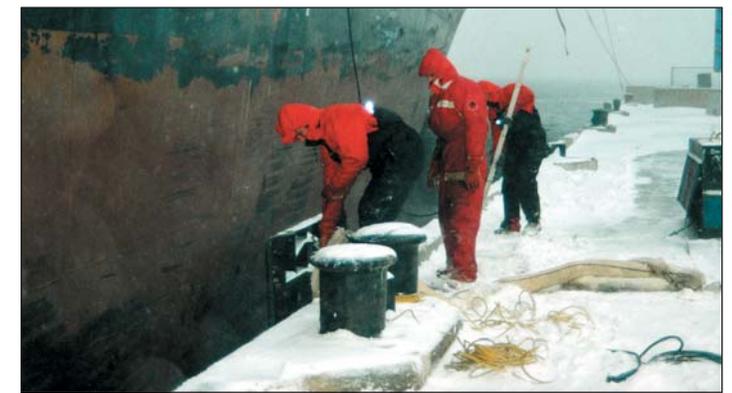
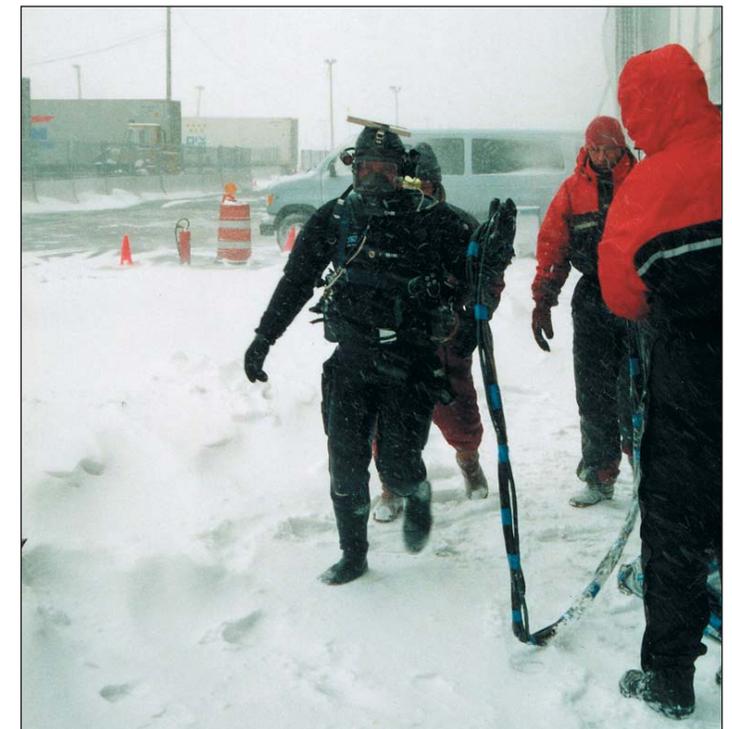
*There were blizzard conditions during the entire operation.*

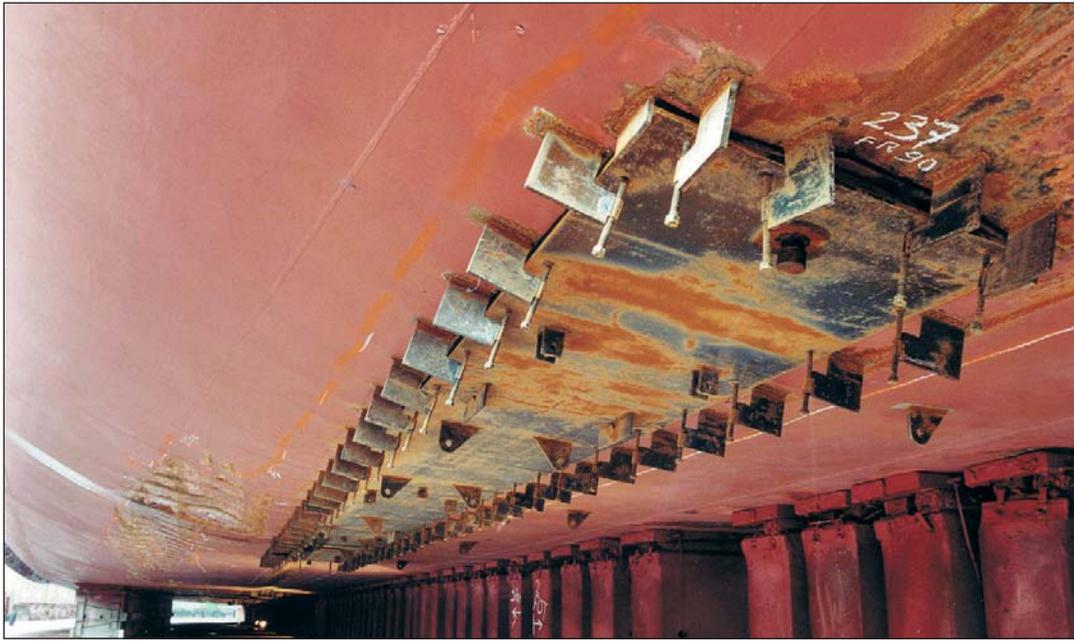
*One of the patches seen in drydock after crossing the Atlantic Ocean.*

The plates themselves, while flat on the outside, were designed with 2 concave surfaces on the inside meeting in the middle. This method meant that the inside of the plate would press against the damaged area and increase the surface contact

and pressure with the flat bottom, thus ensuring a better contact.

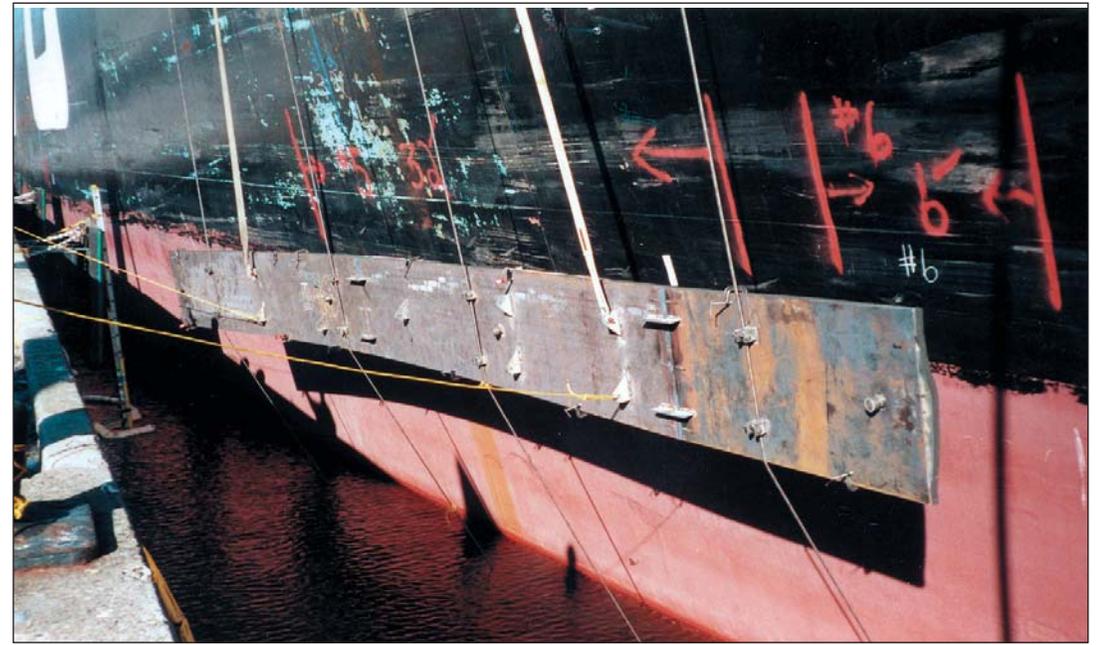
*Technical precision was needed to coordinate the placement of the patches.*

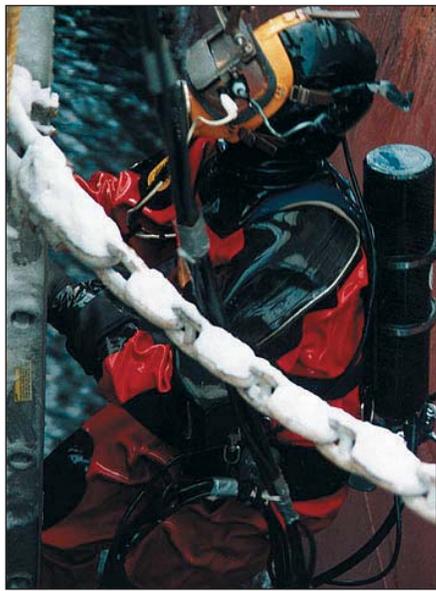
*Our divers worked at very low temperatures.*

weld seams were done by our divers, all of which are qualified and certified underwater welders. These welds were all above head welds as they were made on the flat bottom.

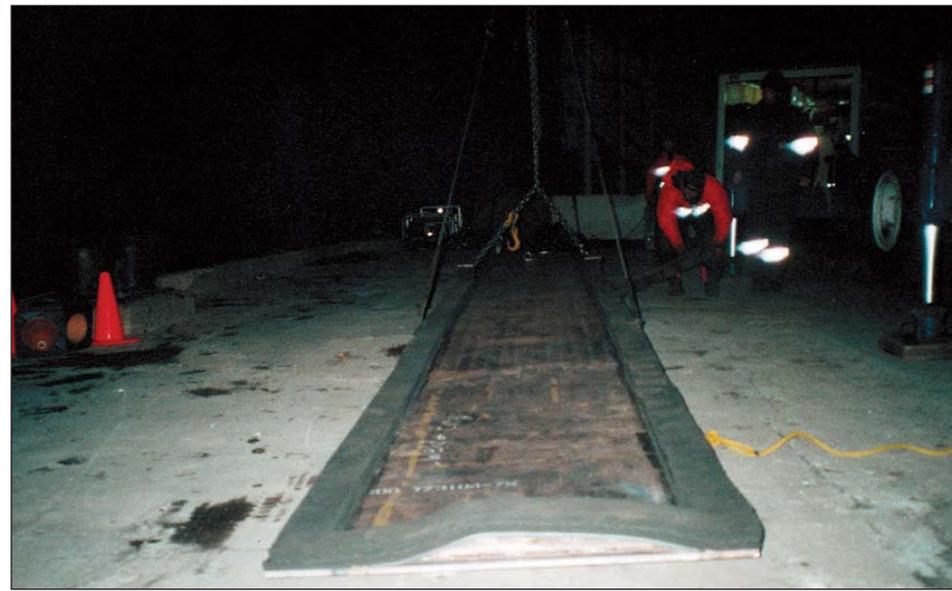
*One of the larger doubler plates.*
