# Shipping World & Shipbuilder

# Fixing seals on-the-go

## ON SITE REPAIRS OF SEALS MEAN OWNERS CAN AVOID THE INCONVENIENCE AND COSTS OF VISITING A DRYDOCK

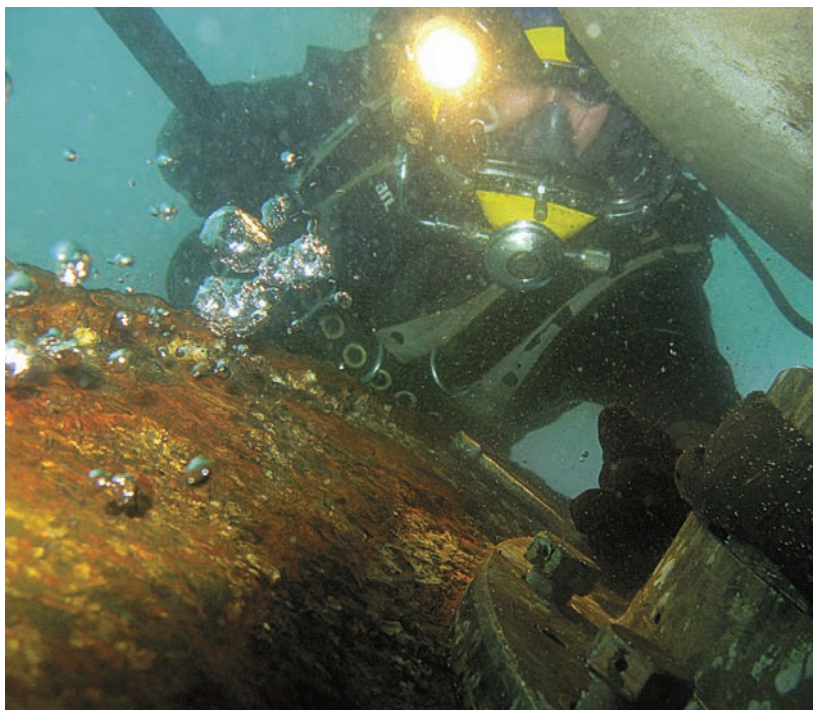
Diver working on a seal assembly

In one recent case, the mobdock technique was used to reposition the aft stern tube seal assembly of a 210m container ship in Le Havre. A Hydrex diver/technician team performed the operation to stop an oil blockage that occurred just after the vessel came out of drydock.

After the rope guard was removed the diver/technicians discovered that the oil flow through the stern tube seal assembly was blocked because part of the assembly had been positioned 180 degrees the wrong way. After the flexible mobdock was

installed, the assembly was opened and all parts were closely examined and cleaned. This inspection revealed that all seals were in good condition but that the bonding was faulty. The seals were rebonded and the seal assembly refitted correctly. The job was completed after four days, including full re-welding of the rope guard and shifting of the vessel to another berth.

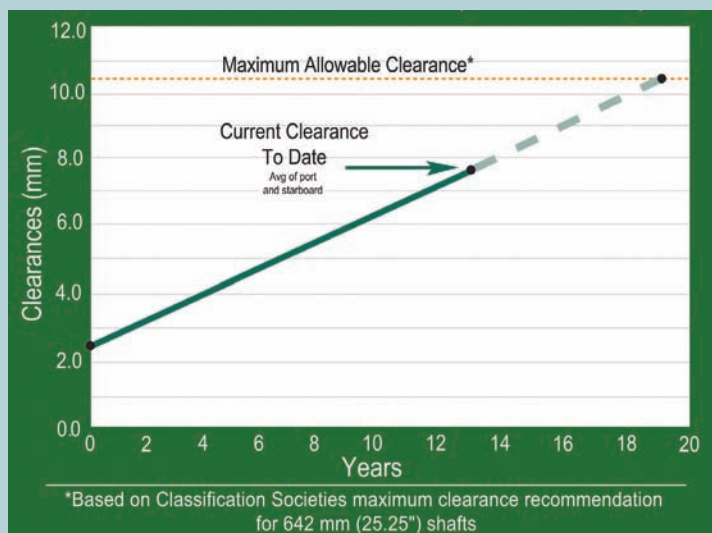
Thordon compac seawater lubricated propeller shaft bearing clearances (for *Grand Princess*)

Bearing clearances in the original Thordon COMPAC strut and stern tube bearings were checked and indicated that the bearing wear was well within acceptable limits. The two propeller shafts have never been withdrawn

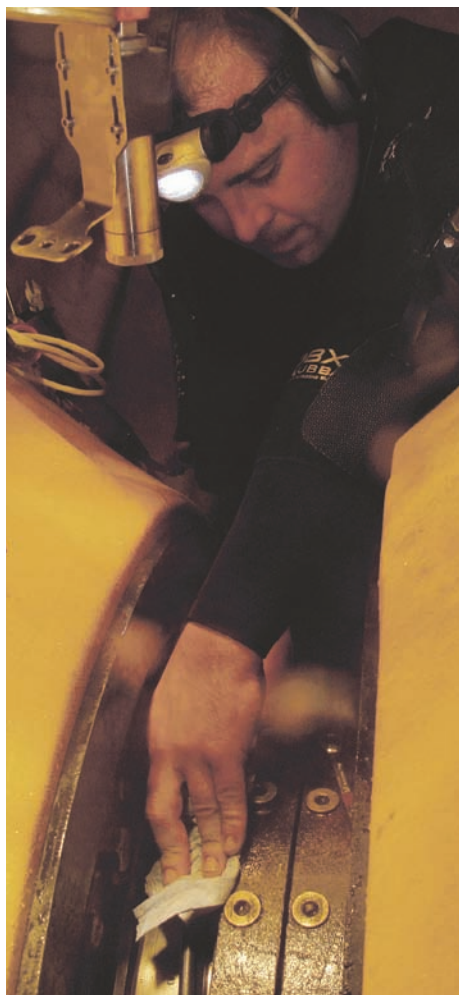
#### Dry underwater stern tube seal repair inside flexible mobdock

A team immediately left from the company's office in Clearwater, Florida, together with the needed equipment, and set up a diving station at the berthing location of the ship. After the flexible mobdock was installed around the stern tube seal assembly and a dry underwater environment was created, the damaged seals could be replaced.

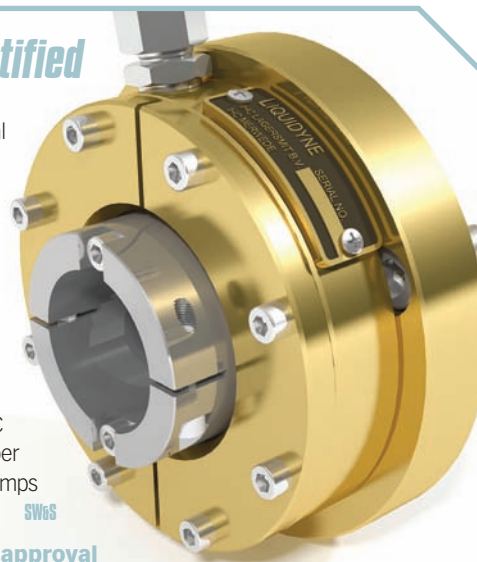
The Liquidyne shaft-seal has ATEX approval

The Liquidyne pump shaft seal – types LDS, L2T and L3T – is cleared for use in zones one and two (potentially explosive gas atmospheres) and zones 21 and 22 (potentially explosive dust atmospheres). IHC Lagersmit now anticipates an increased number of applications of the seal for cooling water pumps in these types of environments.
