UNDERWATER TECHNOLOGY

Magazine

Number 315

45-ton cofferdam to repair a large bulk carrier after a severe grounding

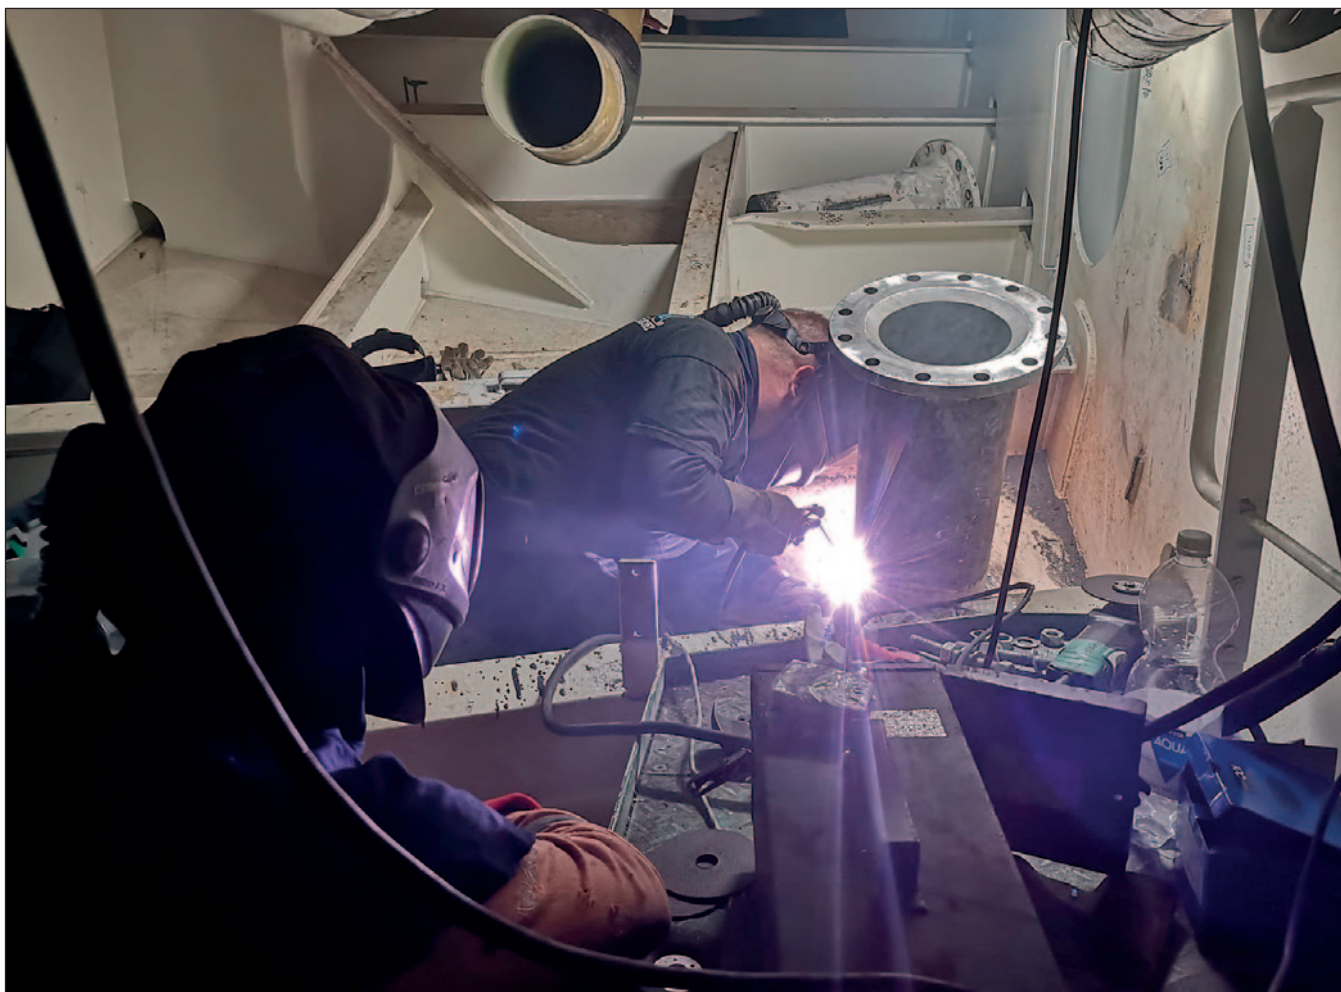
Scrubber pipe repairs and lasting protection

Exhaust scrubbers filter out all harmful toxins from exhaust gases of marine diesel engines. These hazardous pollutants can severely corrode the pipes of the scrubber. Using the experience we have accumulated over the years allows us to assist you at moment's notice if this happens.

We offer a full package to owners that are experiencing similar damage. Not only can we replace the corroded exhaust pipe while your vessel stays on schedule, but we can make sure that you will not have to call us again in a few months time for the same problem. This is done by coating the pipes with a highly

corrosion resistant coating called Ecospeed.

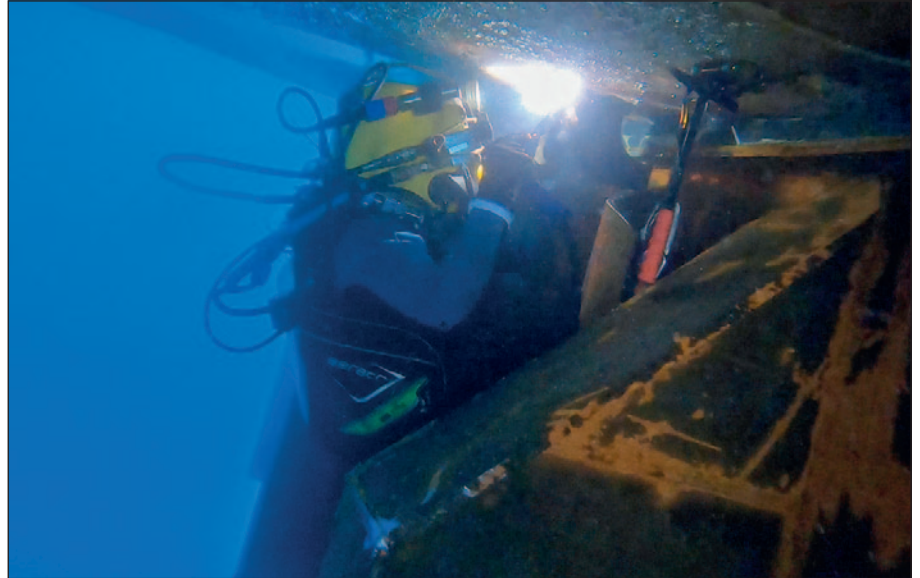
Welding the cofferdam in place.

As soon as the fabrication was completed, a Hydrex team of eight diver/welder/technicians flew back to Suez to install the cofferdam. After some needed modification, the massive, 45-ton cofferdam was lowered into position by crane and secured against the hull with welded screw dogs, stoppers and thick seals.

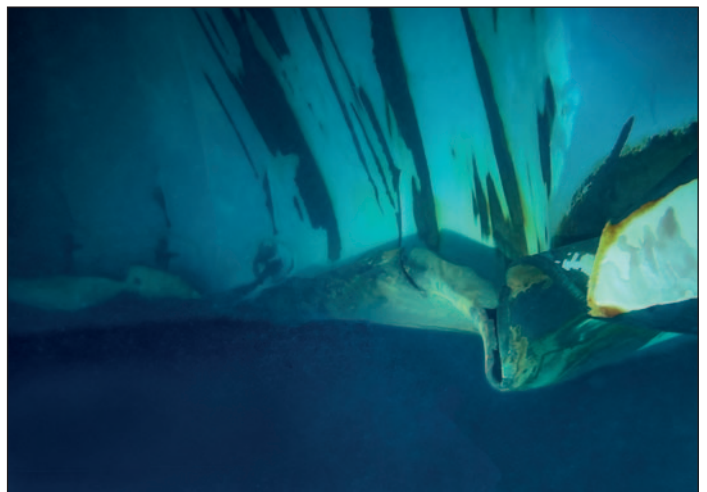
The underwater inspection revealed and documented the full extent of the damage, which was quite severe. It included one hull penetration at

Severe damage to the hull from the grounding.

the turn of bilge 7m long with a maximum width of 5m and another smaller penetration of 10x5 cm.

Based on the initial inspection and rough measurements, a plan was proposed to carry out precise measurements of the hull where the large damage occurred so that a cofferdam could be designed which would then be installed to make the hull water-

The proposal for handling the additional damage was to arrest the crack by drilling holes and then weld a doubler plate over the large crack in the hull. The plan was approved by class (LR), and ship management gave the go ahead to implement it. The Hydrex team took

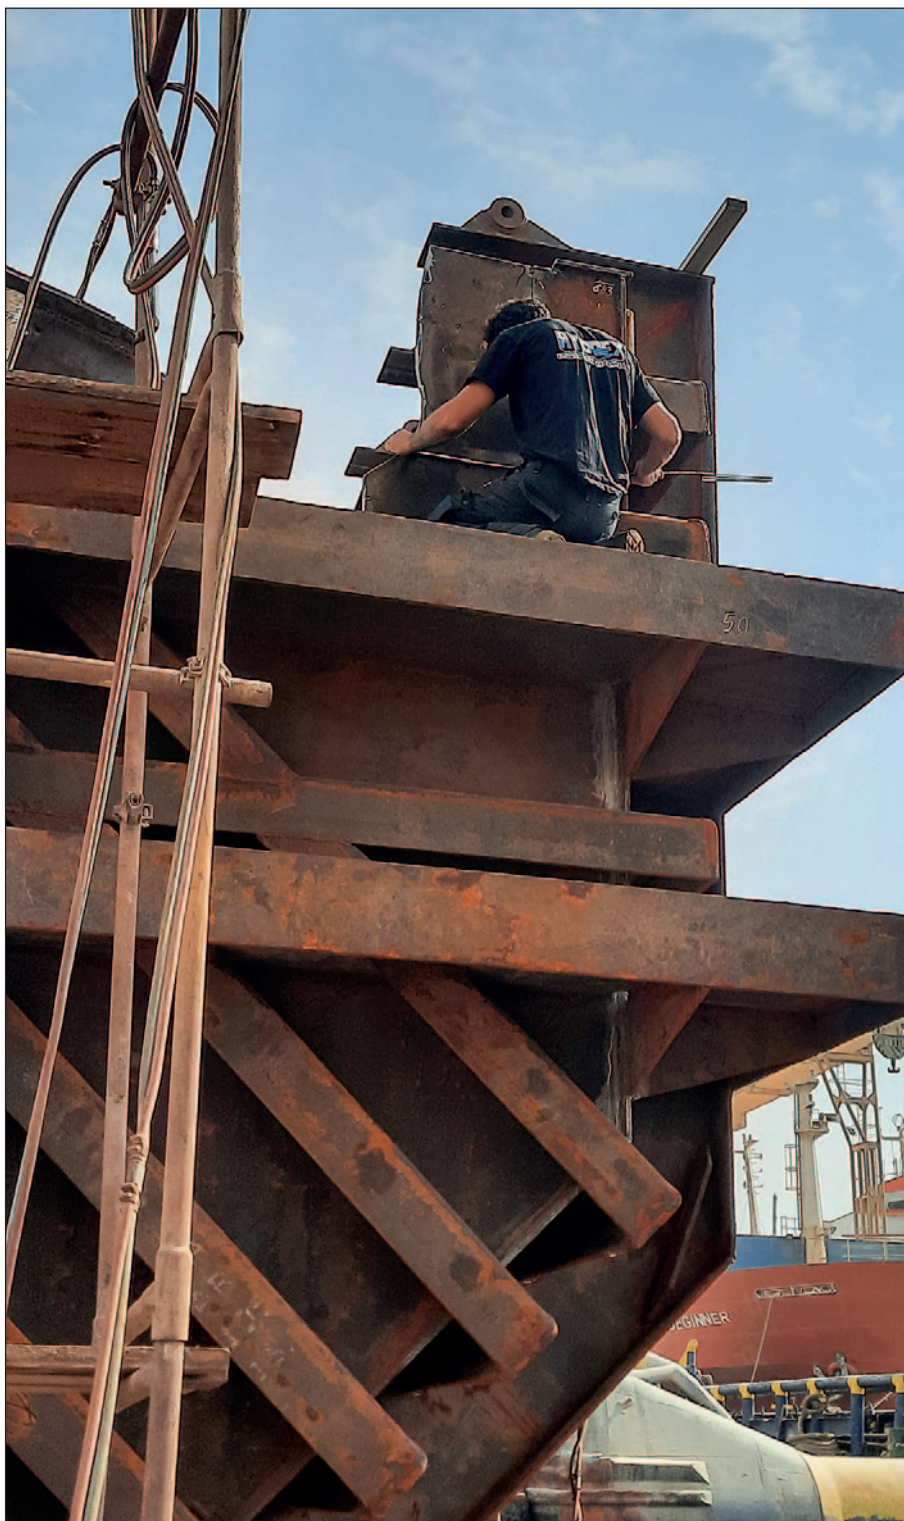
Fabrication of the 45 ton cofferdam.

full measurements of the hull in the damaged area using a fabricated frame. The measurements were relayed to the engineers in Antwerp who produced drawings for the yard in Egypt where the cofferdam was fabricated. The final cofferdam consisted of a frame or shell with a flange built to the shape of the hull and insulation material to make it watertight.

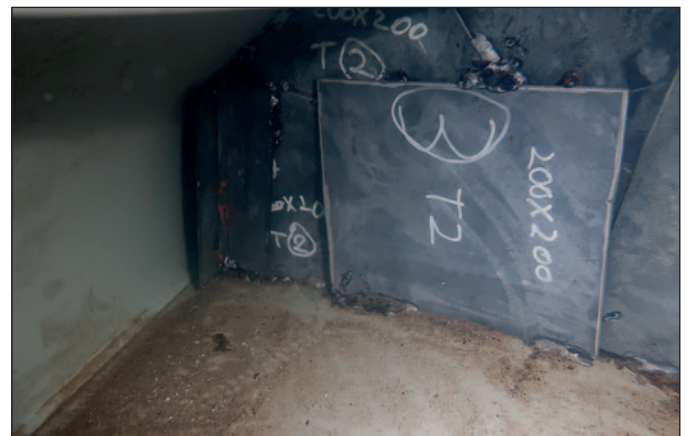
Concrete used to strengthen the bulkhead between water ballast tanks 2 and 3.

In order to reinforce the bulkhead between the water ballast tanks, a new plan was proposed to build cement boxes and pour concrete to provide enough strength for the bulkheads in between the ballast tanks. But WBT 2 port could not be

emptied. Part of the plan, therefore, was to lighten the ship as necessary until the class-required draft could be achieved.

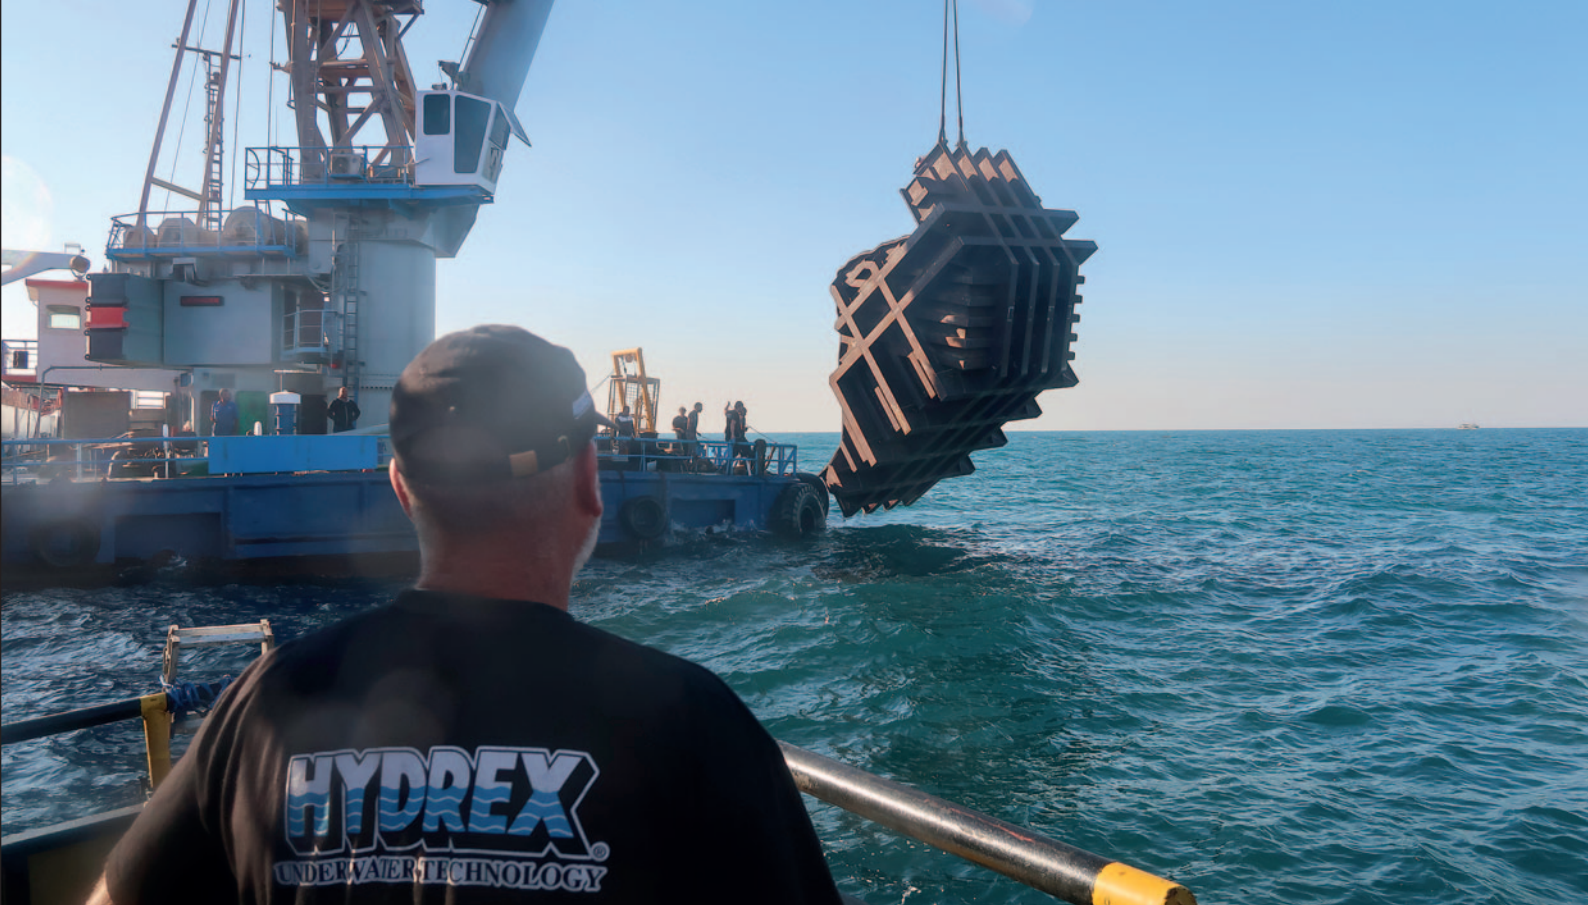
Crane barge moving the cofferdam into position.

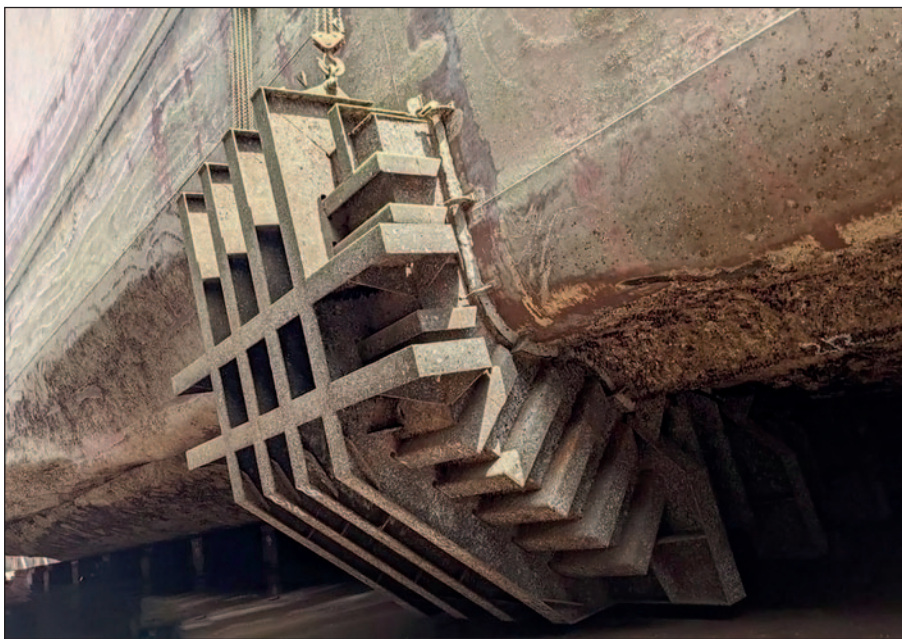
When the ship arrived in drydock, the sheer size of the cofferdam could be appreciated.

Because WBT 2 could not be pumped out, the ship had to be partially lightered so that the class-required draft could be achieved and she could sail on to drydock. Once the ship was dry, it was possible to see the sheer magnitude of the repair job. It was the largest cofferdam

ever installed in a hull repair by Hydrex. It remained firmly in place until it could be removed when the ship was in drydock and permanent hull repair could be carried out.

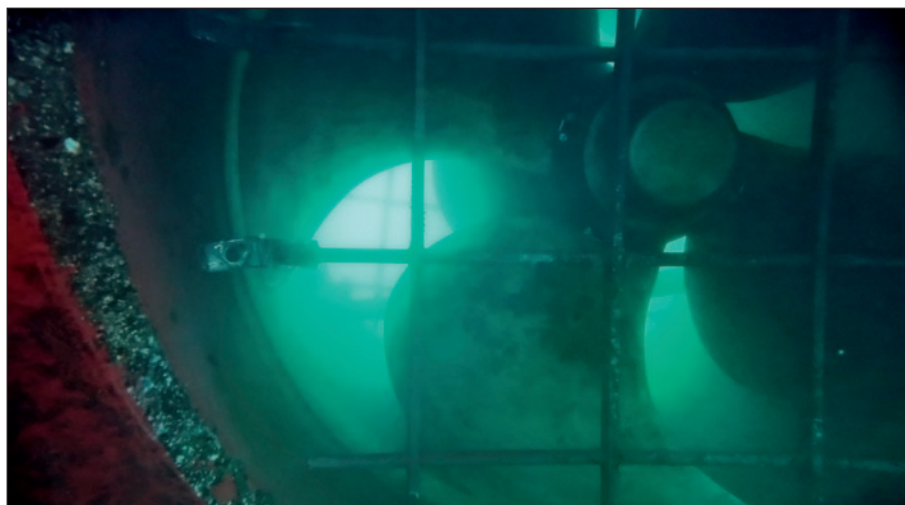
Bow thruster during initial inspection of the tunnel and grid.

After the team set up a monitoring station next to the vessel, the divers started the operation with a detailed inspection of the bow thruster and tunnel. In the meantime, initial preparations were made in the bow thruster engine room for the removal of the unit so that there would be no ingress of water once it was taken out.

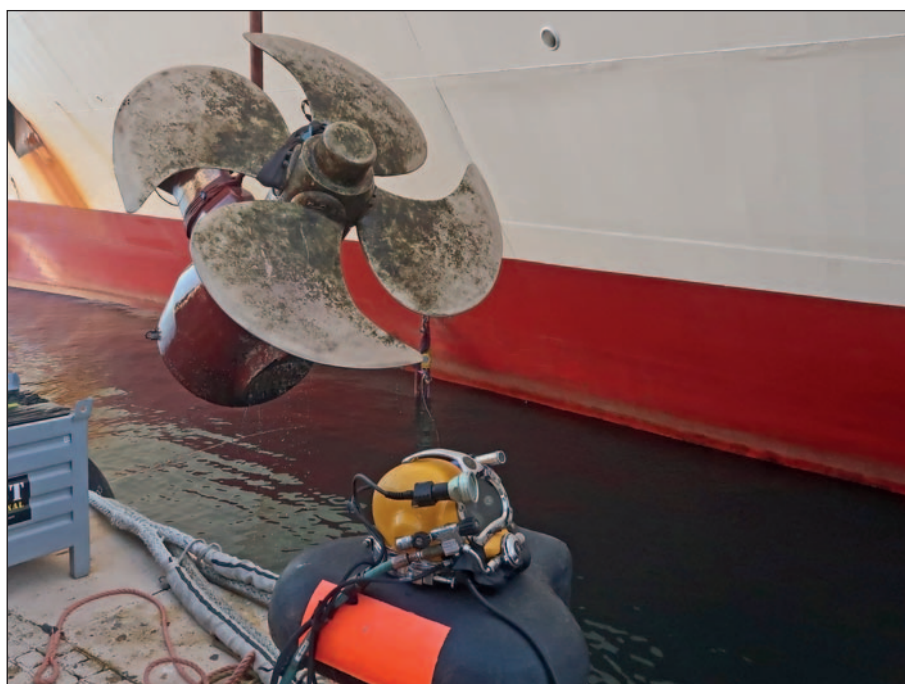
Thruster unit brought to the surface.

The next step was to secure the gearbox with hoisting equipment. The team then disconnected the unit from the engine room and removed it from the thruster tunnel. It was then brought to the surface where it was overhauled by the OEM's technician, with assistance of our diver/technicians.

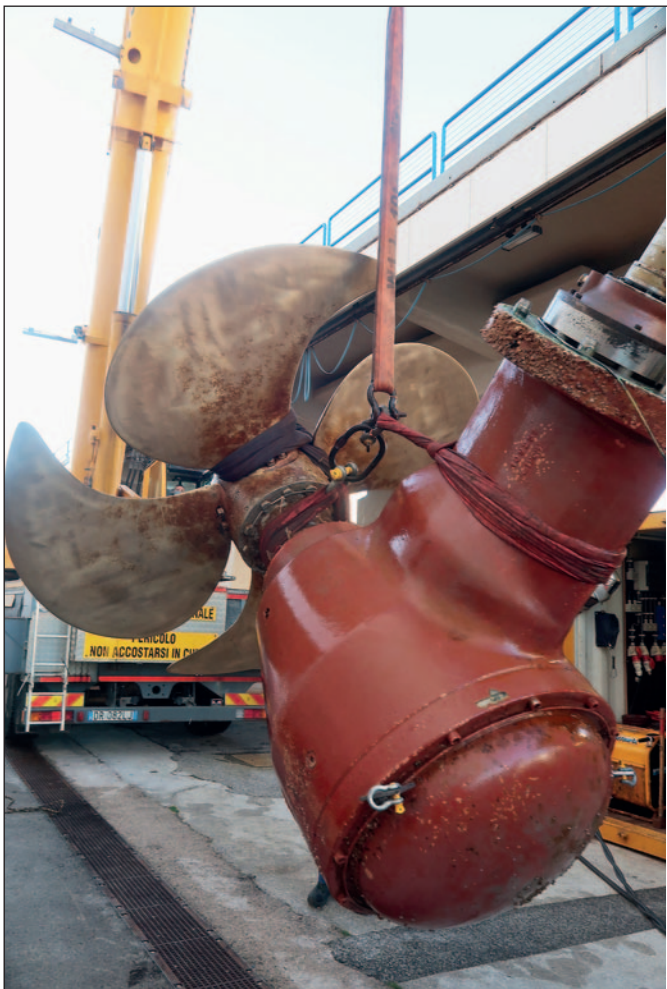
The bow thruster unit could be removed and reinstalled with the blades attached.

Because the thruster was fully assembled and prepared, it could be installed in its entirety without the need to create a dry environment in the tunnel as is required when the

blades are installed separately. Our diver/technicians lowered it into the water and brought it into the thruster tunnel. The team secured the unit and connected it to the engine room.

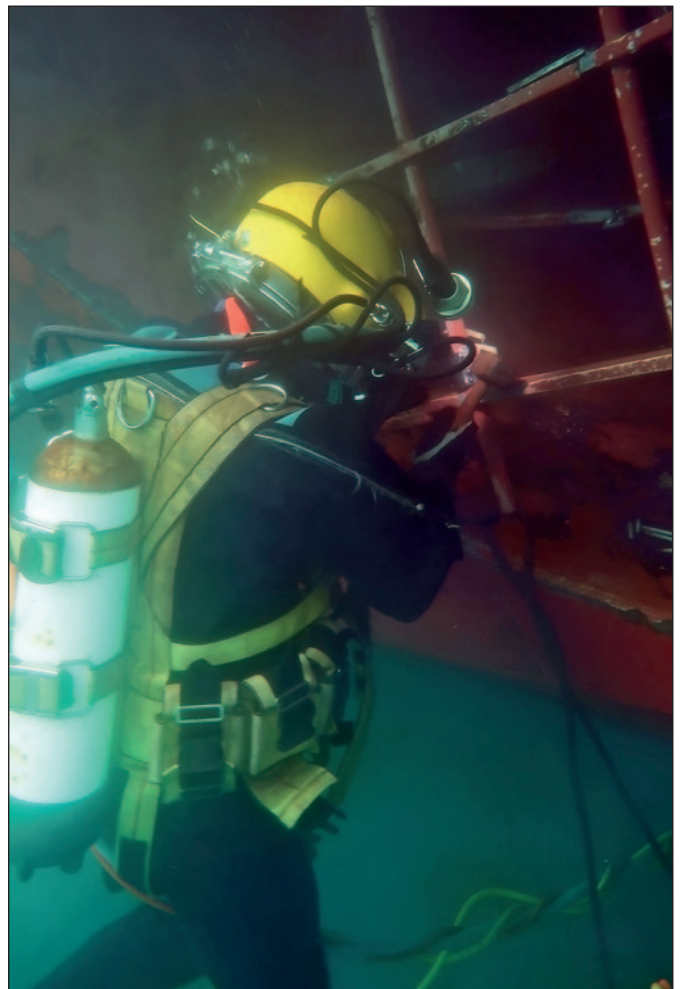
Hydrex diver working on the tunnel grids.

The divers first action was to take off the external thruster tunnel grids to provide access for removal of the unit. Next pad eyes were welded inside the tunnel to hoist the thruster unit up and down.

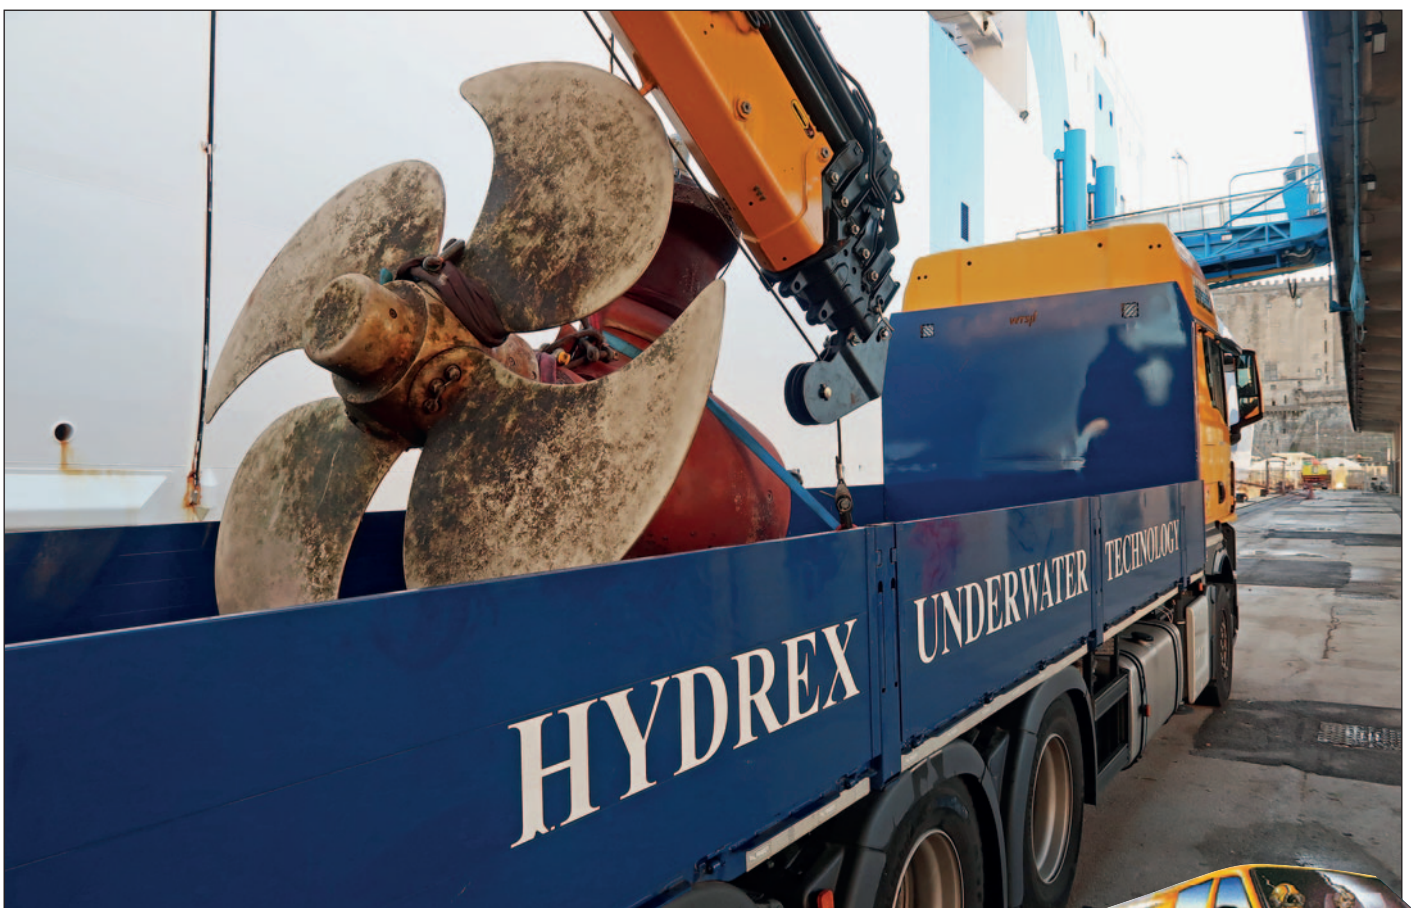
Bow thruster on Hydrex truck prior to overhaul.

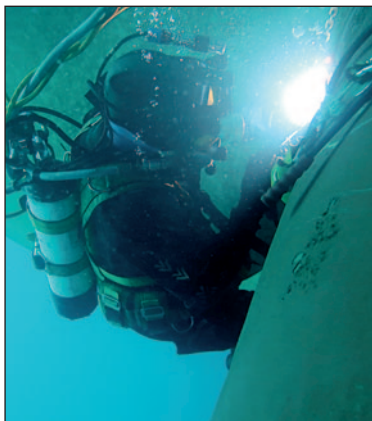
Stern tube seal repairs

Using our flexible mobdock method to create a dry underwater environment, we have carried out stern tube seal repairs and replacements underwater for many years now in cooperation with OEMs.

This technology brings drydock conditions to the ship rather than having to take the ship to drydock, saving a considerable amount of time and money in doing so.

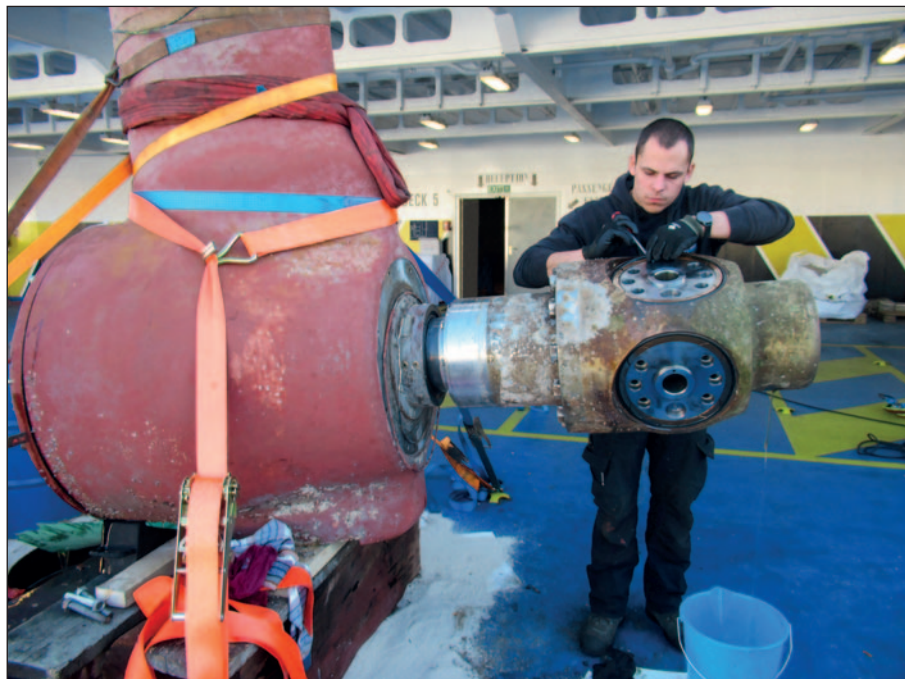
Hydrex technician during overhaul of the thruster.

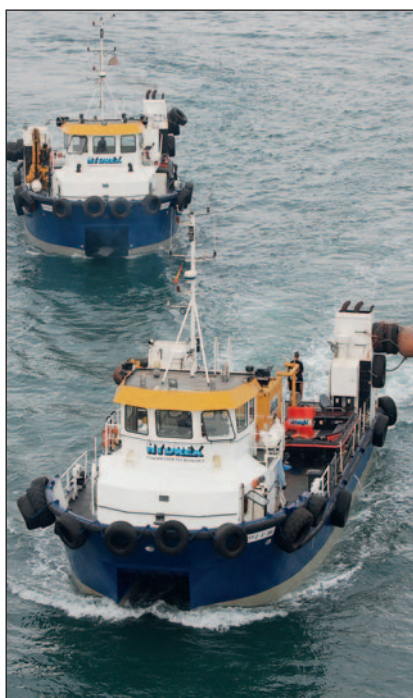
Both workboats are fully equipped as dive support stations.

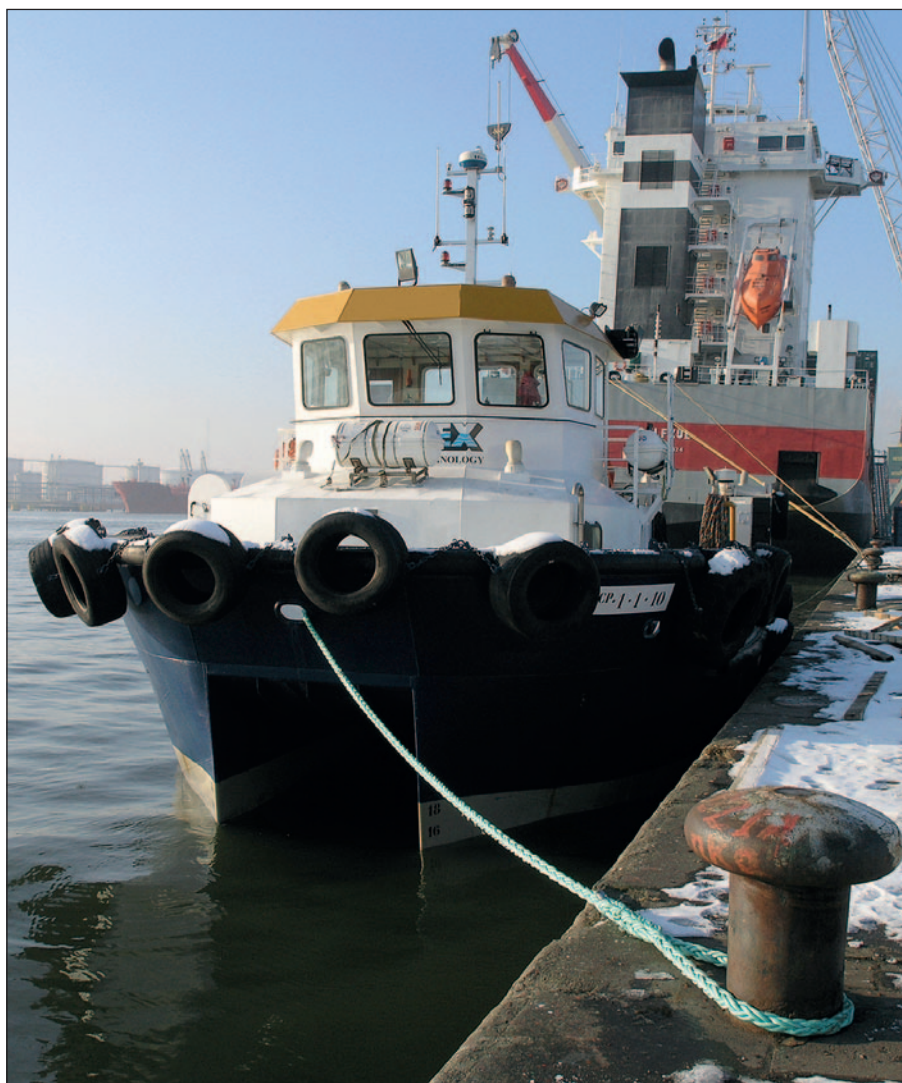
Hydrex workboat during operation.
