UNDERWATER TECHNOLOGY

Hydrex

Case Study II: Hull Repair

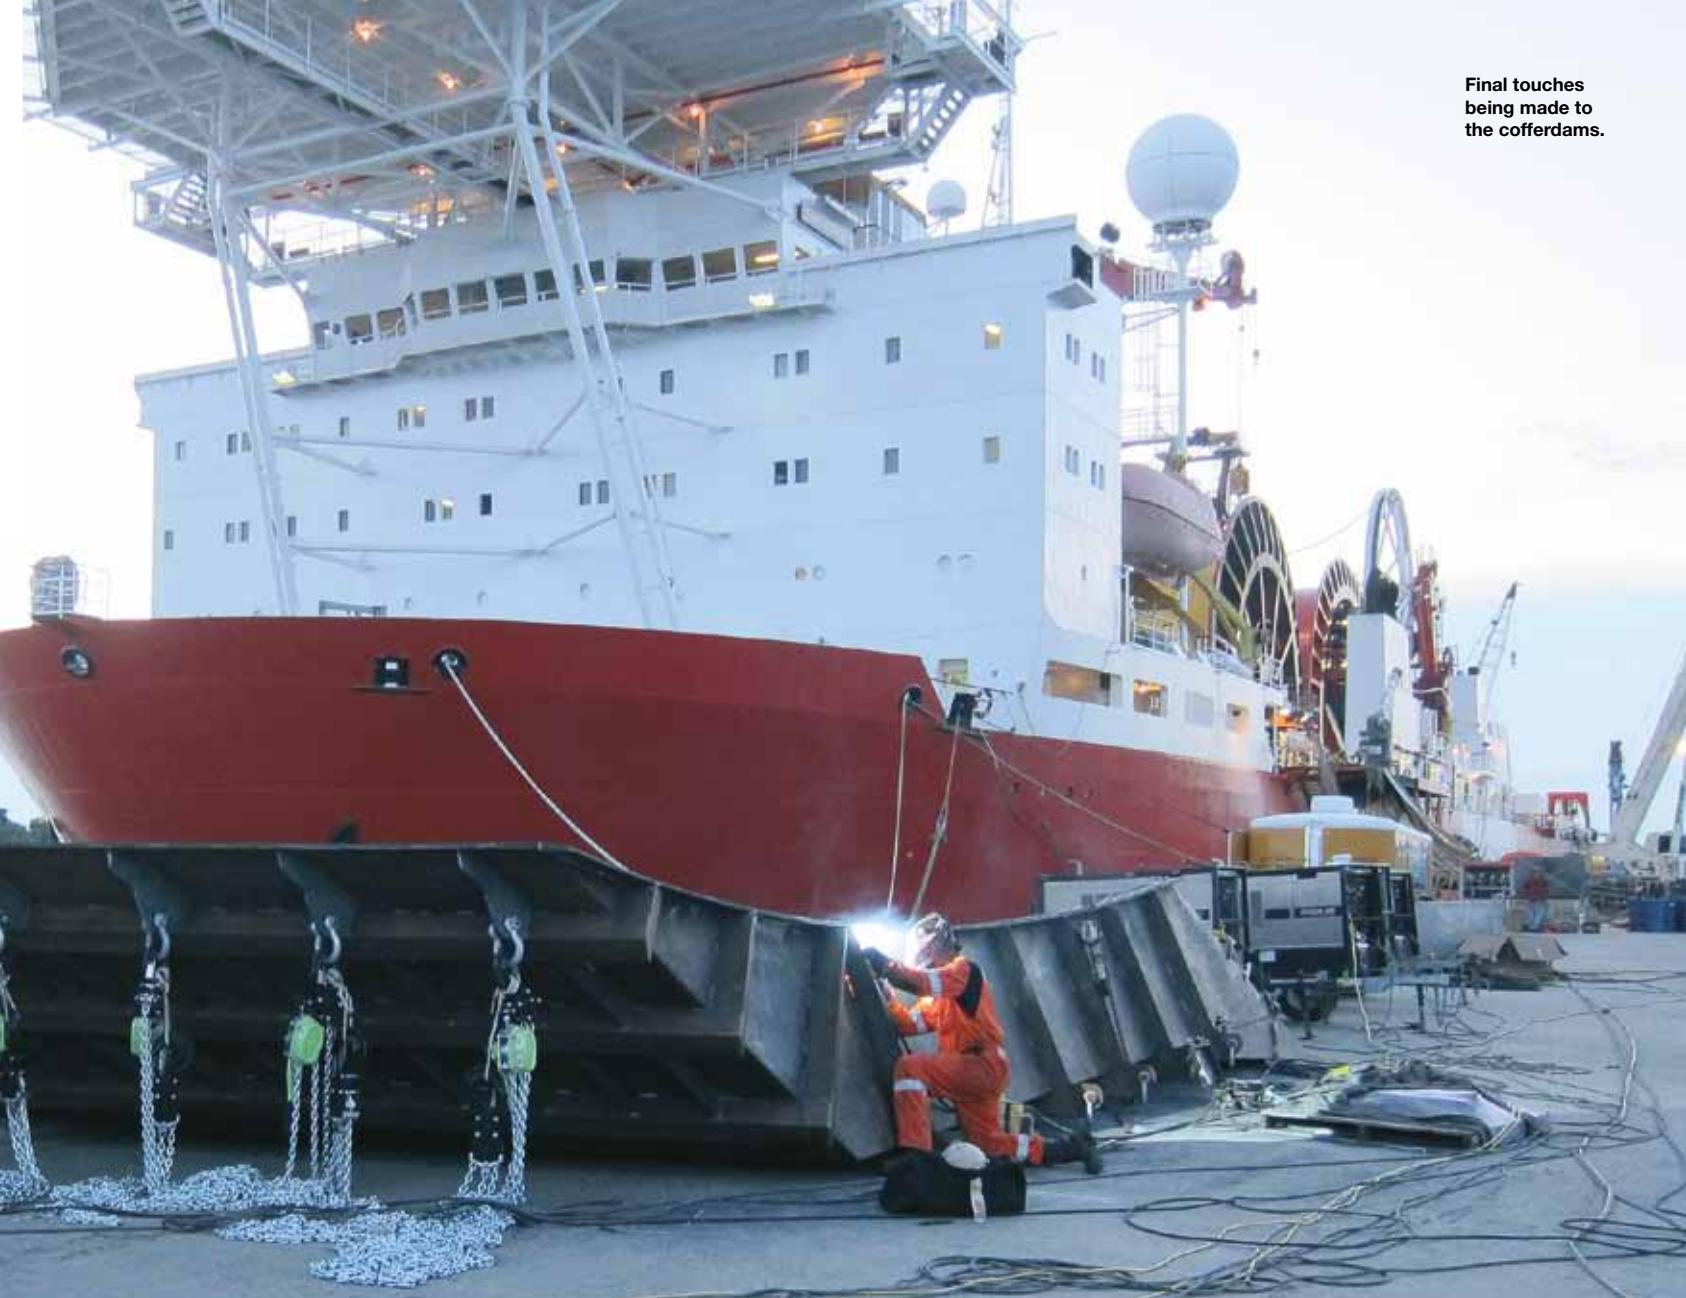
Final touches
being made to
the cofferdams.

was then removed from the thruster tunnel, creating a dry environment inside the tunnel. The required inspection and repair work could then be performed in conditions similar to those in dry-dock. Hydrex technicians removed the tunnel grid to gain access to the bow thruster unit, which was then inspected by original equipment manufacturer specialist who carried out necessary repairs. The Hydrex technicians then removed all the equipment from the tunnel and repositioned the grid. All that remained to be done was re-flood the bow thruster tunnel and detach the cofferdam.
