UNDERWATER TECHNOLOGY

Number 201

Underwater repairs in Poland allow ship to sail on after severe grounding damage

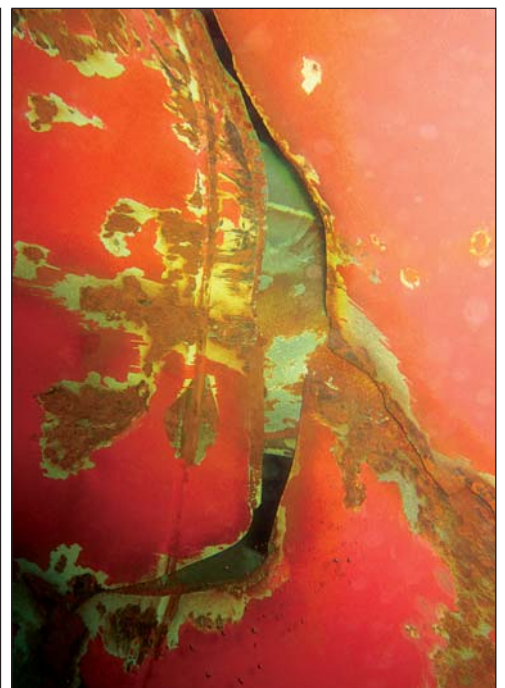
The bulker had suffered severe grounding damage.

In Gdansk the operation started with the installation of a flat doubler plate over the largest part of the 14-meter crack. The area around the last part of the crack was too badly deformed and required a special doubler plate that would fit the new shape of the hull.

The first step was to get accurate measurements for the area of damage on a hull that was badly deformed, pierced and indented. These measurements were subsequently used in the fabrication of the doubler plate. The plate was made at a local dockyard under supervision of a Hydrex diver/technician. Extra stiffeners were welded on the doubler plate as additional reinforcements.

The doubler plate was then secured to the hull with a weld all the way around. With the large crack completely closed off, the Hydrex team moved on to the 2-meter crack in the bulkhead.

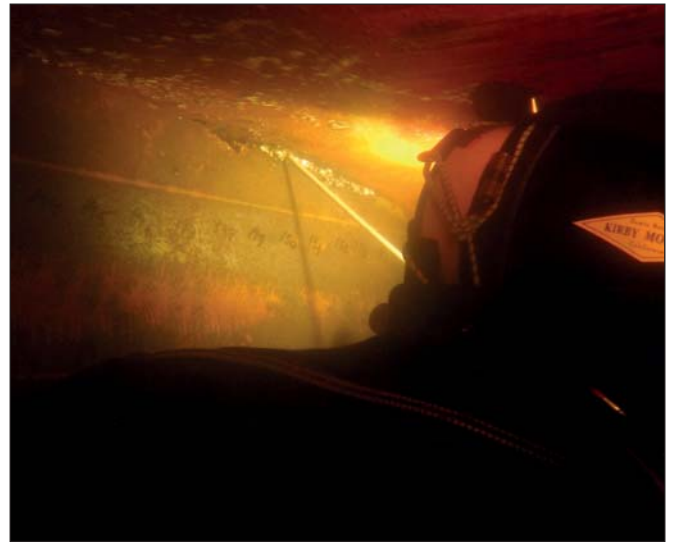
Hydrex diver/technician performing weld work.

The doubler plates were secured all the way round with a full penetration weld.

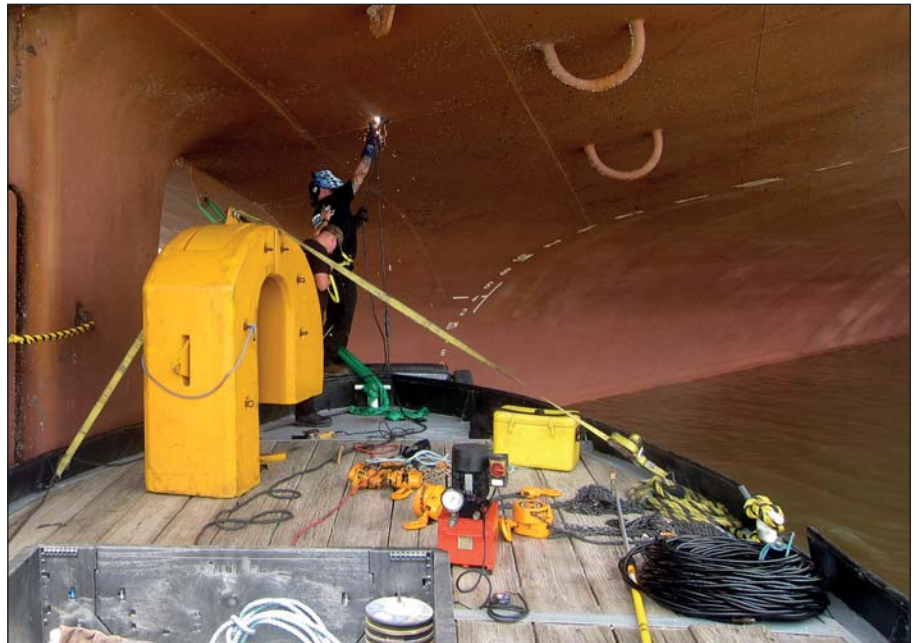
Preparation of the stern area for installation of the Hydrex straightening machine.

One of the bent propeller blades of a 245-meter oil tanker.

With the survey completed, the team positioned the straightening machine over the bend in the trailing edge of the damaged blade. In close communication with the team leader

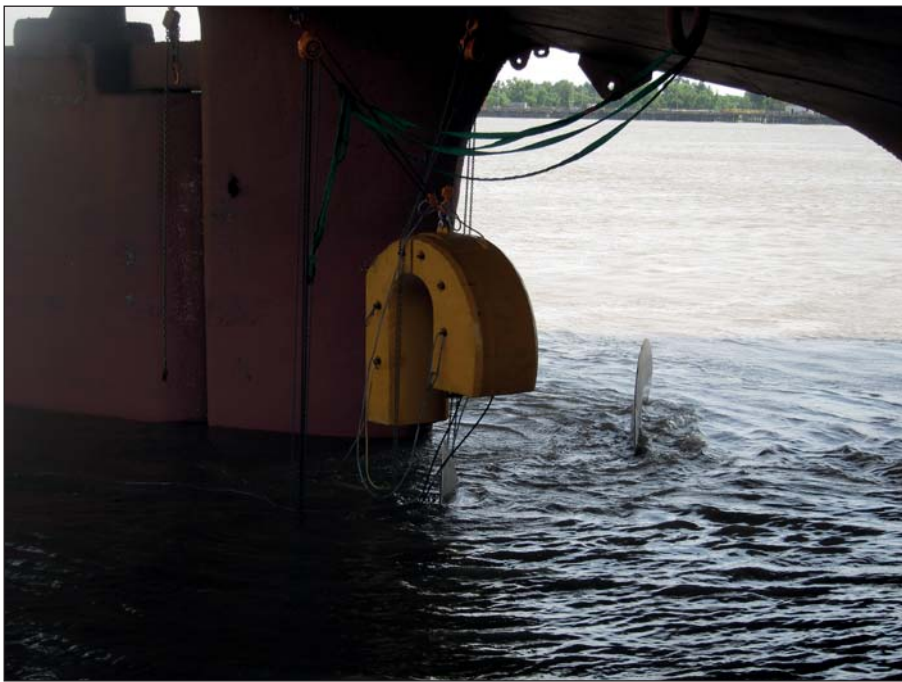
Straightening machine being removed after propeller blade straightening.

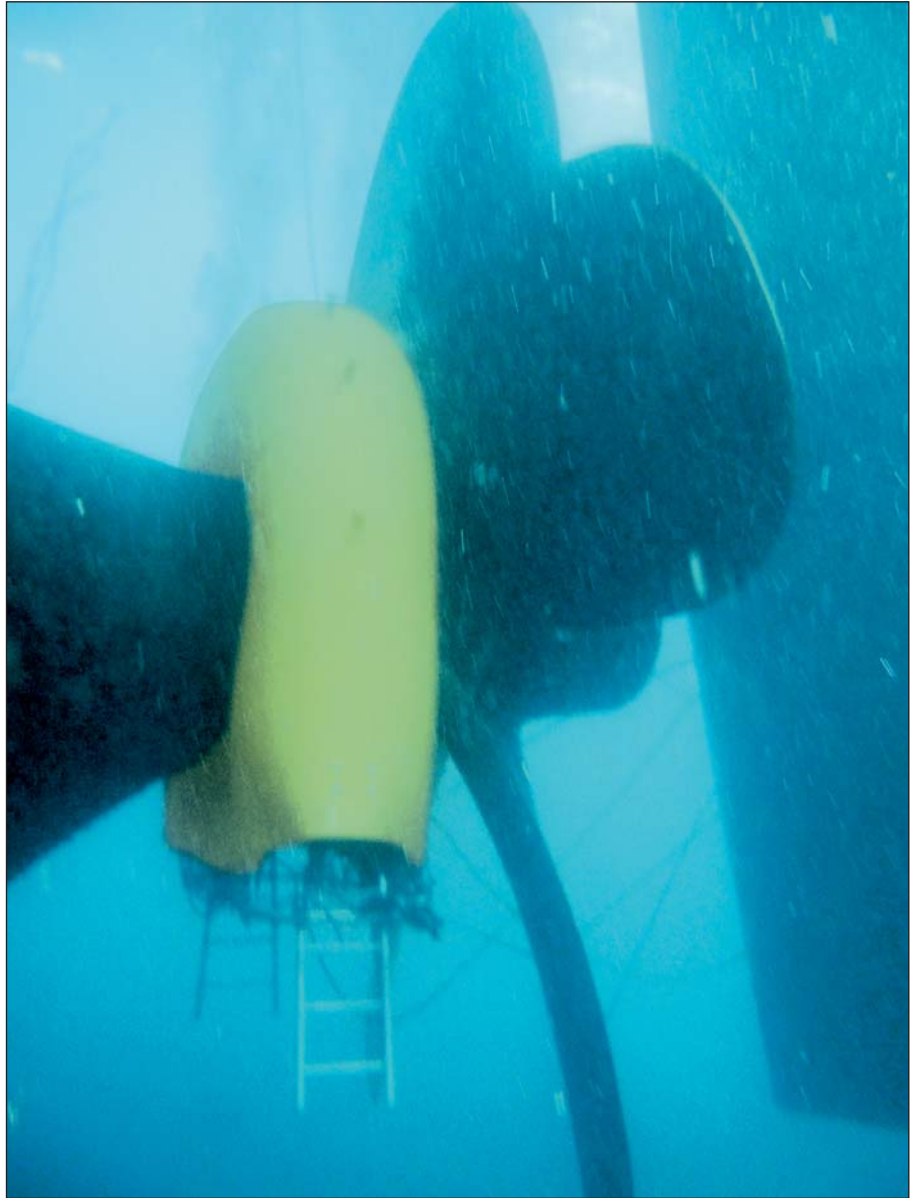
The Hydrex flexible mobdock creates a dry environment around the stern tube seals.
