# Permanent afloat repairs with unique rudder mobdock

# Rudder repair case studies

## Emergency flap rudder repair in Greenland

# Fast repairs in Spain and France put a spin on propeller cropping

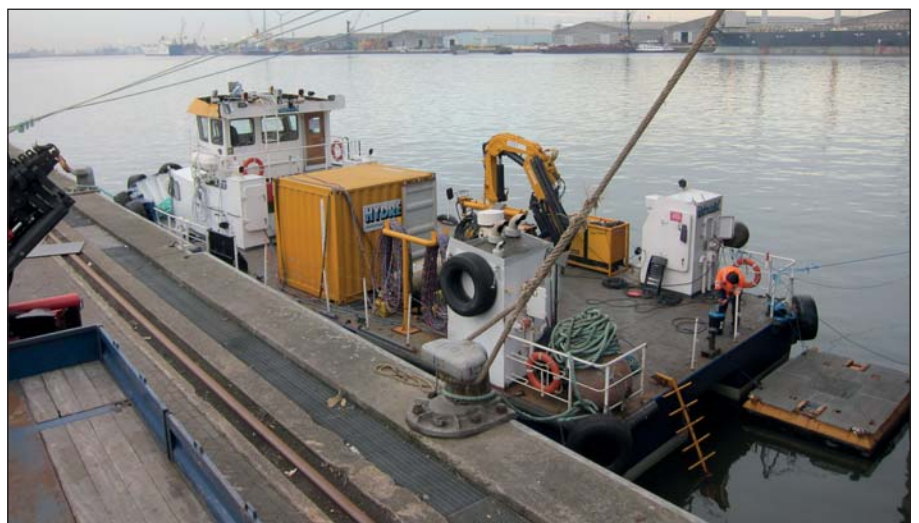
Our universal rudder repair mob-dock allowed the rudder specialist that was present to perform further inspections in drydock-like conditions. He could then make a detailed assessment of the situation of the rudder and observed several reasons

*Hydrex workboat with monitoring station and equipment on-site.*

Following the inspection we proposed a repair plan which was accepted by OEM and the owner. The team then carried out several repairs to remedy the rudder problems. First the existing rudder seal was tightened. Next the two wrong-sized rings were replaced with correct ones and both the upper and lower casing of the rudder seal assembly were reinstalled. The team pumped grease into the system and secured all nuts and bolts. The vessel could then continue its schedule with a fully functioning rudder.

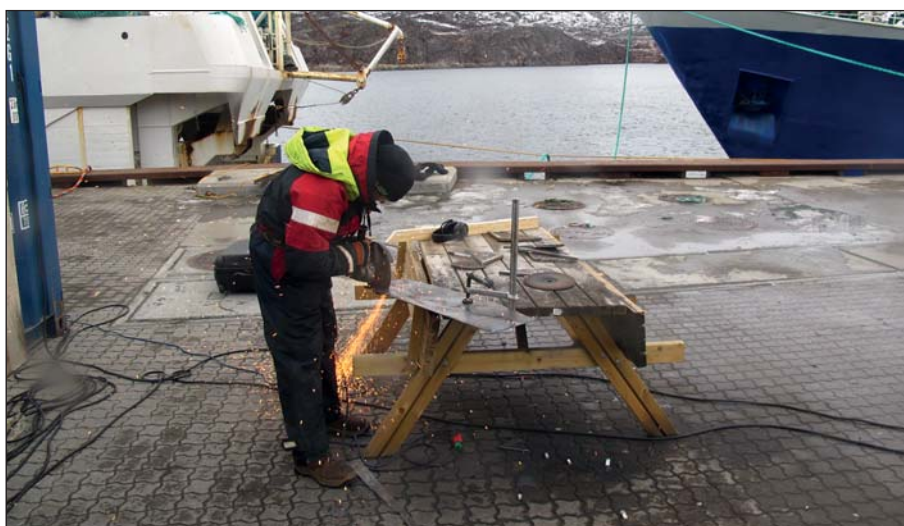
A secondary underwater inspection was performed by our divers to get the exact measurements for the girders. Next the plates were cut on-site by our team to the exact size. The rudder and its flap were then put in the neutral position. Three girders were placed on each side of the rudder, securing the flap to the rudder. The plates were welded underwater by our divers. A steering test was successfully performed, concluding the repair.

*Preparing the lightweight plates used to take exact measurements.*

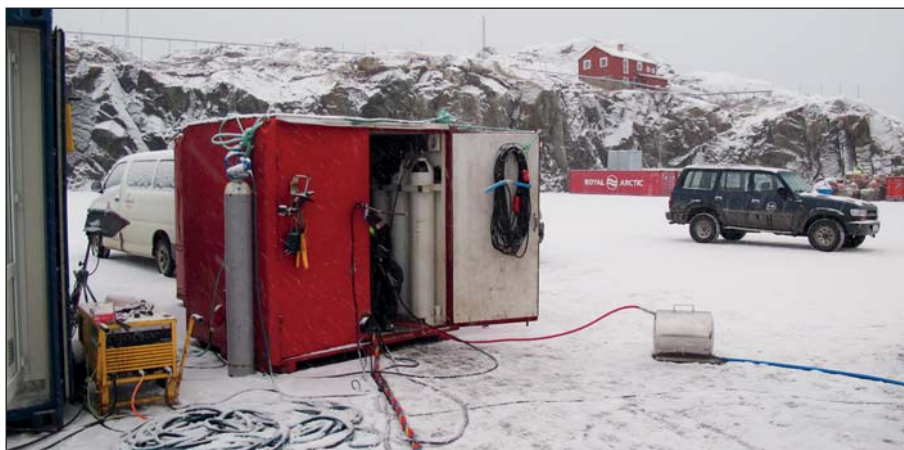
*Monitoring station in polar winter conditions in Sisimiut.*

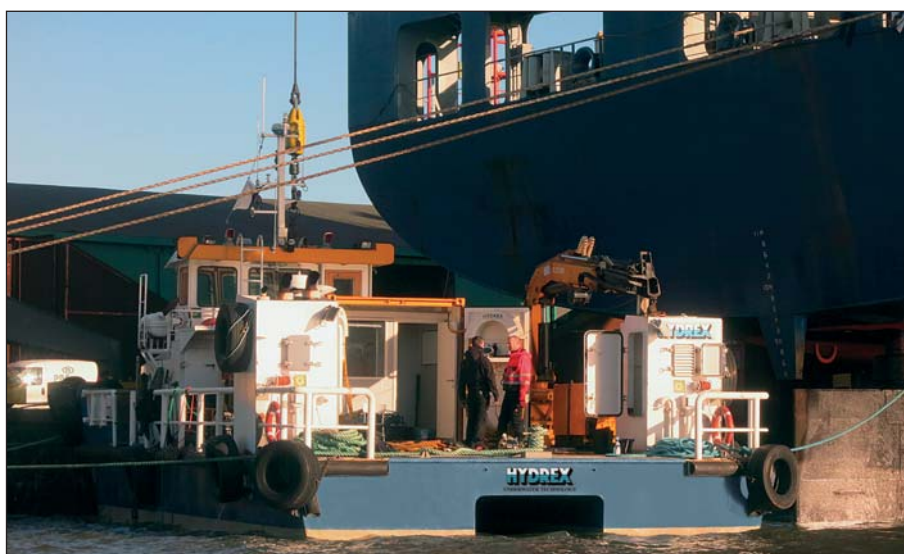
A Hydrex diving team mobilized to a 170-meter container vessel with one of our workboats. The team installed a doubler plate over the cavitated area of the rudder during the ship's scheduled maintenance stop in Rotterdam.

*Hydrex team members on workboat discussing the operation.*

When the rudder had been prepared our certified diver/welders fitted the plate and secured it. The team then installed anodes on both sides of the rudder for further protection. This concluded the repair.
