A world's first in underwater repair: the insertion of a complete, prefabricated replacement hull section at anchor

Navios Sagittarius: behind the scenes at a remarkable salvage operation

In 2011 Hydrex was the chief subcontracting company for the inspection, planning and repair work when the bulk carrier *Navios Sagittarius* had run aground on the Tonneberg Banke, about 23.5 miles east of Frederikshavn, Denmark.

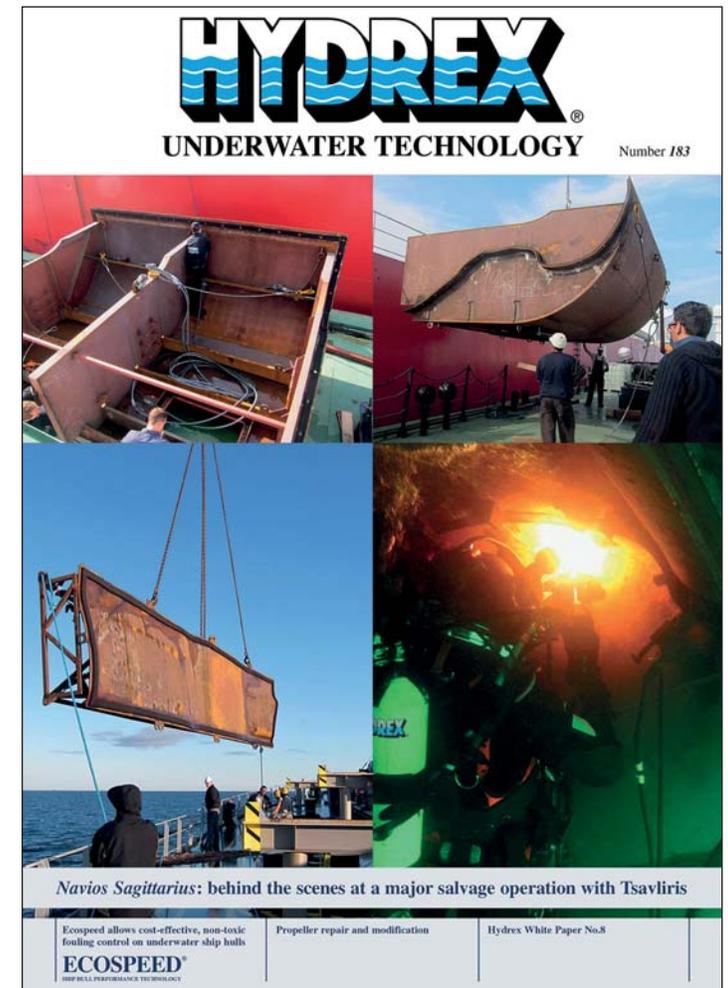
It was the first time that an entire hull section had been prefabricated and inserted into a ship's hull after cutting away the damaged plates, with the ship still afloat. This permitted the vessel to continue on a major voyage without the need to drydock. ■
