# Save the day

**The insertion of a complete, prefabricated replacement hull section in a badly damaged ship at anchor is believed to be a world-first in underwater repair**

David Phillips, Hydrex NV

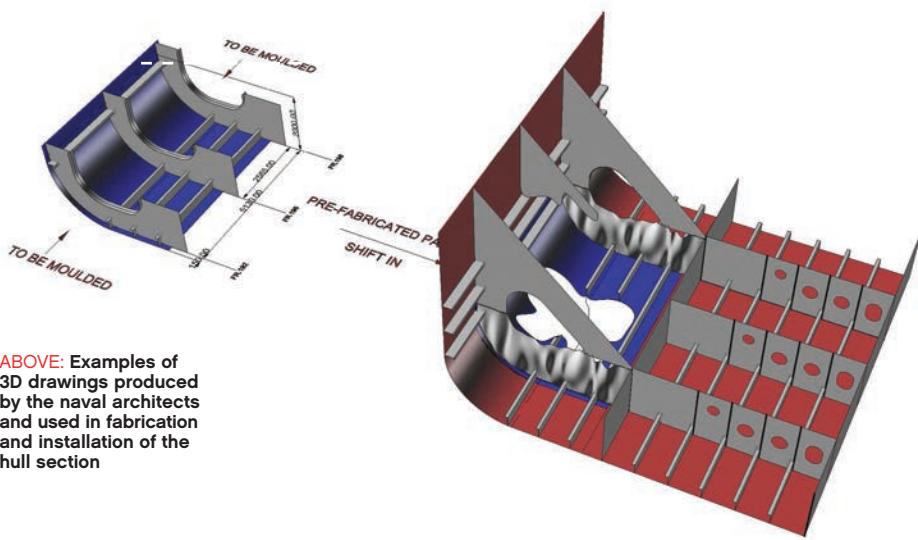
**ABOVE:** Examples of 3D drawings produced by the naval architects and used in fabrication and installation of the hull section

Using these measurements and the original drawings of the ship, the naval architects were then able to produce final drawings from which a doubler plate could be fabricated and installed. Using these drawings, a section was prefabricated at the local dockyard to repair the large hole, and a doubler plate was constructed to cover the long damaged area, with three holes in the area of double-bottom ballast tank (DBBT) No 1. The steel used had to be 12mm thick, which is too thick for easy, rapid bending, so the plates had to be measured and cut to fit the hull as accurately as possible.
