WELDING *Journal*

March 2012

UNDERTAKING A COMPLEX UNDERWATER REPAIR

A damaged freighter needed repairs to stop a leak, prevent buckling, and keep cracks from spreading so the ship could sail to where she could unload

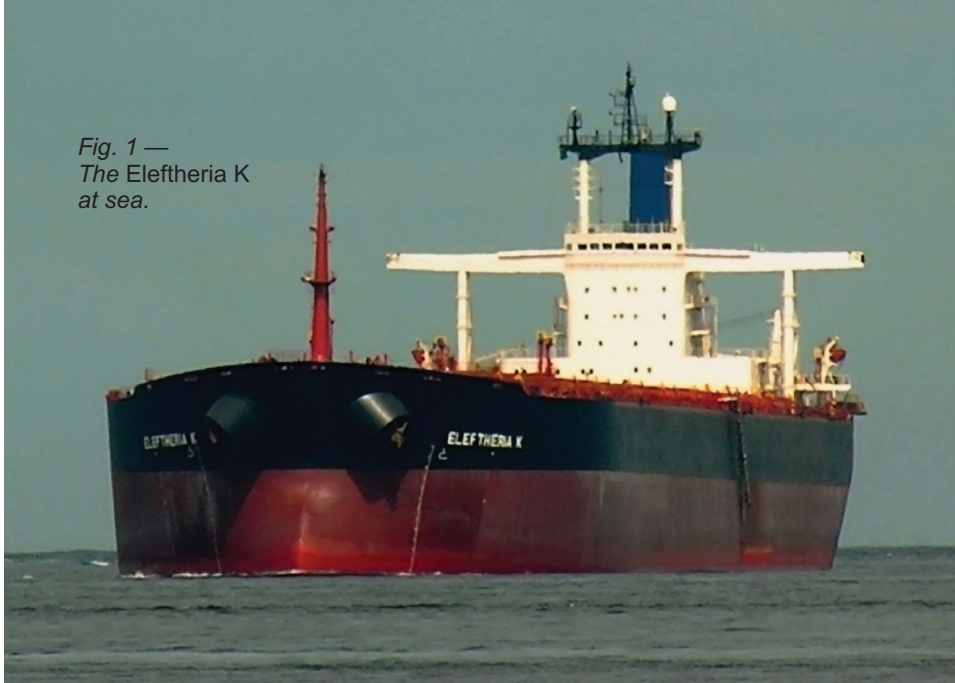
Fig. 1 —
The Eleftheria K
at sea.

The *Eleftheria K* (Fig. 1), a Capesize-class bulk carrier, ran aground at the mouth of the Suez Canal in July 2011. European Navigation, Inc., Piraeus, Greece, operates the ship, which was built in Japan in 1985. The *Eleftheria K* is 297 m long overall, 50 m in the beam, 214,263 metric tons DWT (dry weight), with a 26.7-m depth, 19.8-m draught, and a displacement of 240,311 tons.
