# ON SITE STERN SEAL REPAIRS

Around the world the Belgian specialist Hydrex has carried out repairs and replacements on all types of seals in-situ, and in most cases underwater, for a number of years

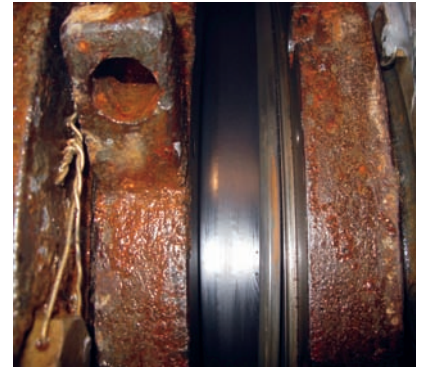
revealed that a fishing net had been caught in the assembly and was tangled up around the entirety of the seals. The flexible mobdock was then installed. This created a dry working environ-

ment for the divers at a depth of 12m in which they could replace the damaged seals.
