Emergency hull repair on ferry *Texelstroom*

Underwater stern tube seal repair on container ship in Algeciras

KEEPING SHIPS IN BUSINESS

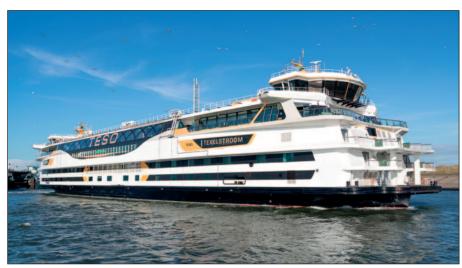
The ferry Texelstroom sails between Den Helder on the Dutch mainland and Texel, the largest and most populated Dutch Wadden Sea island.

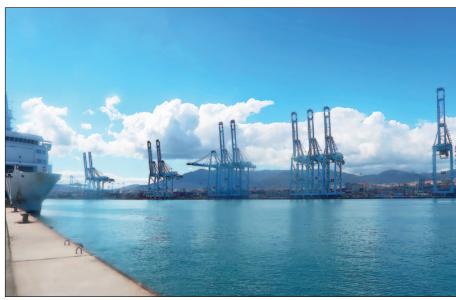
Algeciras is an ideal location for seal repairs and other underwater operations.
