Scrubber overboard pipe operations on sister vessels in Denmark

Rudder repairs in Zeebrugge, Dunkirk and Le Havre

# Scrubber overboard pipe operations on sister vessels in Denmark

# Rudder repairs in Zeebrugge, Dunkirk and Le Havre

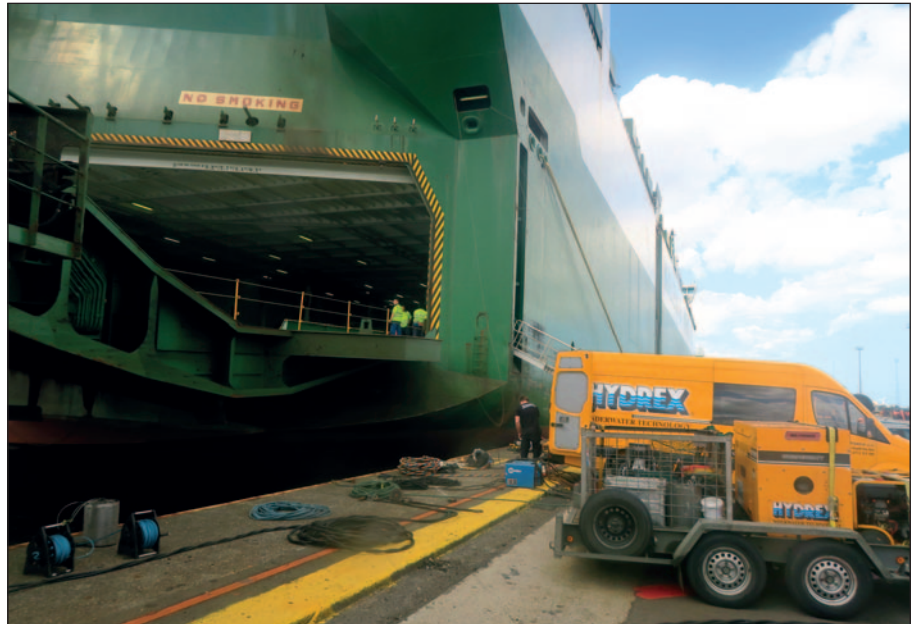
A 230-meter ro-ro ship in Zeebrugge had suffered cracks on both sides of the rudder flap. On the starboard side a branching crack was found

*Hydrex team preparing for rudder operation in Zeebrugge.*

while a single crack was present on the port side.

Our divers first drilled arrests on all extremities of the cracks to prevent

them from spreading. They then positioned C-shaped plates over the crack arrests and secured these with wet welding.

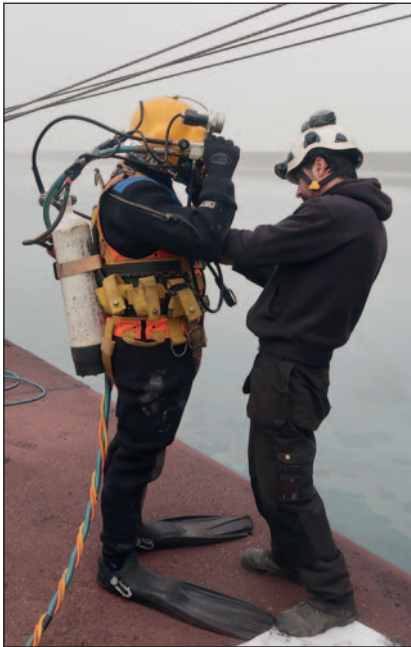
On two 229-meter sister bulker ships in Le Havre and Dunkirk respectively, cracks were found on the upper pintle corner of the hinge that connects the rudder flap to the main rudder blade. Fortunately these cracks could be repaired by grinding them out after a crack arrest had

*One of our divers getting ready for underwater rudder operation in Dunkirk.*

been drilled. The affected area was then filled with welding.
