Looking back at 2023

# Looking back at 2023

## **45-ton cofferdam repair after a severe grounding**

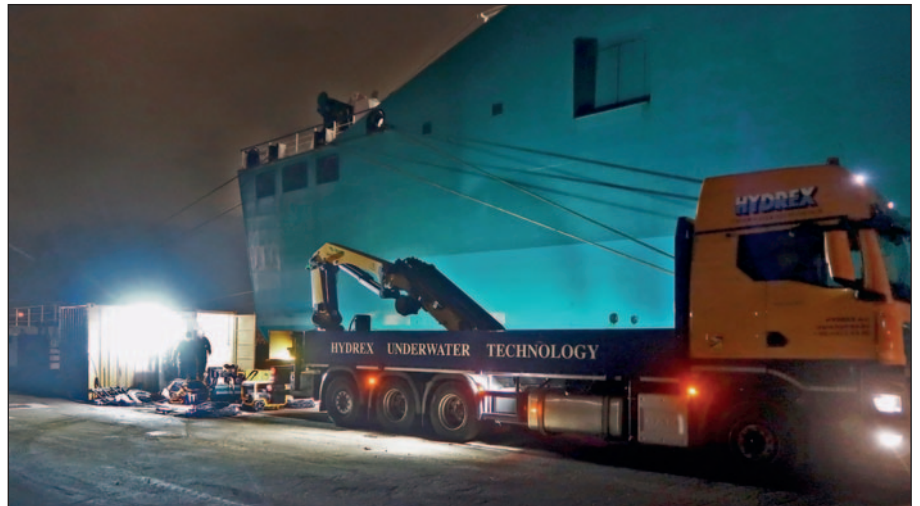
One of our diver/technician teams carried out an underwater stern tube seal repair on a ro-ro ship berthed in Algeciras. The ship was leaking oil, making on-site repairs necessary.

*Hydrex night shift in Algeciras.*

Working together with the OEM allowed us to provide our customer with original spare parts which guarantees the best quality material. A technician from the seal manufacturer was present during the repair.
