Underwater hull repairs save time and money

Underwater bow thruster removal and reinstallation in Zeebrugge

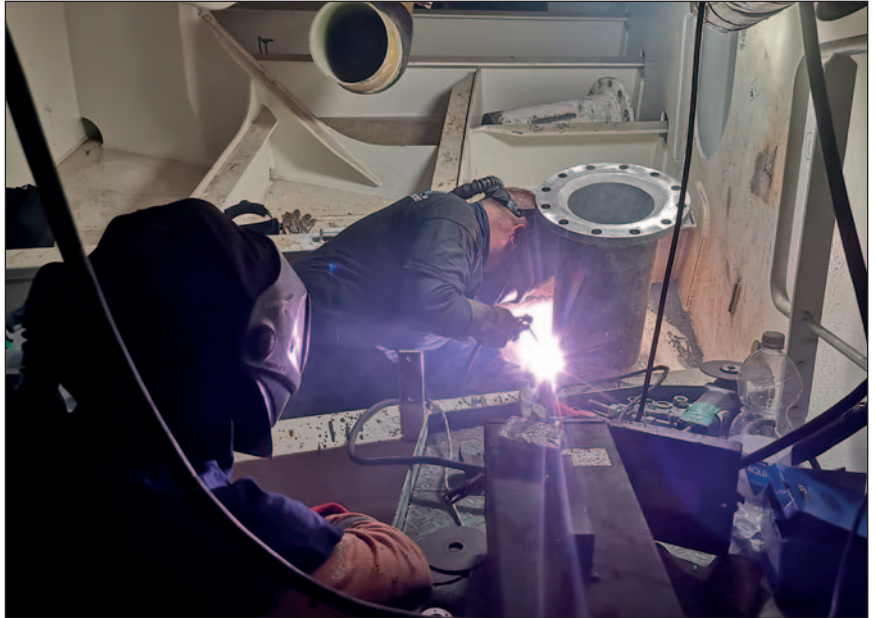
Scrubber pipe repairs and lasting protection

Exhaust scrubbers filter out all harmful toxins from exhaust gases of marine diesel engines. These hazardous pollutants can severely corrode the pipes of the scrubber. Using the experience we have accumulated over the years allows us to assist you at moment's notice if this happens.

corroded exhaust pipe while your vessel stays on schedule, but we can make sure that you will not have to call us again in a few months time for the same problem. This is done by coating the pipes with a highly corrosion resistant coating called Ecospeed.

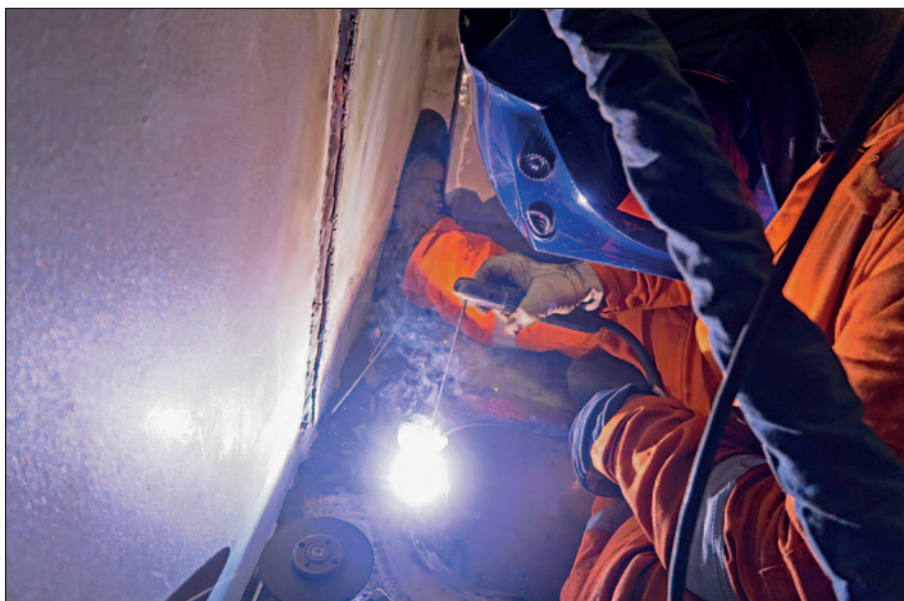
All welding work is done by our certified welders.

After the mobdock was installed, the frame covering the damage was removed. This allowed the team to cut away the damage and the surrounding area. A new insert plate was then positioned and welded following our class-approved procedure.

An independent inspector carried out ultrasonic tests and the repair was approved by the classification surveyor who was present during the operation.

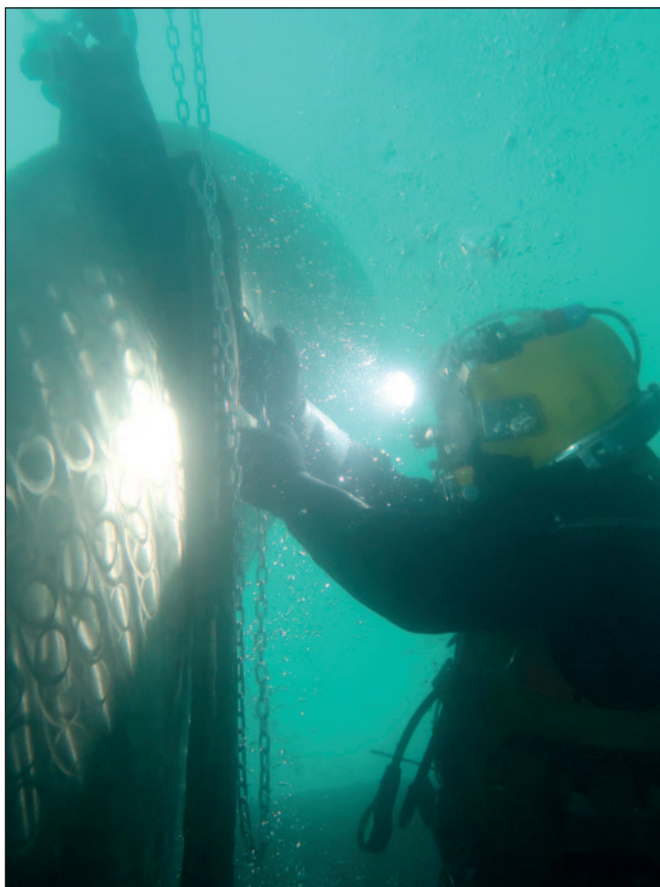
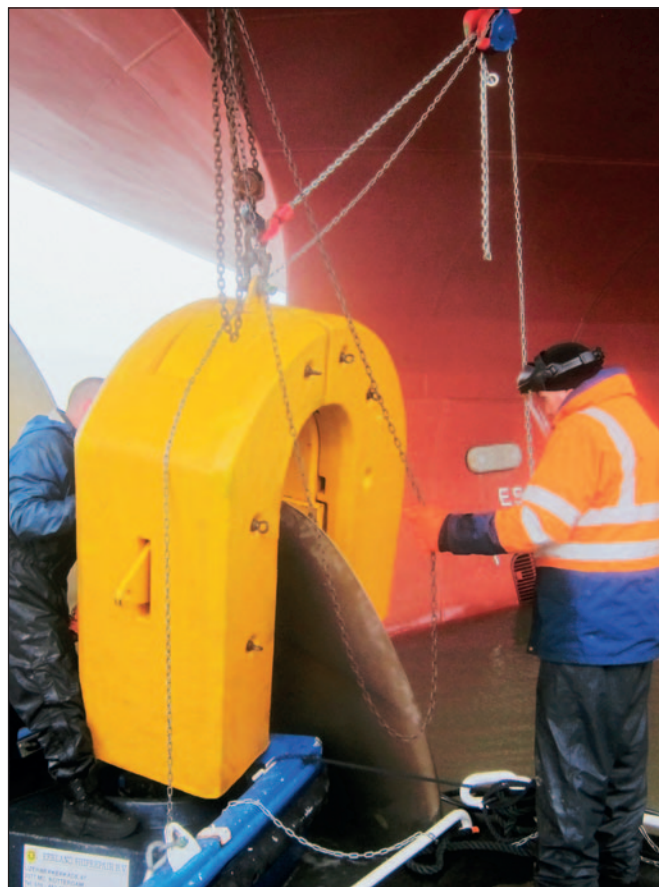
Inwater propeller repairs

When damage to propellers occurs due to impact with ice and other debris we can help you, even if the damage is quite extensive. Our teams can restore the propeller's balance and efficiency.

By taking advantage of the in-house developed cold straightening technique, damaged blades can be straight-

Our teams can also carry out any other repair work on the propeller. Examples of this are the removal and reinstallation of entire propeller blades or replacement of the propeller seal ring.
