UNDERWATER TECHNOLOGY

Magazine

Number 331

Double stern tube seal repair on roro vessel in Tasmania

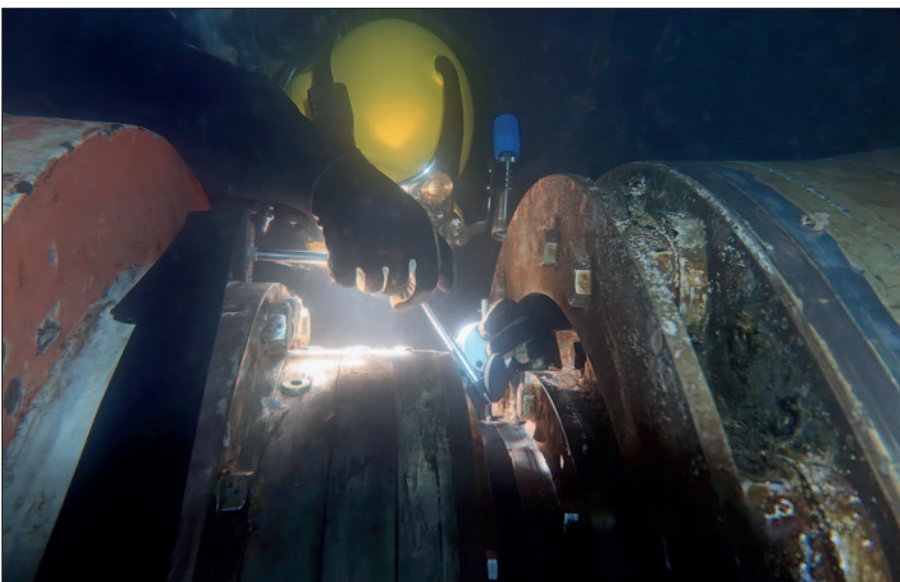
Hydrex diver taking shaft readings.

The exact same procedure was followed on both stern tube seal assemblies. The split ring was first disconnected and brought to the surface to be cleaned. After cleaning the entire assembly, the divers removed the first seal and replaced it with a new one which was then bonded. This was done in cooperation with the supervising OEM technician. The procedure was repeated with the other three seals.

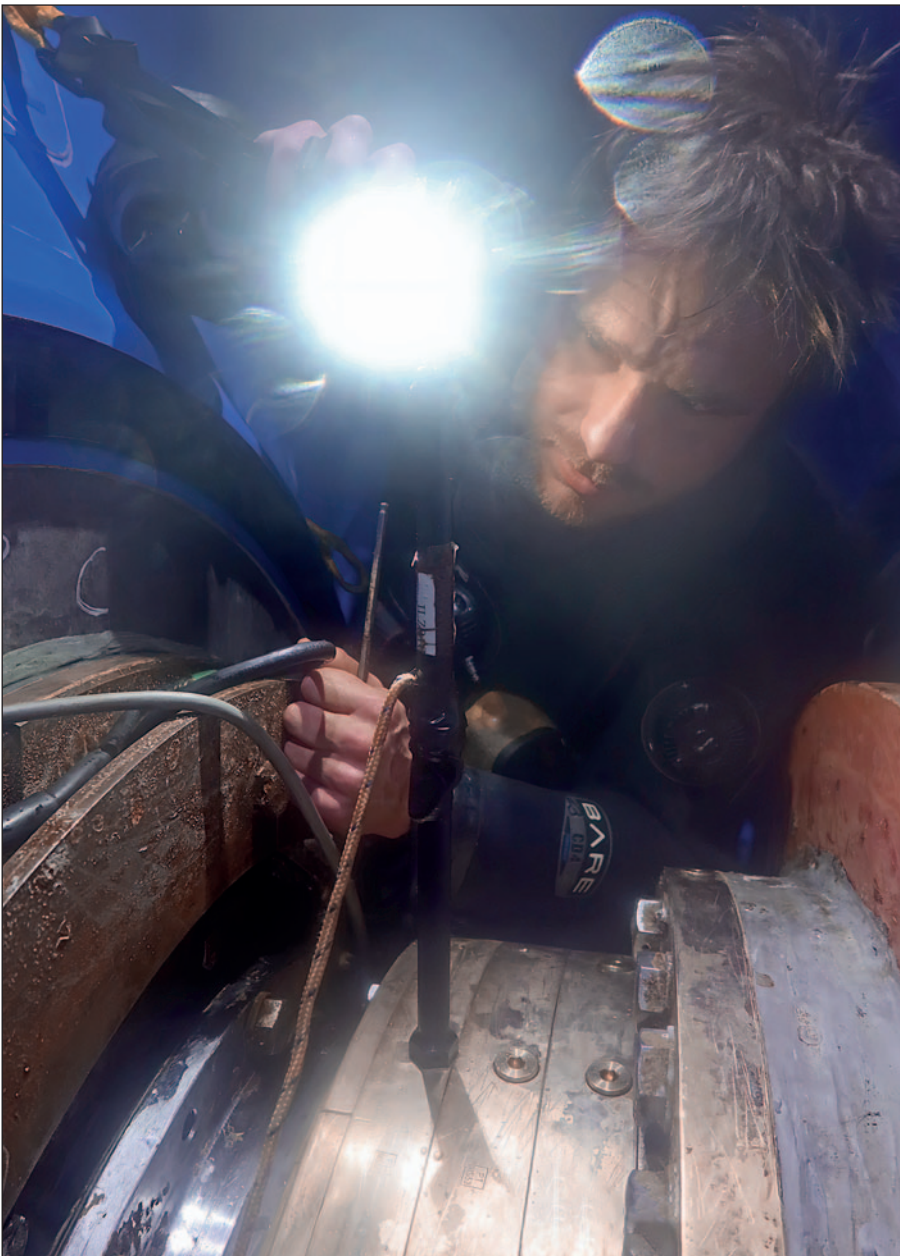
Hydrex diver working inside the mobdock.

After the inspection the divers cleaned the assemblies and installed both flexible mobdocks. By doing this they created a dry underwater environment so that they could work in drydock-like conditions.

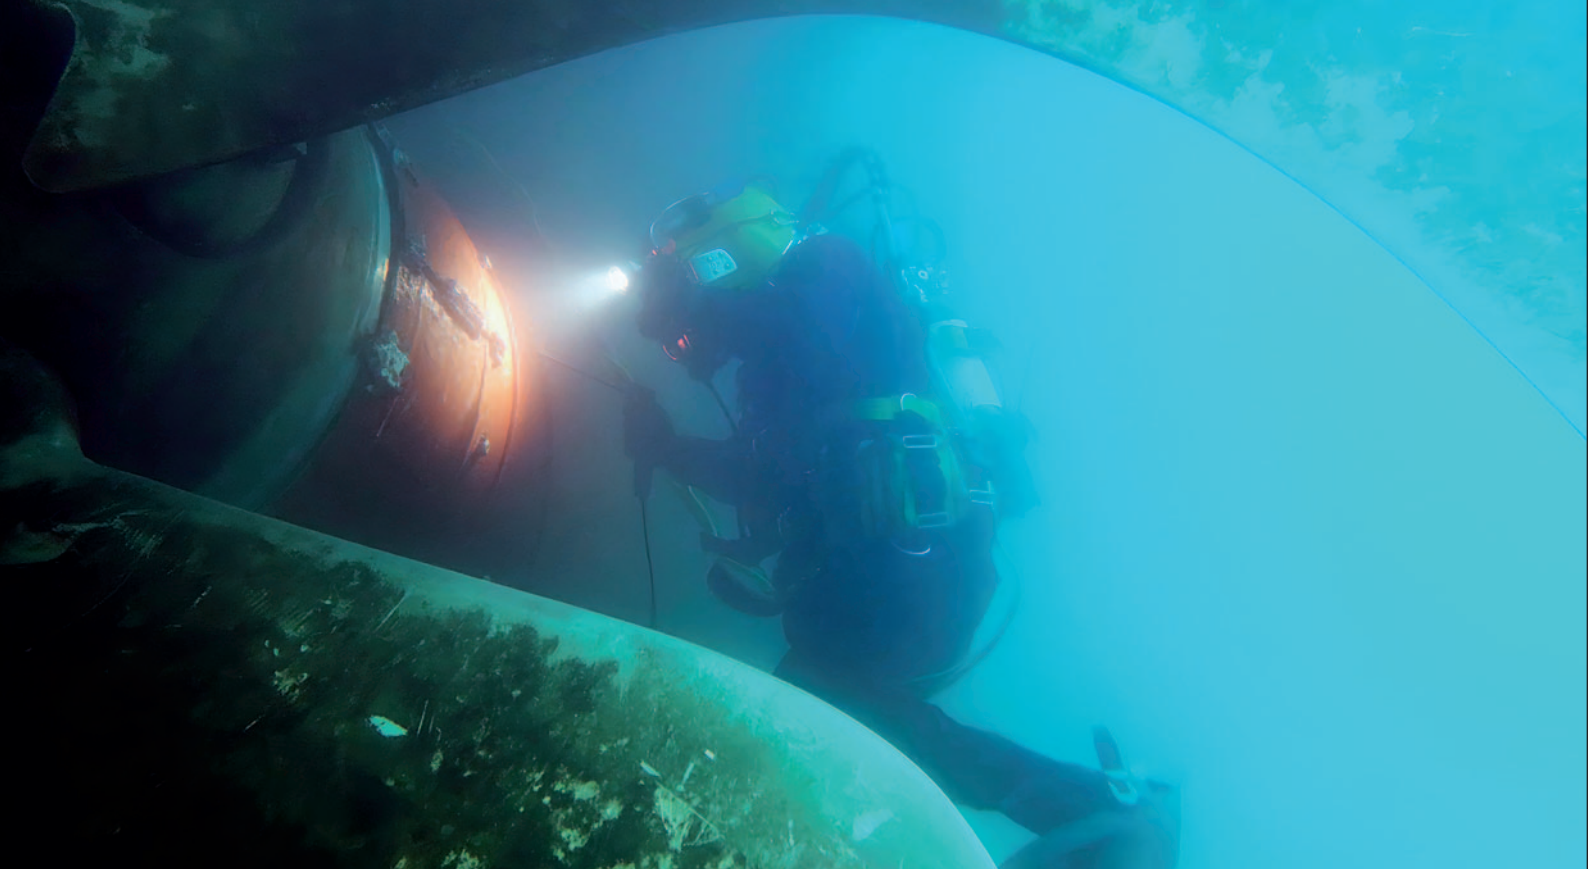
One of our divers during reinstallation of the first rope guard.

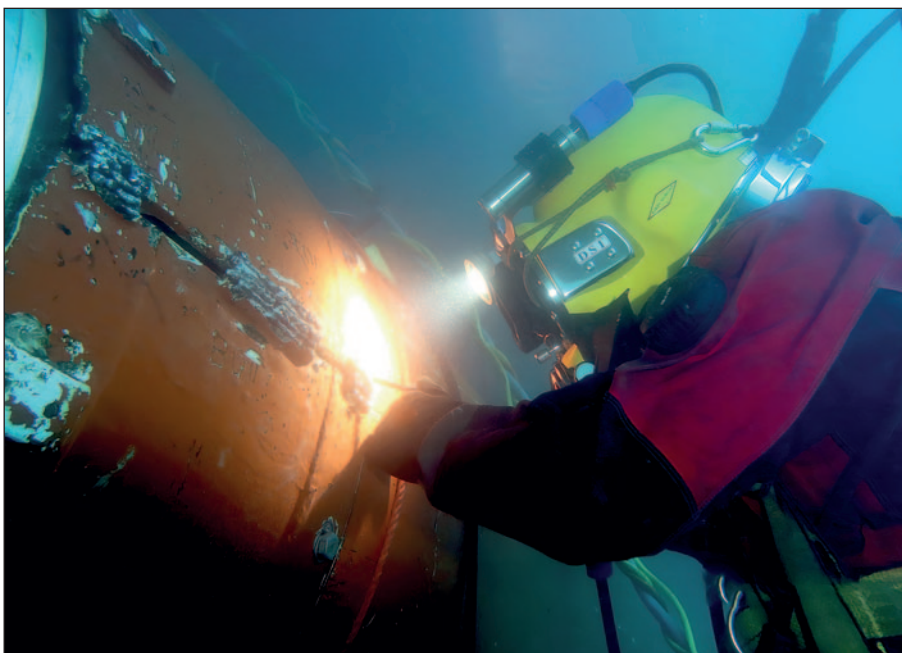
Reinstallation of the second rope guard.

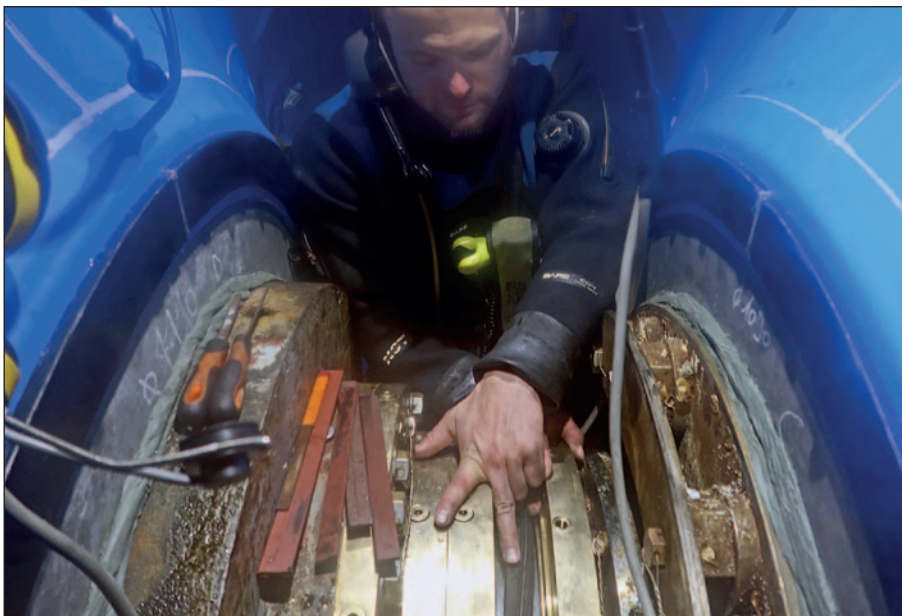
Two mobdocks were installed at the same time to work on both assemblies simultaneously.

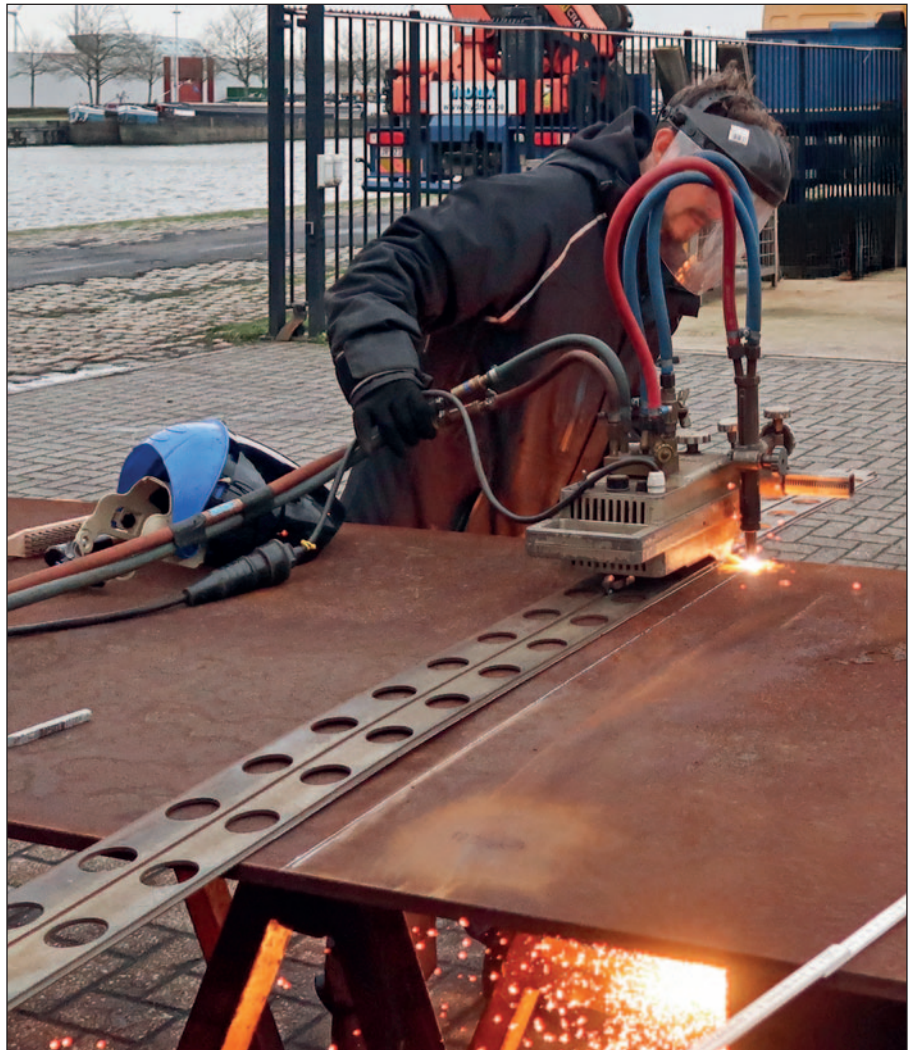
A 164-meter chemical tanker needed to have an insert installed on a damaged section of its bottom plate.

New insert prepared at our workshop.

The damaged plating was underneath the sounding pipe in one of the ballast tanks. A temporary repair had been performed, but a permanent repair was needed to avoid going to drydock.

A round section of the damaged plating with a diameter of 200 mm was then removed. The size of this area was decided in communication with the classification society and the owner. Next our team prepared the edges of the hole for the insert, and positioned the new plate. The insert was then welded following the Hydrex procedure for insert plates, using a full penetration weld.

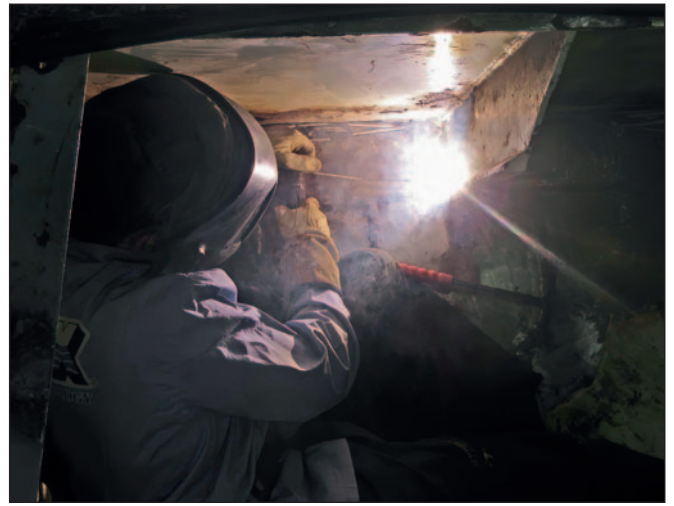
Hydrex welder during operation in Amsterdam.

A similar operation was performed close to home on a 144-meter oil tanker during its stop in Amsterdam. In this case the damage was situated in the ship's engine room and an insert measuring 300 by 300 mm was installed.

The same standard procedure as in Trinidad was used. Our divers have carried out many insert repairs on all types of ships and in all areas of the hull, so they finished the operation very quickly without any delay.

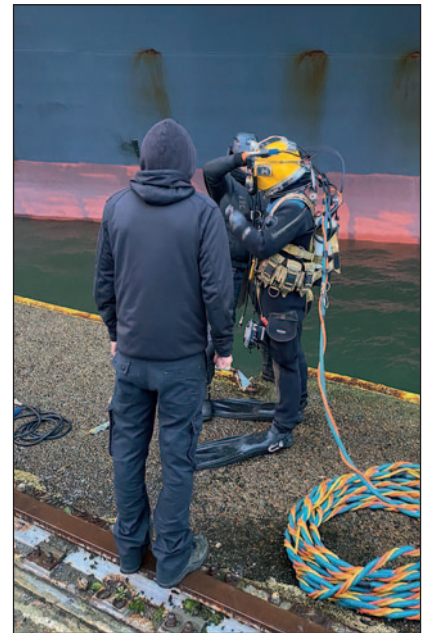
Diver getting ready for operation in Zeebrugge.

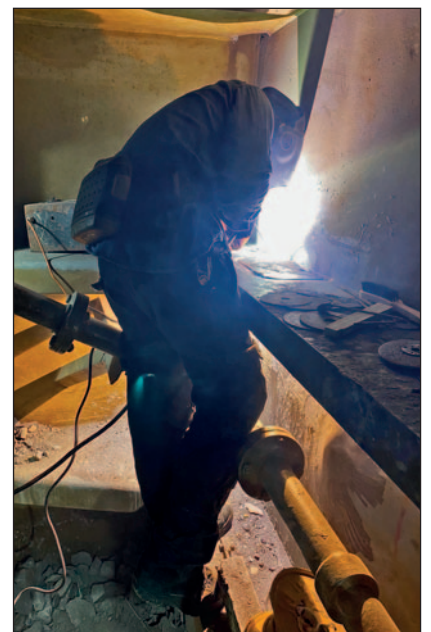
One of our welders during crack repair in Zeebrugge.

For smaller damage such as crack repairs, it is not always necessary to install a new insert. This was the case for a 229-meter car carrier in Zeebrugge, Belgium that had a leak in its forepeak ballast tank. As our fast response centers have a large stock of state-of-the-art equipment ready, mobilization for smaller operations like this can be almost immediate.

the crack and take the exact measurements. The crack was ground out over its entire length and filled with our class approved full penetration welding.

The repair was inspected by an independent inspector and approved by the attending class surveyor. Our team concluded the repair by reinstalling the frame and removing the cofferdam.
