## FAST PROPELLER REPAIR

## LARGE DREDGER REPAIR

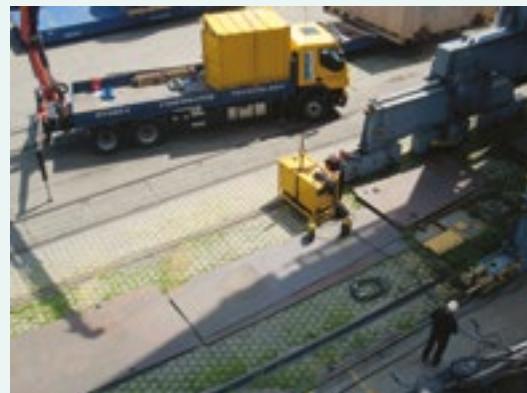
From top to bottom:  
*The Hydrex team and equipment arriving on site; Cutting the opposite blade of the damaged propeller to keep the balance; The cropped and buffed blade*

After the equipment arrived at the vessel's location, the team started the operation with a detailed survey of the affected propeller blade. The team then used the information acquired during the inspection to calculate and determine the correct measurements needed to modify the trailing edges of the propeller blade. Next the divers cropped the blade and ground its edge to give it the correct radius. The opposing blade was modified using the exact same cutting line, to give

the propeller back its balance.

When the cropping was complete, the Hydrex technicians buffed the blades to make sure that any remaining loss of efficiency would be minimal.
