New techniques meet need for speed

Diver-technicians from Belgium-based Hydrex have recently carried out a variety of work to tight time scales

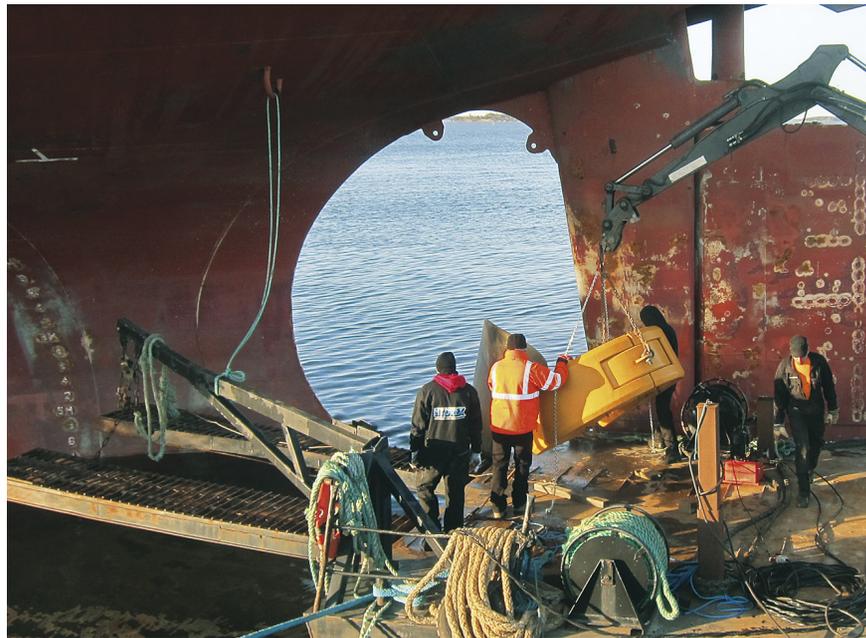
Diver/technicians positioning the latest version of the Hydrex cold straightening machine over a bent propeller blade

By taking advantage of the in-house developed cold straightening technique, damaged blades can be repaired underwater, allowing the ship to return to commercial operations without the need to drydock, while the optimum efficiency of the propellers can be restored by bringing the blades back close to their original form. Verhoeven says: "The cold straightening machine has been in use for quite some time now but our research department has been looking into ways to enhance the technique even further to improve our services. A new model of the straightening machine was recently put into service, and this is compatible with the existing model and can be used to restore more severely bent propeller blades."
