International Tug & OSV

Speed of the essence in complex operation

The complexity of co-ordinating and overseeing a major salvage operation and bringing it to a successful conclusion under demanding circumstances with full regard for the ship's schedule, the protection of the environment and the safe management of the salvage team, is no mean feat. Tsavlis Salvage Group takes us behind the scenes.

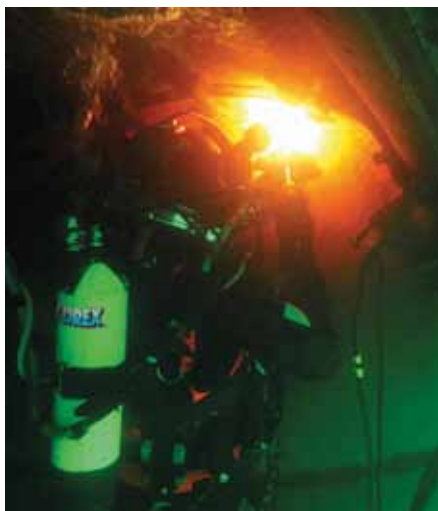
◀ Repairs to smaller areas of damage where the hull was holed or cracked.

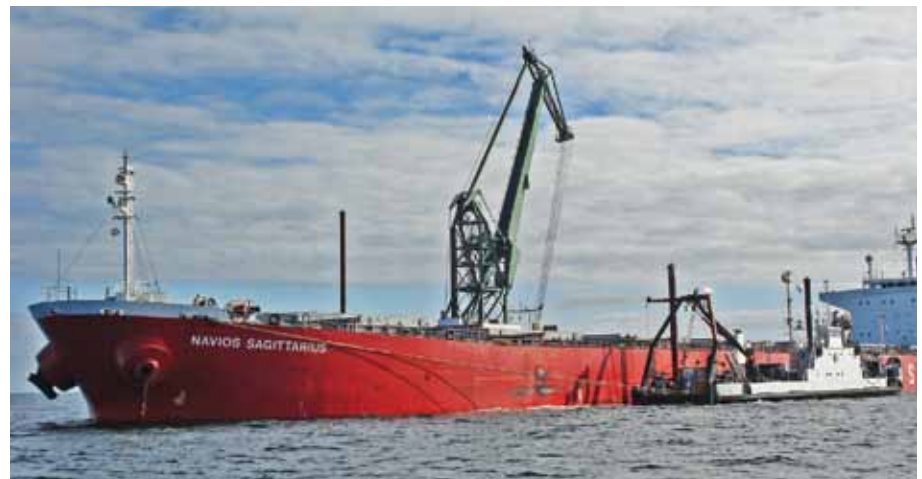
▶ The prefabricated insert was lowered into the water and pulled into place in the hull using chain blocks.

The repair was a combination of accurate engineering and precise cutting, fitting, assembly and welding. In the case of the section, it was necessary for divers to cut through the hull plates where the hull was distorted and broken. The prefabricated insert was lowered into the water by the crane barge and pulled into place with chain blocks.
