International **Tug & OSV**

May/June 2013

New dive support stations

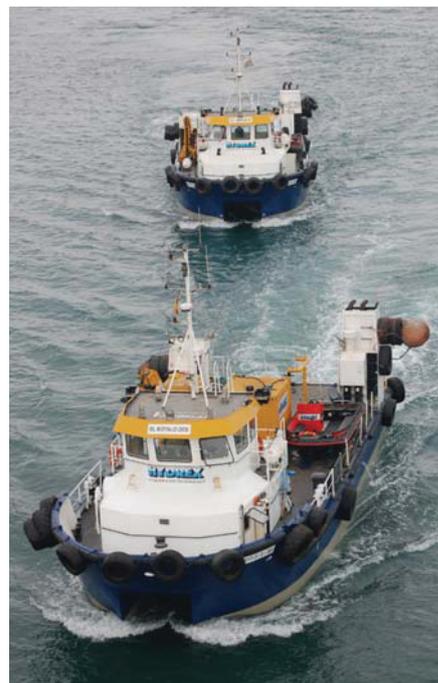
▲ *The new Hydrex workboats leaving for an operation in Rotterdam.*

The team was mobilised from the Hydrex headquarters in Antwerp with the vessels fully-equipped as dive support stations.

Dave Bleyenbergh, Hydrex production executive, told *IT&O*: "We wanted both vessels to be fully-equipped dive support and service stations. It was therefore important that they were equipped with hydraulic cranes, hydraulic winches, nautical and communication equipment, a dive control room and sleeping quarters operations in shifts around the clock."
